# TOYOTA

## SERVICE BULLETIN

REFERENCE AUDIO  
NUMBER 009  
DATE 08-18-89  
MODEL '89 MX

### '89 CRESSIDA SPEAKER STATIC DURING POWER MIRROR OPERATION

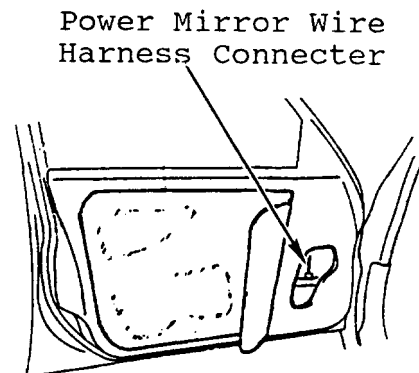
(Fig. 1)

To reduce the audio system's electric motor static noise during power mirror operation on the 1989 Cressida, a noise filter has been installed in the power mirror circuit.

1. Operate the power mirrors while listening to the audio system to confirm that the electric motor static noise is caused by power mirror operation.
2. Remove inner door panel and speaker from both front doors. **Repeat Steps 3 through 6 for both doors.**
3. Carefully pull back waterproofing plastic to uncover front service hole and locate power mirror wire harness connector. (See Figure 1.)
4. Unplug the connector and insert the Noise Filter (90980-05164) in-line.
