Technical Service BULLETIN

PORT INSTALLED RS3000 TVIP TRUNK & DOOR COURTESY CONNECTIONS

'99 Avalon

AX004-00 ACCESSORIES

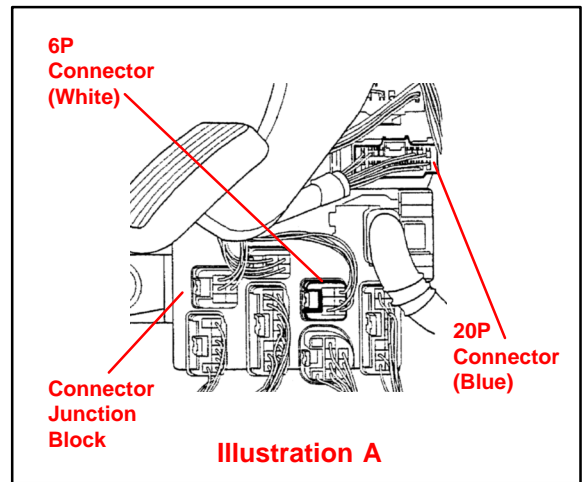
1. Remove the negative battery cable.
2. Remove the driver's step cover.
3. Remove the driver's cowl cover (1 nut).
4. Locate the Connector Junction Block in the driver's cowl area. You will notice a RED/WHITE wire routed to the White 6P connector which terminates at an adjacent splicing connector. This is the TVIP Door Courtesy Wire. You will also notice a GREEN wire routed to the Blue 20P connector located right above the Connector Junction Block. This is the TVIP Trunk Courtesy Wire.

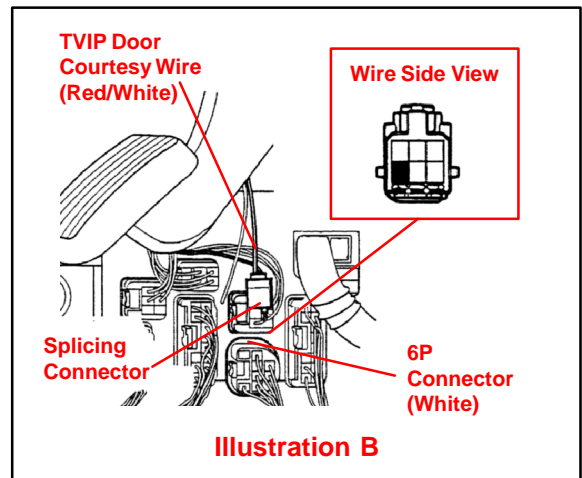
5. Disconnect the White 6P connector from the Connector Junction Block. With the tab of the White 6P connector facing up, look at the back (wire side) and locate the wire in the bottom row, third space from the right, which has the splicing connector attached to it. This is the Vehicle's door Courtesy Signal Wire. The RED/WHITE wire, that's also attached to the splicing connector, is the TVIP Door Courtesy Wire.

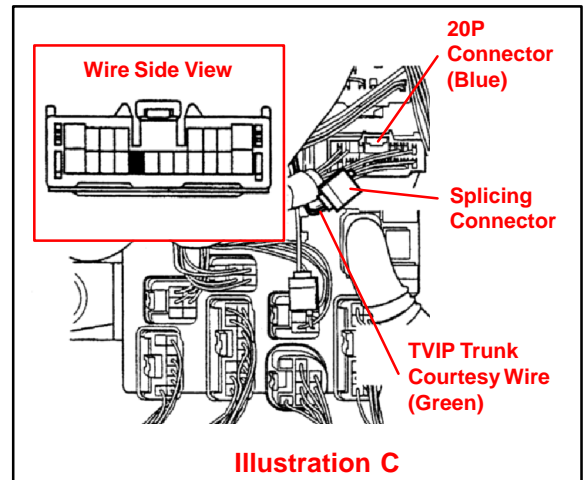
6. Disconnect the Blue 20P connector from above the Connector Junction Block. With the tab of the Blue 20P connector facing up, look at the back (wire side) and locate the wire in the bottom row, fifth space from the left, which has the splicing connector attached to it. This is the Vehicle's Trunk Courtesy Signal Wire. The GREEN wire, that's also attached to the splicing connector, is the TVIP Trunk Courtesy Wire.
7. After completing the parts inspection and repairs if applicable, reconnect the White 6P and the blue 20P connectors and install all previously removed parts.

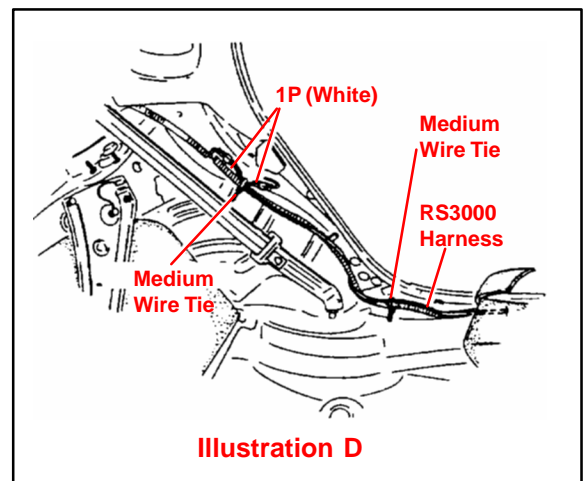
- The previous location is the same as the dealer installed RS3000 door courtesy connection to the door courtesy switch connectors on the driver side rear fender body panel. (Refer to page 3, Illustration D.)

1. The White 1P connector for the Vehicle's Door Courtesy Signal is located on the driver side rear fender wall.

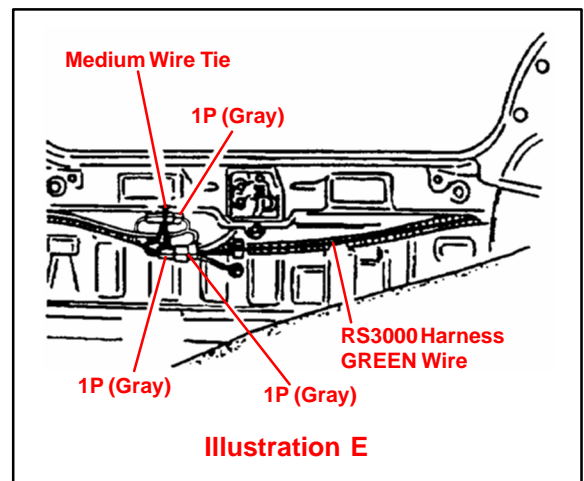
- The previous location is the same as the dealer installed RS3000 trunk courtesy connection to the luggage compartment light switch connectors. (Refer to page 3, Illustration E.)

2. The White 1P connector for the Vehicle's Trunk Courtesy Signal is located in the trunk compartment near the trunk latch.
