Technical Service BULLETIN

Title: ASHTRAY DOOR INOPERATIVE

Models: '00 – '01 Avalon

BODY
B0003-01

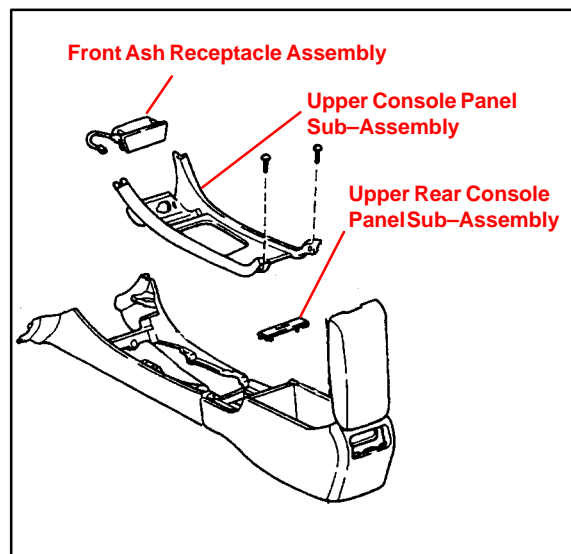
Introduction A field fix is available for incidents of the ashtray door not opening on 2000 and 2001 model year Avalon vehicles. Replace the ashtray receptacle with a revised part.

1. Set parking brake and move gear selector to "N".
2. Remove the upper rear console panel sub-assembly. Use a door panel removal tool to pry at the rear edge of the part.
3. Remove the upper console panel sub-assembly. Remove the two Phillips screws and pry the panel at the rear edge.
4. Remove the front ashtray receptacle assembly from the upper console panel sub-assembly.
5. Install the new front ash receptacle assembly onto the upper console panel sub-assembly. Assure the electrical connector is firmly installed and the door properly functions.
6. Reinstall all the removed parts in reverse order of removal. Assure all parts are properly aligned and fasteners are tight.
