**Technical Service
BULLETIN**

**WATER LEAK AT HEADLINER
OR FLOOR AREA**

'05 – '07 Avalon, '07 Camry, & '04 – '07 Solara

REVISÉD
B0005-07
BODY

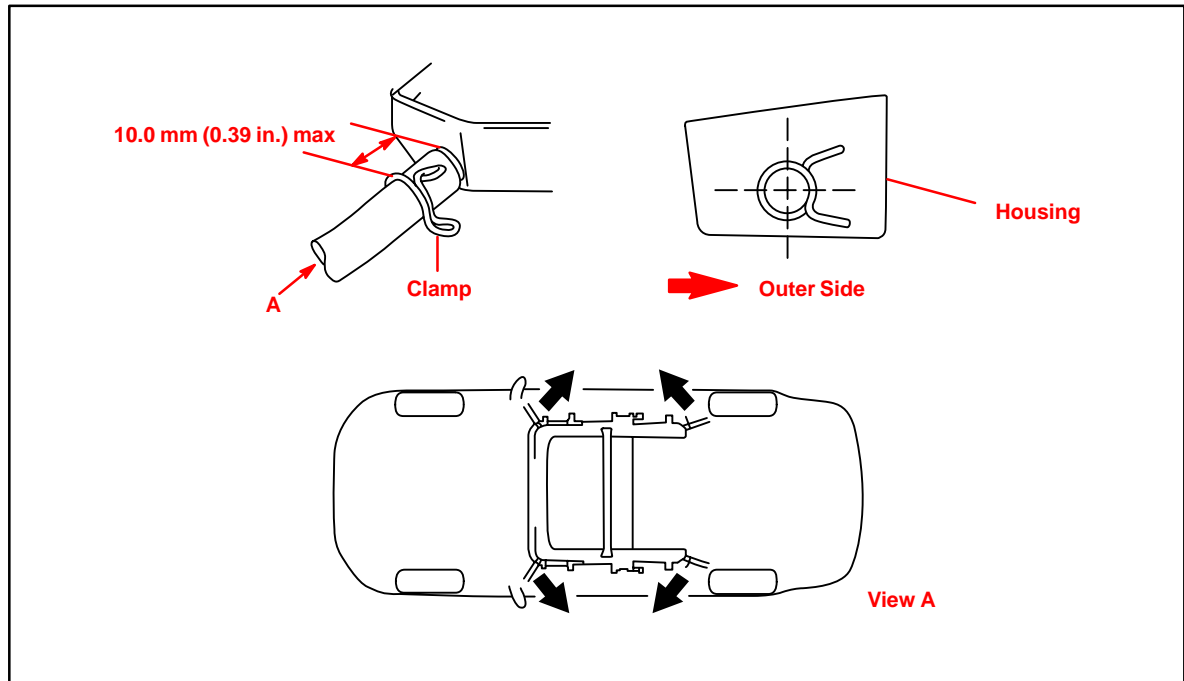
Introduction Some customers may experience a water leak condition in the headliner or possibly the foot well area. This condition may be the result of one or more moon roof drain hoses becoming loose or disconnected from a moon roof drain pan nipple. The following procedure describes the repair method to correct this condition.

1. Remove the headliner.
2. Remove all 4 drain hoses from the drain pan nipples.
3. Install the drain hose clamps as shown in the diagram:

When installing the drain hoses, the 4 clamps **MUST** face toward the outside of the vehicle and also be above the lower surface of the sliding roof housing.
