**Technical Service  
BULLETIN**

**WINDSHIELD WASHER FLUID LEAKING  
UNDER THE FRONT OF THE VEHICLE**

'05 – '07 Avalon

**BODY**  
**B0008-07**

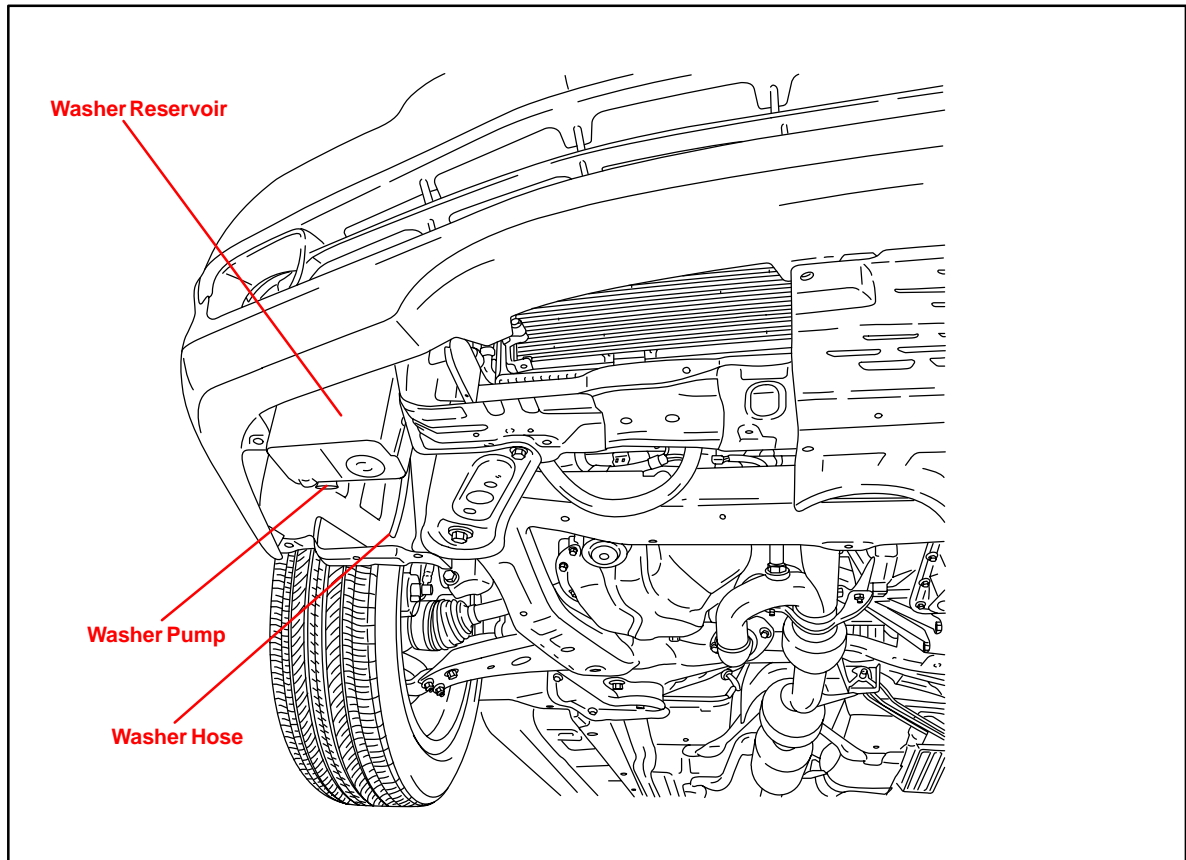
**Introduction** Some 2005 – 2007 model year Avalon customers may complain that the windshield washer low fluid light is illuminated and that fluid is leaking out under the front of the vehicle. The leak may be caused by the washer hose having fallen off or separated from the washer pump. Use the following repair procedure to improve this condition.

1. Remove the RH side plastic engine under cover (5 bolts and 3 push clips).
