SERVICE BULLETIN

REFERENCE BODY
NUMBER 027
DATE 01-19-90
MODEL 4RUNNER

4RUNNER RUNNING BOARD APPEARANCE

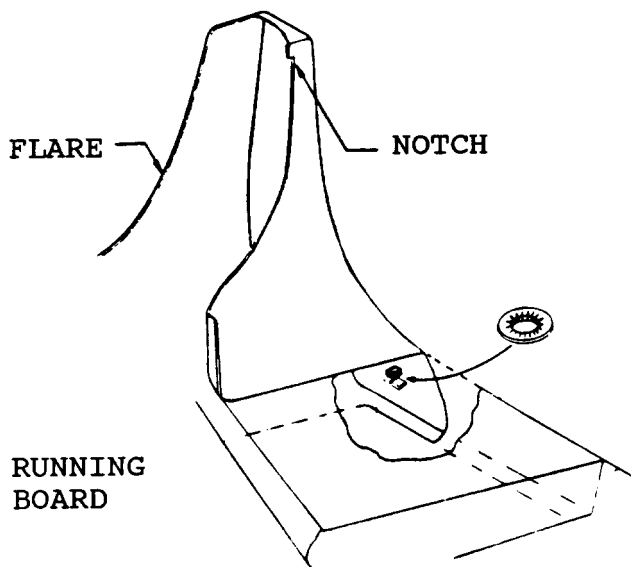
CONDITION #1: A gap between the end cap and the face of the running board is caused when the Carat (securing tab) pops out when weight is applied on the surface of the step pad.

CAUSE: The end cap Carat (securing tab) does not have enough retention to keep it securely fastened in the retention slot in the step assembly.

CORRECTION: Install the internal tooth lock ring on the end cap Carat after the Carat has been inserted in the running board receiving slot (see detailed instructions below).

LOCK RING

(1) SIDE VIEW OF CARAT
(install toothed lock ring into
gap between 2 tabs of carat)

(2) SIDE VIEW OF CARAT
(push outside of ring firmly
down to step plate)

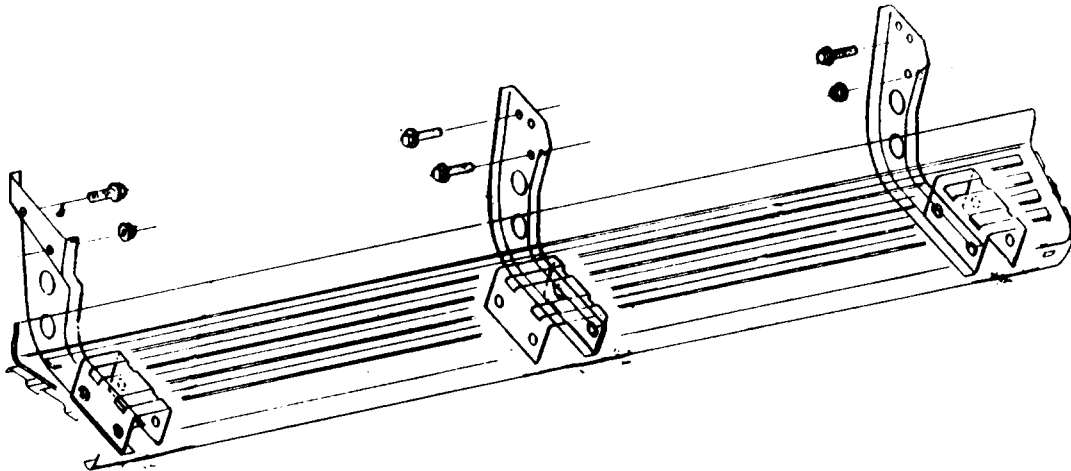
CONDITION #2: The horizontal surface of plastic step pad has a distorted (wavy) appearance.

CAUSE: The vertical surface of the black plastic step pad becomes lodged behind the pinch weld located just below the rocker panels.

CORRECTION: The following procedure will allow for greater overlap of the pinch weld by the vertical portion of the step pad:

Slightly loosen the six (6) running board mounting bolts (just enough to allow the repositioning of the running board). Rotate the three (3) running board brackets inward and upward as shown below. Hold the running board up in position against the pinch weld area as you tighten the mounting bolts to the proper torque value.

Note: Be sure to check the gap between the top of the end cap flare where it meets the body of the vehicle and the bottom of the end cap flare where it meets the step plate surface of the running board. Too much rotation of the running board will cause the above mentioned gap.
