**Technical Service
BULLETIN**

ACCESSORY DRIVE BELT NOISE

'03 4Runner (1GR-FE)

ENGINE
EG012-03

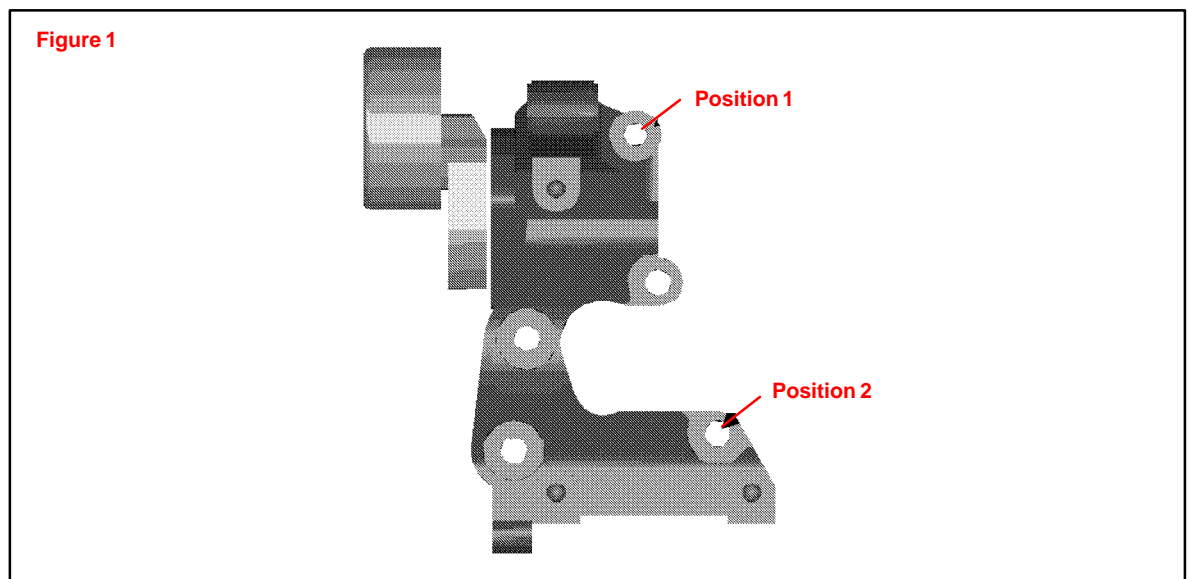
Introduction On some 2003 model year 4Runner vehicles equipped with the 1GR-FE V6 engine, under certain conditions, the accessory drive belt may make a “squealing” or “chirping” sound when the engine is first started. An improved auto tensioner assembly, flange bolt, V-rib belt, and service procedure have been developed to correct the condition.

4. Remove the five bolts holding the auto tensioner assembly to the engine block and remove the auto tensioner assembly from the engine.
5. Install the NEW auto tensioner with the NEW flange bolt in Position 1 and one of the previously removed bolts in Position 2 as shown in Figure 1 below. Install the two bolts finger–tight. Then first torque the flange bolt in Position 1 to 27 ft•lbs and then torque the bolt in Position 2 to 27 ft•lbs. Lastly, tighten the other three bolts to 27 ft•lbs.

Torque: 36 N•m (373 kgf•cm, 27 ft•lbs)
