**Technical Service
BULLETIN**

**BLOWER MOTOR IMPROVED
DURABILITY**

'98-'99 Land Cruiser

HEATING & AIR CONDITIONING
AC004-99

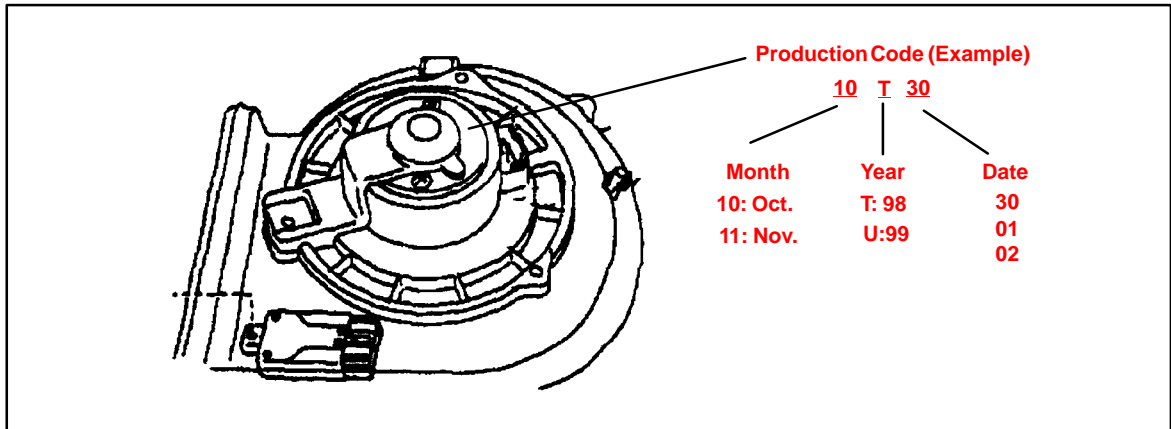
The current production part can be identified by the production code stamped on the motor housing. Confirm that the replacement code begins with 11T, 12T, 01U or higher.

2. After confirming blower controller operation is normal, replace the front blower motor with a current production part.
