# TOYOTA Technical Service BULLETIN

## Title: **BODY MOUNT NOISE**

Models:  
**'03 4Runner**

NVH  
NV002-04

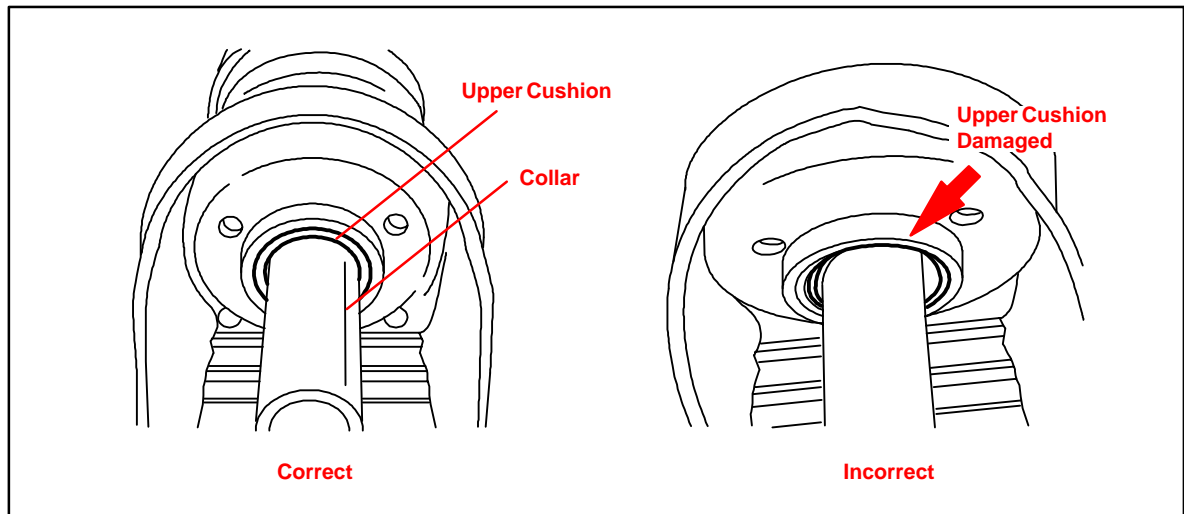
Before performing field fix procedures contained in this bulletin, remove the nut, flat washer and lower cushion from the left front body mount, or any other body mount that exhibits noise, and inspect the upper cushion for damage as shown below. If the upper cushion is damaged, out of position, and/or contact between the bolt collar and the frame body mounting flange is evident, follow the procedures provided below.
