# TECHNICAL SERVICE BULLETIN

REF.: AUDIO  
NO.: AU91-006  
DATE: DECEMBER 27, 1991  
MODEL: ALL MODELS

## CASSETTE INOPERATIVE ON '90 RADIOS (56400/A56400) & '91 RADIOS (56401/A56401)

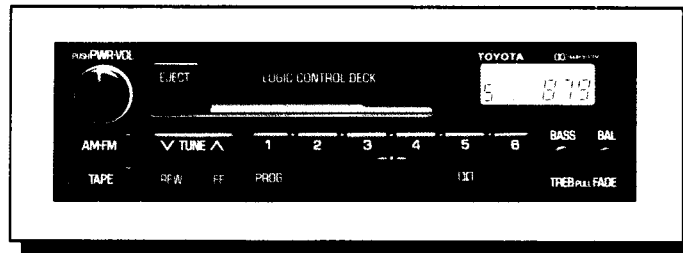
To prevent electrostatic discharge to the cassette section, the ground path between the faceplate and the radio chassis has been improved on the following Panasonic radios:

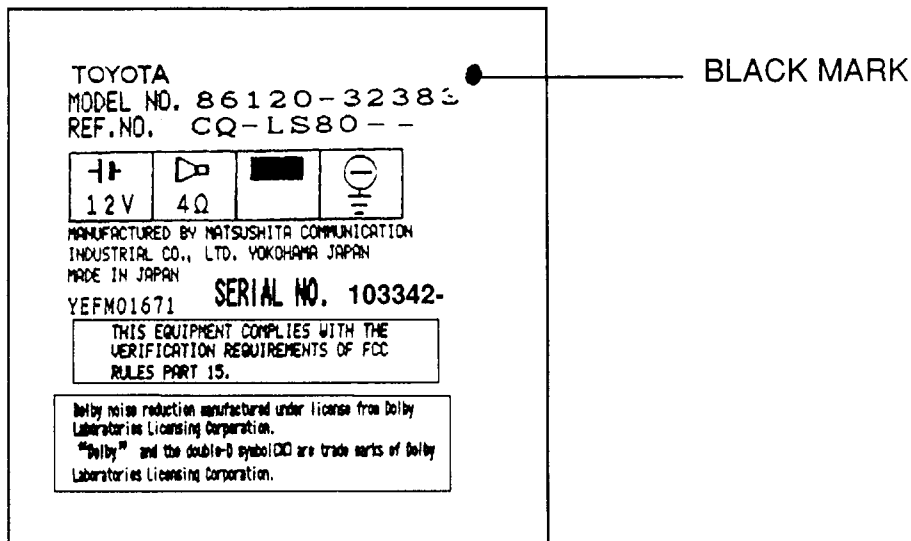
Panasonic began shipping improved exchange units on 5/91. Exchange radios with the counter-measure will have a black mark on the upper right corner of the serial number ID label as shown below.

To release the tape, remove the Dome fuse for 30 seconds to reset the radio. Eject the cassette, then exchange the radio through Panasonic's exchange program.
