Difficulty Closing Glove Box

Service Category Vehicle Interior

Section Interior Panels/Trim

YEAR(S)	MODEL(S)	ADDITIONAL INFORMATION
2009	Matrix

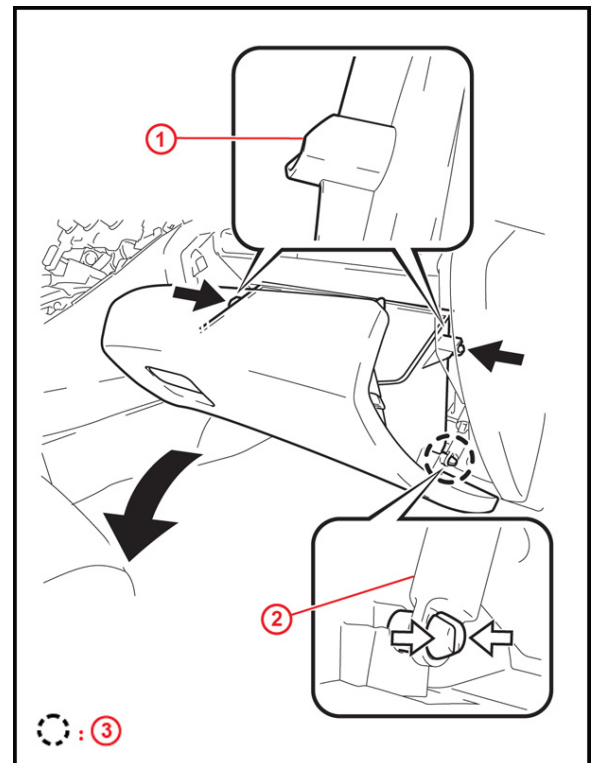
Figure 1.

1	Stopper
2	Glove Compartment Door Stopper
3	Claw

3. Remove the glove box door.
 - A. Disengage the claw and release the glove box door stopper.
 - B. Open the glove box door past the stops in the direction indicated by the arrows in the illustration. Release the 2 stoppers and lower the glove box door until the glove box door is parallel to the floor.

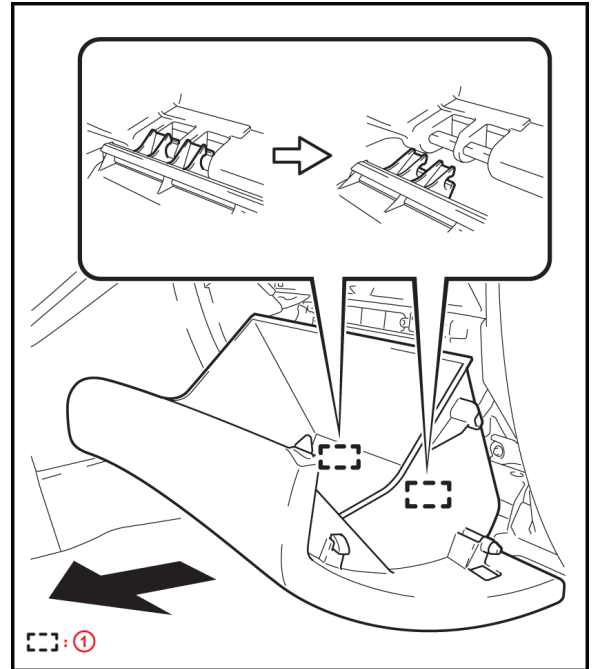
Figure 2.

1	Hinge
---	-------

- C. Pull the glove box door horizontally toward the rear of the vehicle to release the 2 hinges, and remove the glove box door.

Pulling the glove box door upward to remove it causes the hinges to deform. Be sure to pull out the glove box door horizontally.

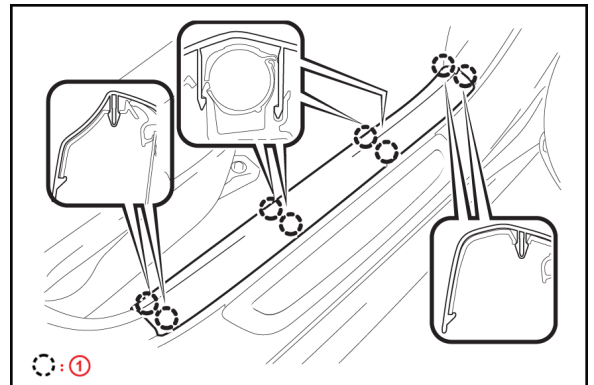
Figure 3.

1	Claw
---	------

- 4. Disengage the 8 claws and remove the RF door scuff plate.

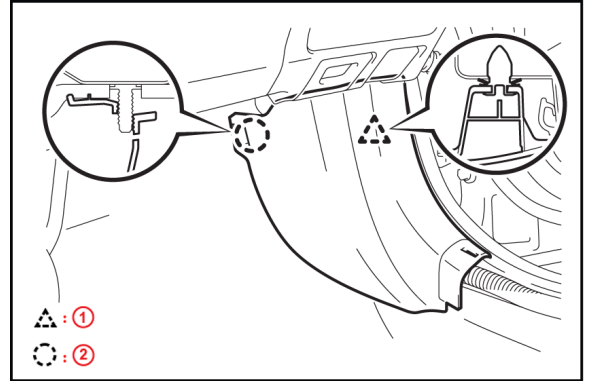
Figure 4.

1	Clip
2	Claw

5. Disengage the clip and claw, and remove the RF cowl side trim board.

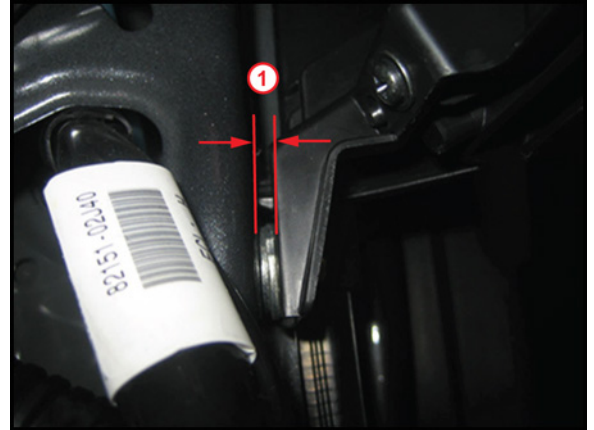
Some 2009 model year Matrix vehicles may exhibit a condition where the latch on the LEFT side of the glove box will not properly engage the instrument panel causing the glove box door to fall open and making it difficult to close. The following repair procedure has been developed to correct this condition.

1	4 mm (5/32 in.) Washer
----------	-------------------------------

7. Gently pull back the lower RIGHT side of the lower instrument panel and insert a 4 mm (5/32 in.) thick washer between the lower instrument panel and the body of the vehicle as shown in Figure 6.

8. Reinstall the lower instrument panel bolt with the 4 mm (5/32 in.) washer in the center.
9. Reinstall the RF cowl side trim board, RF door scuff plate and the glove box door.
10. Verify that the latch on the LEFT side of the glove box door properly latches into the instrument panel and that the glove box door remains closed.
