SERVICE BULLETIN

NUMBER 008

DATE 09-14-90

DOM FUSE INSTALLATION DURING PDS ON '91 MR2

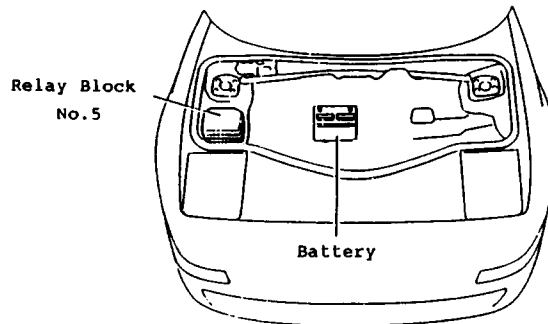
The dome fuse is located in Relay Block No. 5 in the front luggage compartment as shown.

To reduce battery discharge during transportation and pre-delivery storage, all 1991 MR2s will be delivered to the dealer with the dome fuse (15A) removed. The dome fuse must be reinstalled during the pre-delivery service.

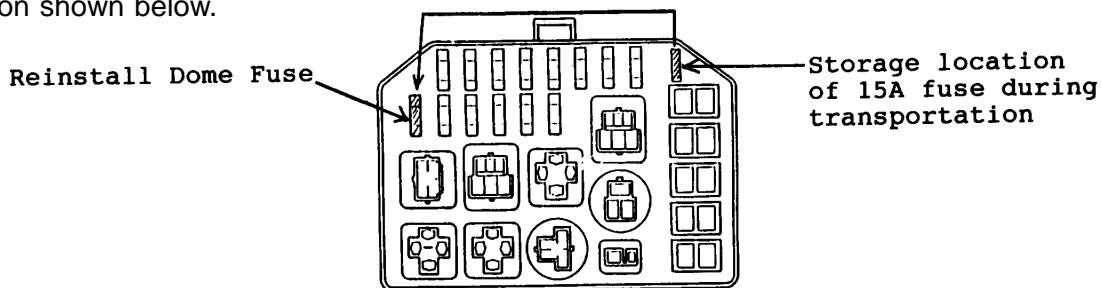
The 15A fuse is stored in Relay Block No. 5 during transportation. Reinstall the dome fuse in the location shown below.

The following systems will be affected if the CIG Fuse is not installed:

FUZE		Affected Electrical System
Dome	15A	Interior Lights
		Clock
		Audio System
		Theft Deterrent Computer
