**Technical Service
BULLETIN**

DOOR WIND NOISE IMPROVEMENT

'01 – '05 Highlander

NV002-05

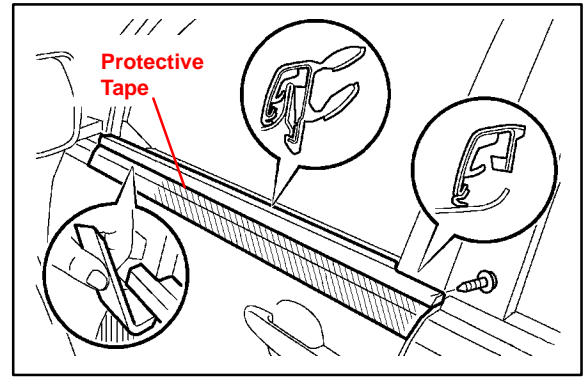
Introduction Some vehicles may exhibit wind noise coming from both the front and rear door window glass. The following repair has been developed to improve this condition.

- E. Remove front door belt molding assembly LH.
 - a. Remove the screw.
 - b. Put protective tape under the molding (i.e., masking tape, body shop tape).
 - c. Using a molding remover or scraper, remove the molding.
