Technical Service BULLETIN

ECM CALIBRATION UPDATE: M.I.L. "ON" DTC P0420 AND/OR P0430

'01 – '03 Highlander (2AZ-FE)

ENGINE
EG041-05

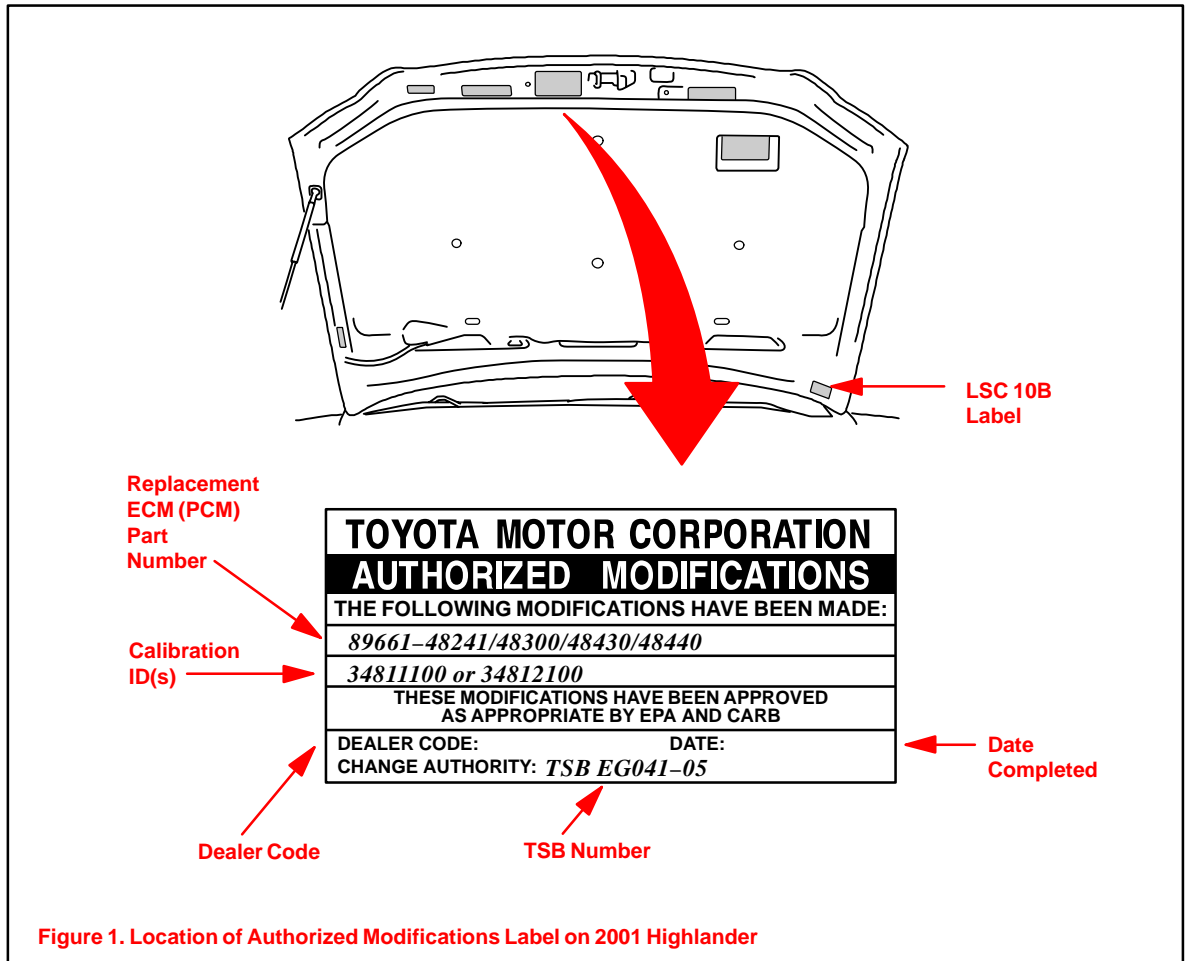
1. Check for the Authorized Modifications Label affixed to the vehicle in the location shown in Figure 1. Confirm if ECM (PCM) calibration has been updated. If NOT the latest ECM (PCM) calibration — go to step 2.

Figure 1. Location of Authorized Modifications Label on 2001 Highlander

1. Follow the procedures outlined in TSB No. SS002-01, "ECU Flash Reprogramming Process," and flash the ECM (PCM) with the new calibration file update.
2. Enter the required information on the Authorized Modifications Label and affix it to the vehicle at the location shown in Figure 1 (page 3). The Authorized Modifications Label is available through the MDC, P/N 00451–00001–LBL.

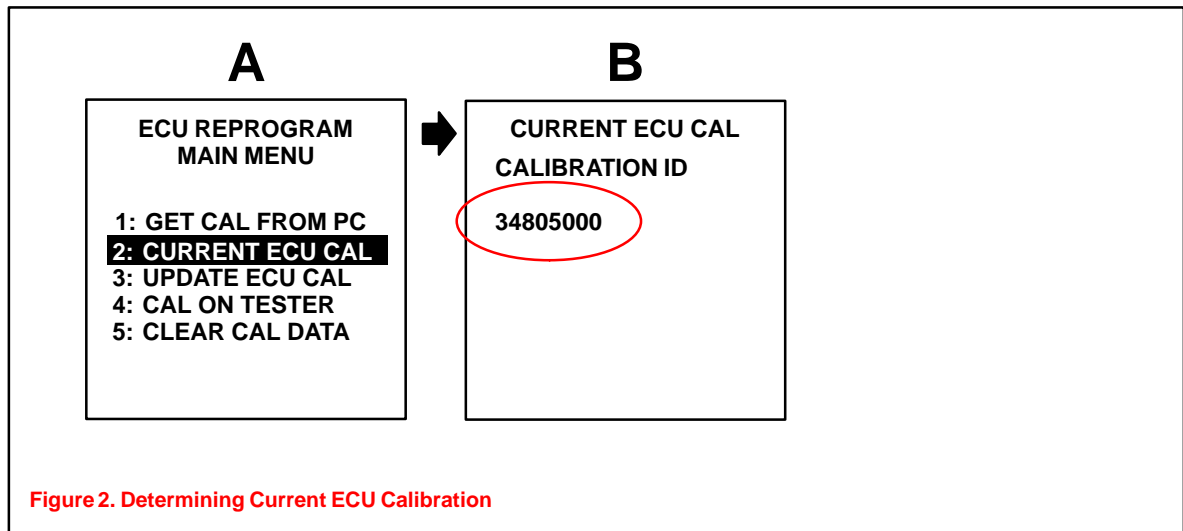
2. Connect the Diagnostic Tester to the vehicle and select CURRENT ECU CAL from the ECU REPROGRAM MAIN MENU. Determine the vehicle's current ECU calibration (see Figure 2).
 - The sample screen prints seen below are the 13.0a software version and may differ from subsequent software versions.

- If Calibration ID matches "Previous Calibration ID" as shown in Calibration Identification Chart on page 2, proceed with flash reprogramming.
- If Calibration ID matches "New Calibration ID" as shown in Calibration Identification Chart, this vehicle has already been programmed. Refer to the Technical Information System (TIS) for diagnostic procedures applicable to any stored DTCs.
