TECHNICAL SERVICE BULLETIN

REF.: ELECTRICAL
NO.: EL91-011
DATE: DECEMBER 27, 1991
MODEL: SW

IMPROVED WATERPROOFING OF DOOR WIRE HARNESS

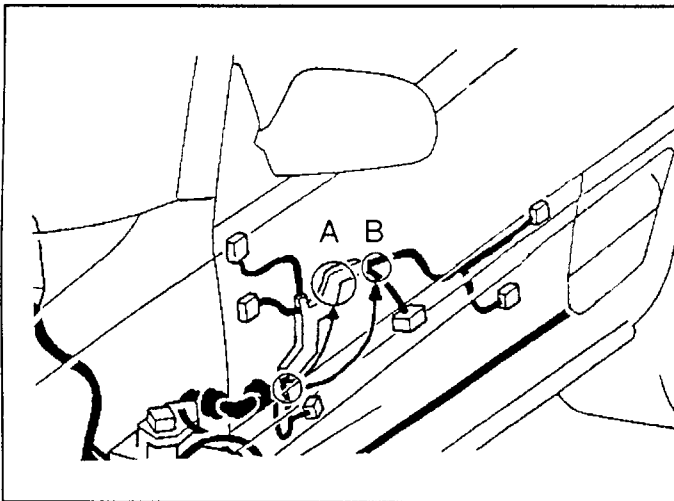
The door wire harness on the 1992 MR2 has been modified to reduce the possibility of water entry into the harness.

The splice points have been moved to "A" or "B" position depending on the wire harness (Refer to page 2).

The following conditions may result from water entering the wire harness splice:

- 1) Door speakers cut-out or are inoperative.
- 2) Radio is inoperative.
- 3) Erratic operation of dome light.

In case of severe corrosion, replace the affected door wire harness (left or right) with the appropriate new part. In case of minor corrosion, replace the corroded terminals and connector as necessary in accordance with the wire harness repair manual. The table below lists the available connector bodies and pins:
