Instrument Panel Rattle Noise

YEAR(S)	MODEL(S)	ADDITIONAL INFORMATION
2009	Corolla, Matrix

TSB REVISION NOTICE

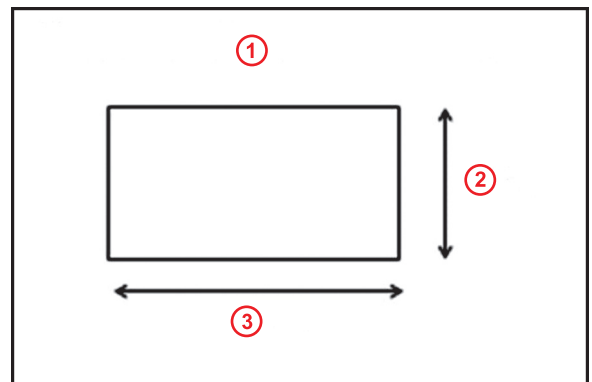
Figure 1.

1	35 mm X 60 mm; t: 0.5 mm
2	35 (L)
3	60 (W)

1. From the interior noise kit use the 0.5 mm felt and cut 3 sections to the following dimensions.

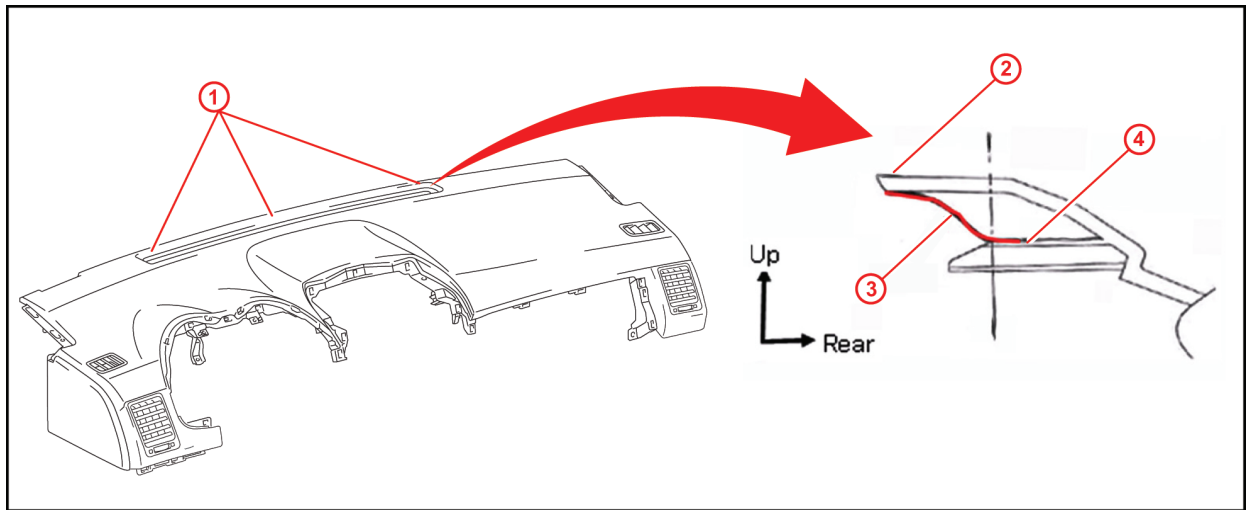
Figure 2.

1	Contact Points
2	Exterior Surface of Dashboard
3	Felt
4	Inserted Completely

2. Apply the cut felt section to the Dashboard clips that contact the cowl panel (3 locations).

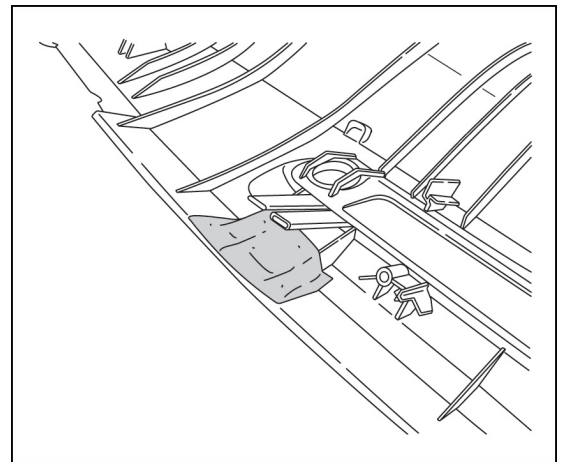
Figure 3.

Figure 3 shows the correct felt application to the dashboard clips (dashboard is upside down to show felt condition).

3. After felt application, it should resemble this condition (Dashboard is up-side-down for purpose of showing felt condition).

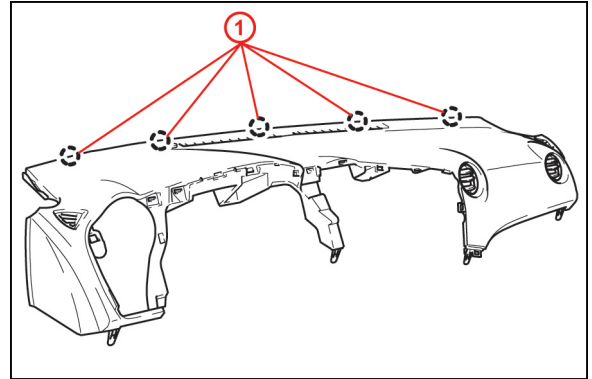
Figure 4.

1	Clips
----------	--------------

1. Add felt to the following locations at the contact points between the dashboard and cowl panel.

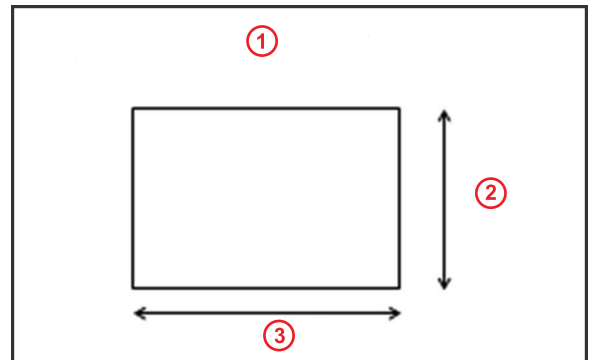
Figure 5.

1	40 mm X 50 mm ; t:0.5 mm
2	40 (L)
3	50 (W)

- A. From the interior noise kit use the 0.5 mm felt and cut 2 sections to the following dimensions.

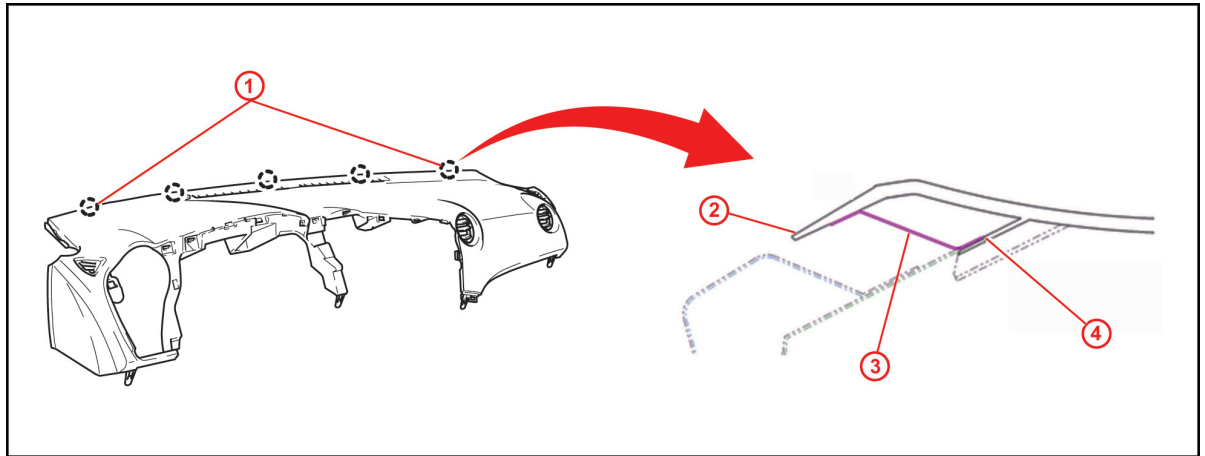
Figure 6.

1	Contact Points
2	Exterior Surface of Dashboard
3	Felt
4	Inserted Completely

B. Apply the cut felt section to the Dashboard clips that contact the cowl panel (2 locations).

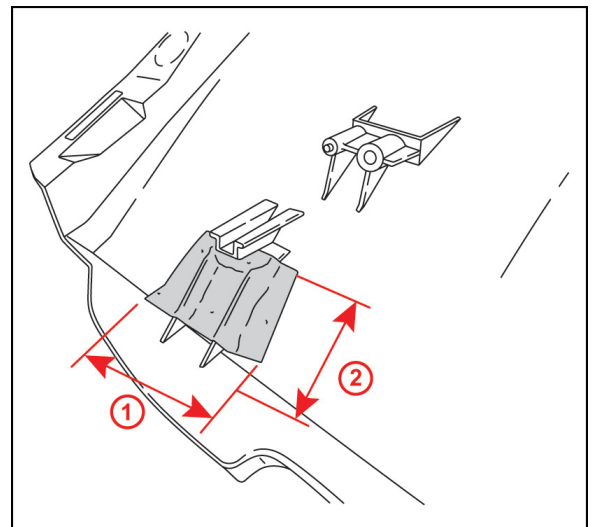
Figure 7.

1	50 mm
2	40 mm

C. After felt application, it should resemble this condition (Dashboard is up-side-down for purpose of showing felt condition).

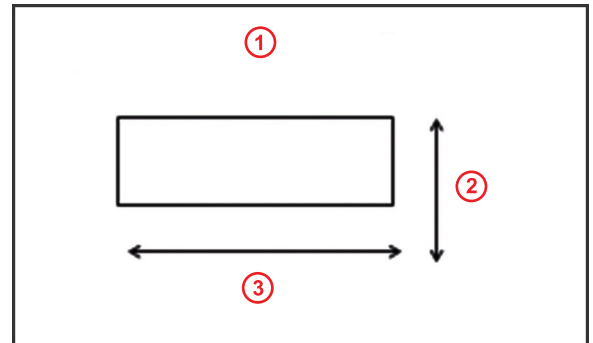
Figure 8.

1	13 mm X 30 mm ; t: 0.5 mm
2	13 (W)
3	30 (L)

A. From the interior noise kit use the 0.5mm felt and cut 3 sections to the following dimensions

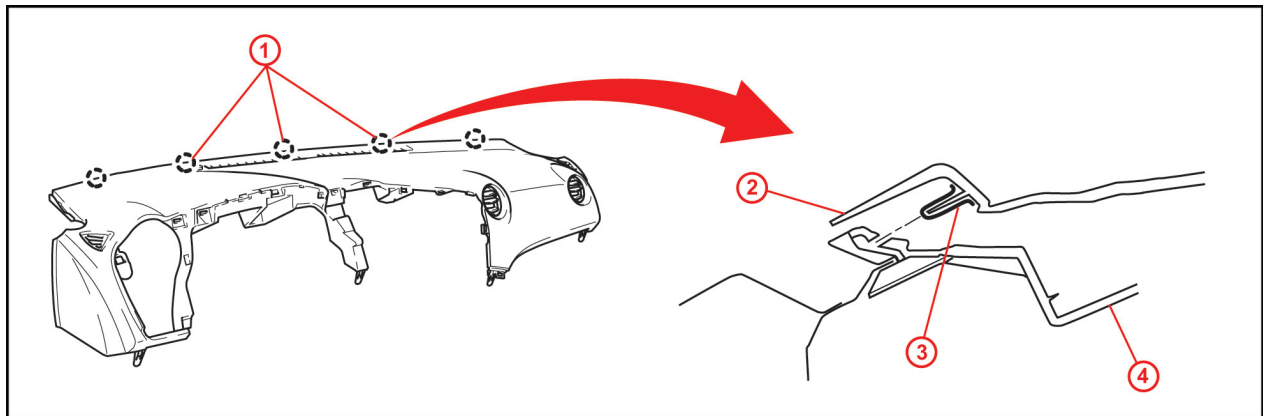
Figure 9.

1	Clips
2	Upper Instrument Panel
3	Felt
4	Safety Pad

B. Apply the cut felt section to the Dashboard clips that contact the cowl panel (3 locations).

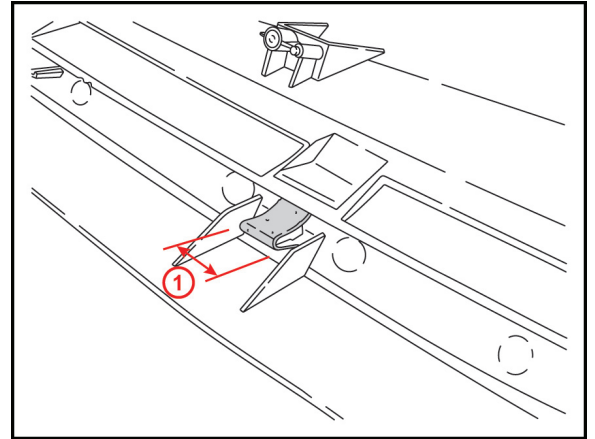
Figure 10.

1	13 mm
---	-------

- C. After felt application, it should resemble this condition (Dashboard is upside-down for purpose of showing felt condition).
