# TOYOTA

## SERVICE BULLETIN

HEATING &  
AIR CONDITIONING  
REFERENCE \_\_\_\_\_  
NUMBER 008  
DATE 11-10-89  
MODEL 1990 4Runner

### INTERFERENCE BETWEEN A/C CONDENSER AND FRONT CROSSMEMBER GUSSET

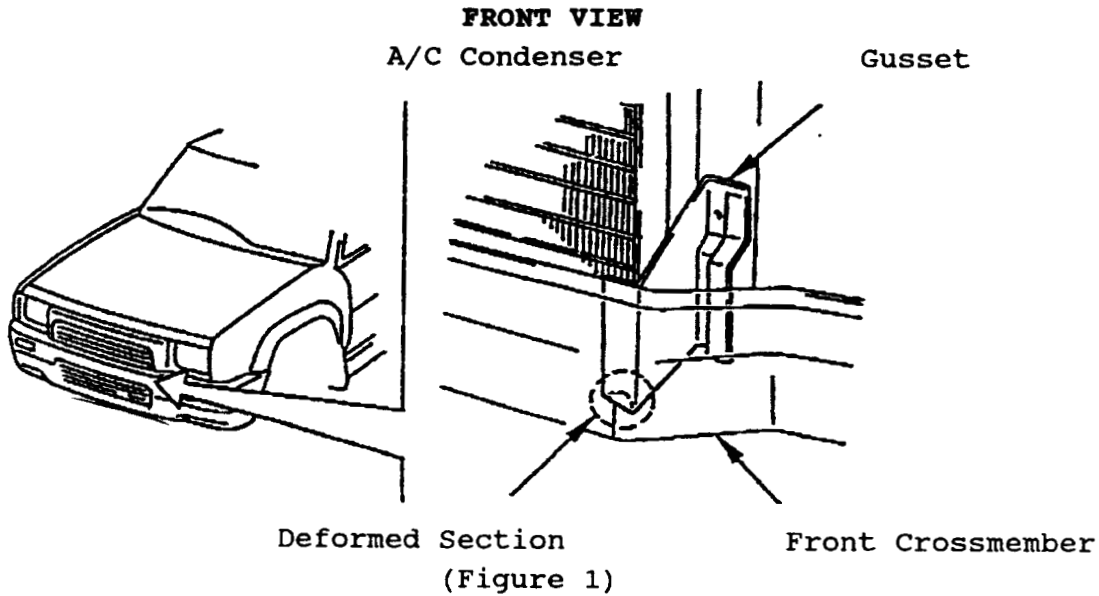
Interference between the front lower left section of the A/C Condenser and the left front Crossmember Gusset on 1990 4Runner may result in damage to the A/C Condenser. This damage may occur during installation or afterwards in service.

- 1) Check the left front Crossmember Gusset for deformation (see Figure 1).
- 2) If the left front Crossmember Gusset is deformed, use the **REPAIR PROCEDURE** (see Figure 2).
