Technical Service BULLETIN

Title: **M.I.L. "ON" DTC P0770**
Models: **'02 4Runner & Tacoma V6**

ENGINE
EG025-02

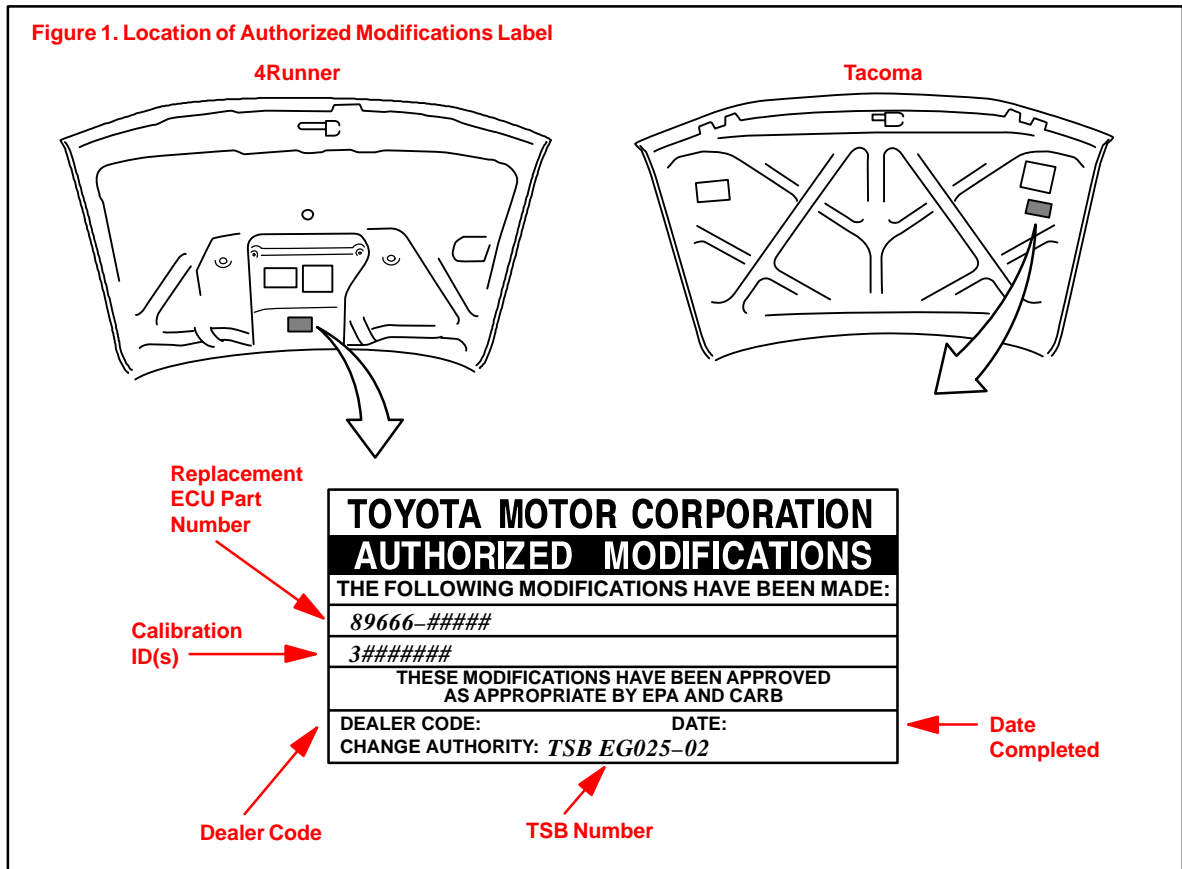
2. Check for Authorized Modifications label affixed to the vehicle in the location shown in Figure 1. Confirm if ECM (PCM) calibration has been updated. If no label or label does not list the "New Calibration ID Number" listed above – Go to Step 3.

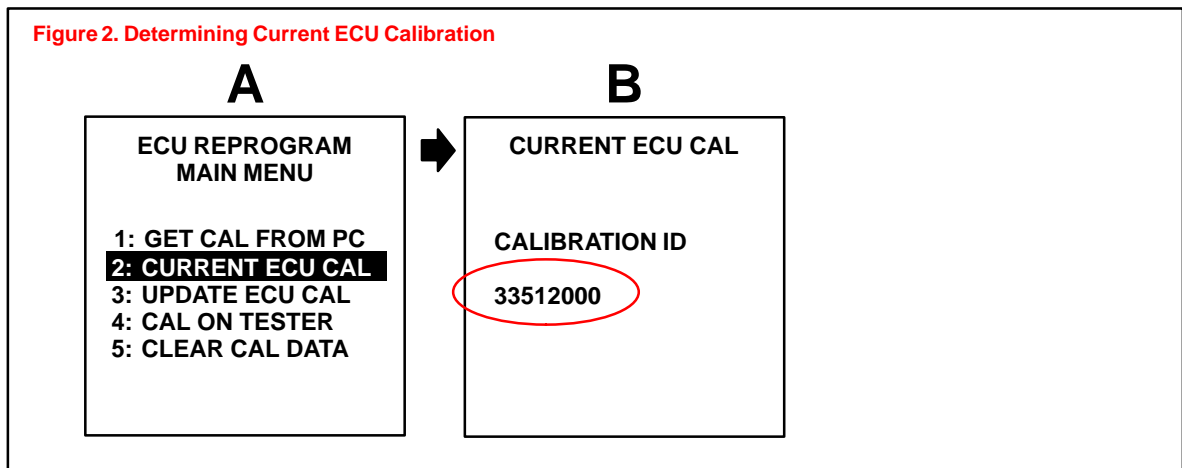
3. Connect the Diagnostic Tester to the vehicle and select CURRENT ECU CAL from the ECU REPROGRAM MAIN MENU. Determine the vehicle's current ECU calibration (see Figure 2).

- If Calibration ID matches "Previous Calibration ID" as shown on page 1, proceed with flash reprogramming.
- If Calibration ID matches "New Calibration ID" as shown on page 1, this vehicle has already been reprogrammed. Refer to Repair Manual for diagnosis.

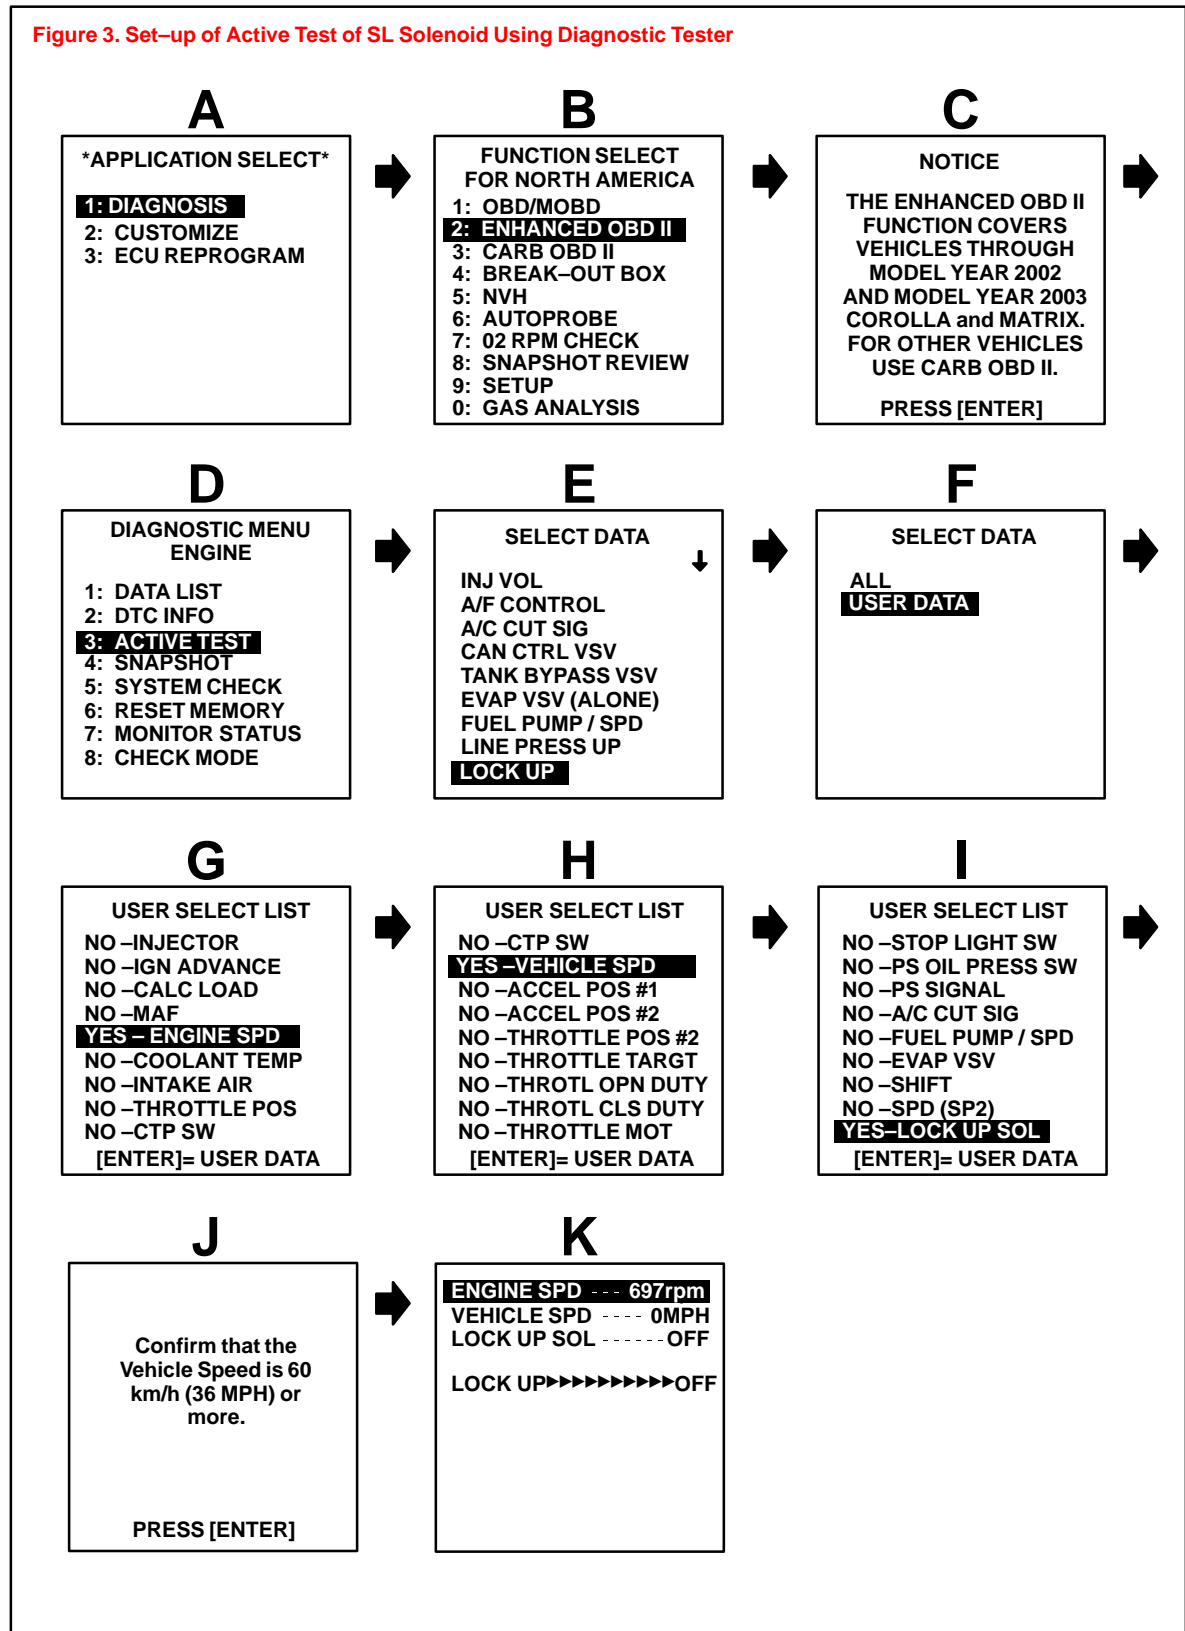
5. Perform Active Test of lockup Solenoid (SL Solenoid or Solenoid "E") using Diagnostic Tester.
 - A. Set up Diagnostic Tester (see Figure 3).

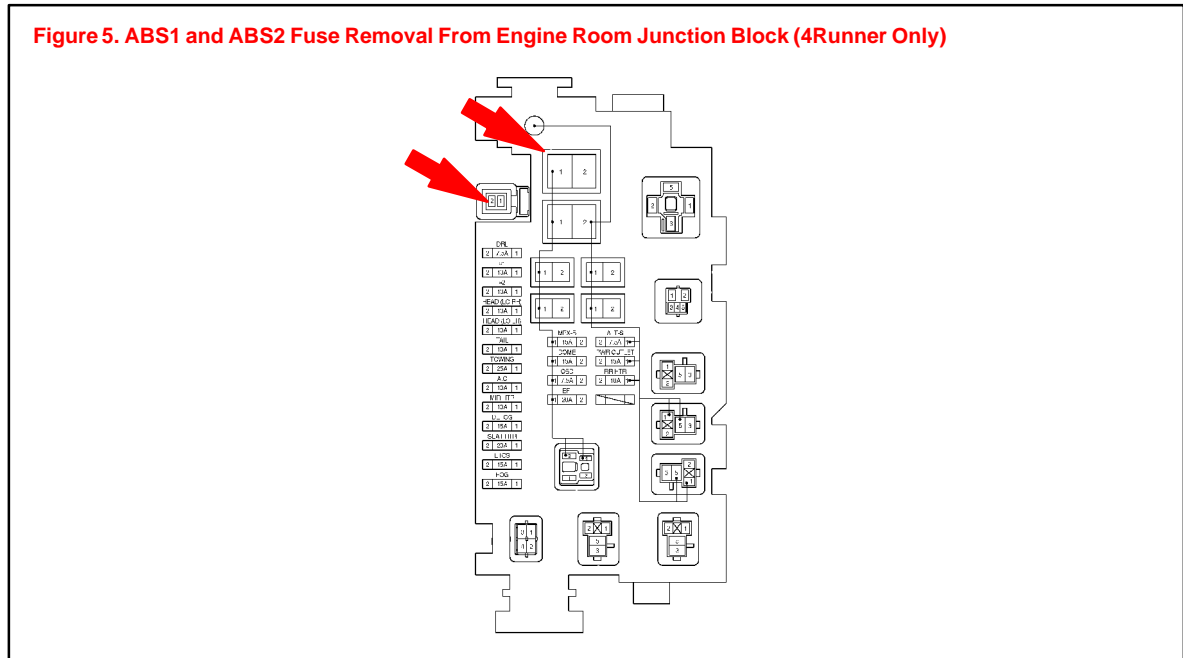
1. **4Runner only:** Remove the ABS1 and ABS2 fuses from Engine Room Junction Block (see Figure 5.)

2. Follow the procedures outlined in TSB SS002–01, “ECU Flash Reprogramming Process,” and flash the ECM (PCM) with the new calibration file update.
3. Enter the required information on the Authorized Modifications Label and affix it to the vehicle at the location shown in Figure 1 (page 3). The Authorized Modifications Label is available through the MDC, P/N 00451–00001–LBL.
4. **4Runner only:** Reinstall the ABS1 and ABS2 fuses (Figure 5.)
5. Use the Diagnostic Tester to delete any ABS/VSC DTCs that may have been set during this repair procedure.
6. Calibration update is complete.

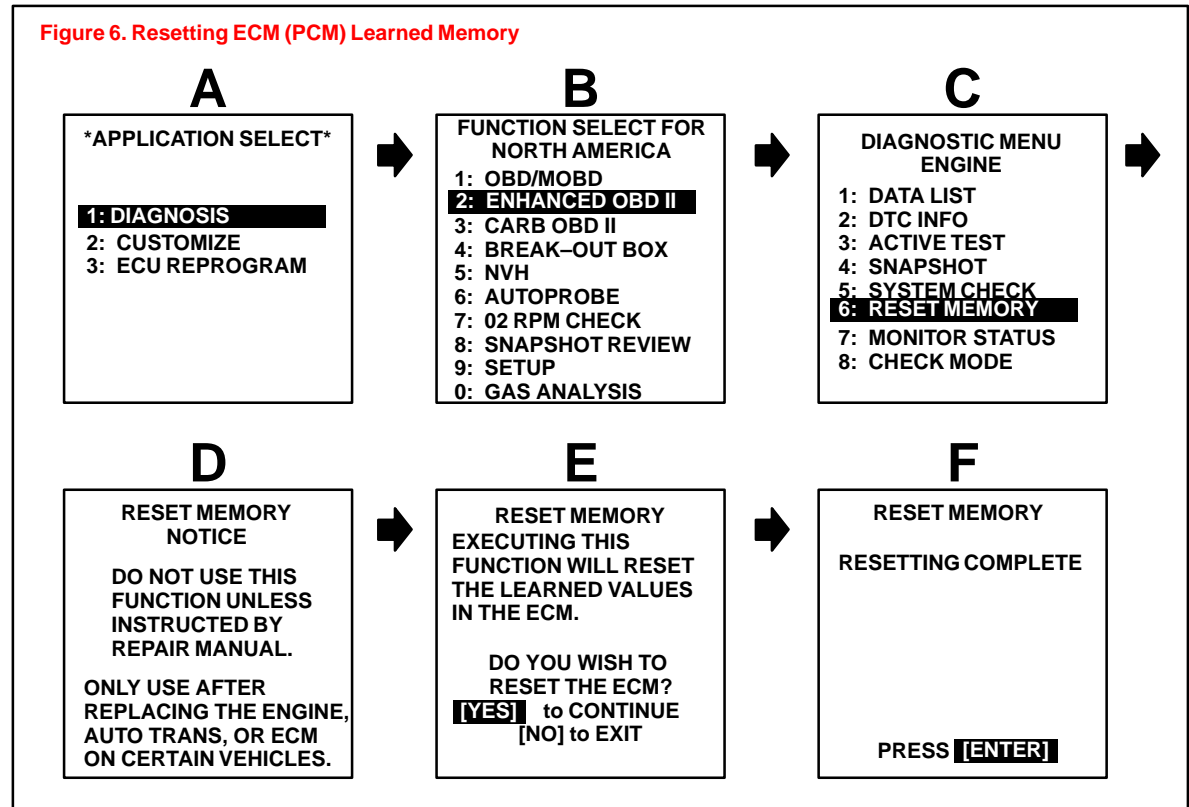
1. Replace valve body assembly per TIS or applicable Repair Manual (2002 Tacoma, Volume 2, Automatic Transmission [A340E, A340F] or 2002 4Runner, Volume 2, Automatic Transmission).
2. Reset the ECM (PCM) learned and memory values. Refer to the procedures below (Figure 6).
