**Technical Service
BULLETIN**

**M.I.L. "ON" VVTi DTCs — OIL CONTROL
VALVE (OCV)**

'08 Highlander

ENGINE
EG003-08

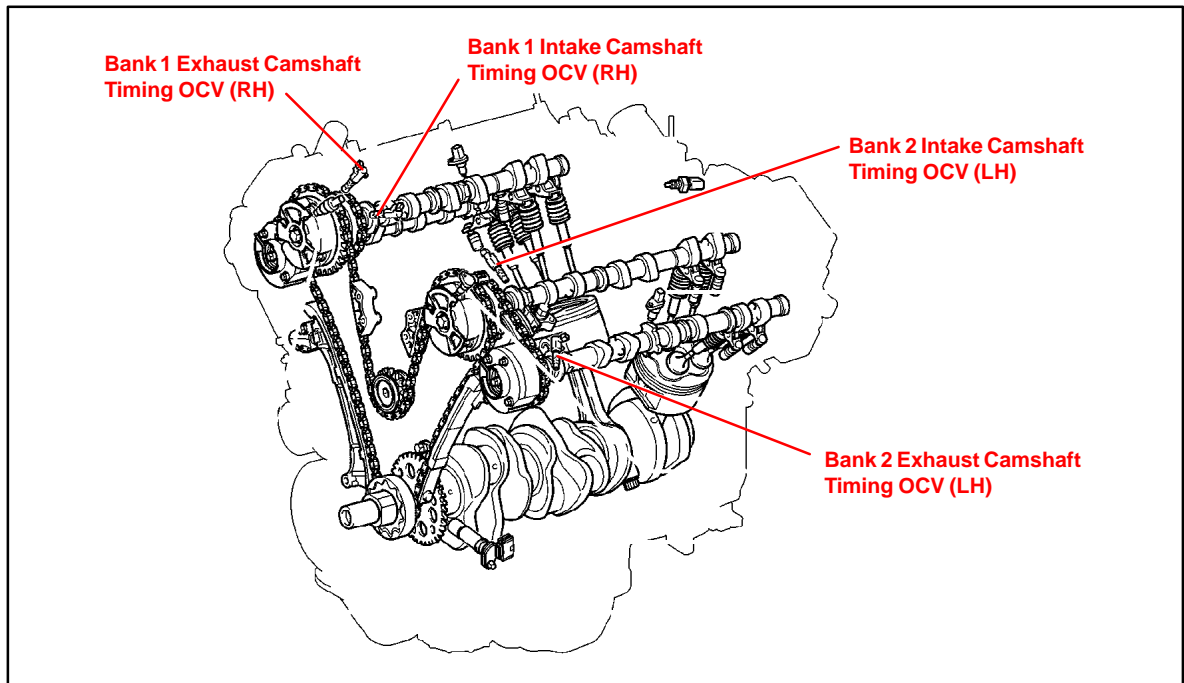
NOTE:
Removal of the intake air surge tank is NOT necessary for R & R of either Bank 2 OCV.

Remove and replace the affected OCV.
