TECHNICAL SERVICE BULLETIN

REF.: AUDIO
NO.: AU91-001
DATE: APRIL 26, 1991
MODEL: SW

NOISE ON 1991 MR2 AUDIO SYSTEMS

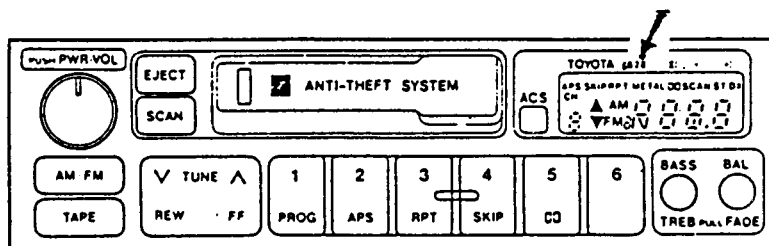
ID Code: 6628 and 51702

Part Number: 86120-89145
86120-17260

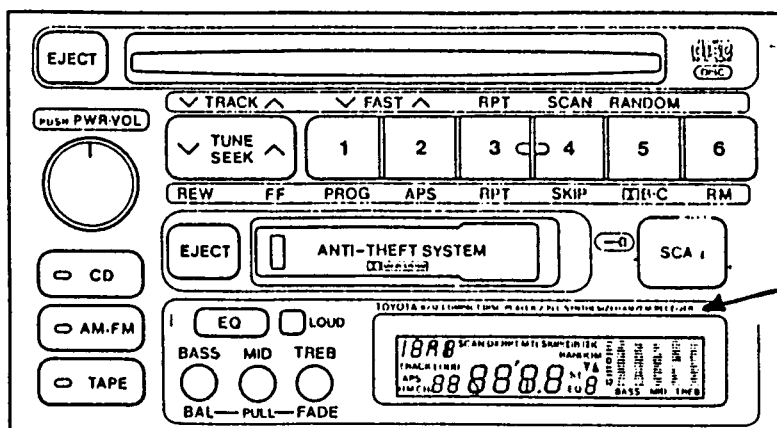
ID Code: 56802

Part Number: 86120-17270
