Technical Service BULLETIN

RUST ON BACK DOOR GARNISH

'06 – '07 4Runner

BODY
B0010-07

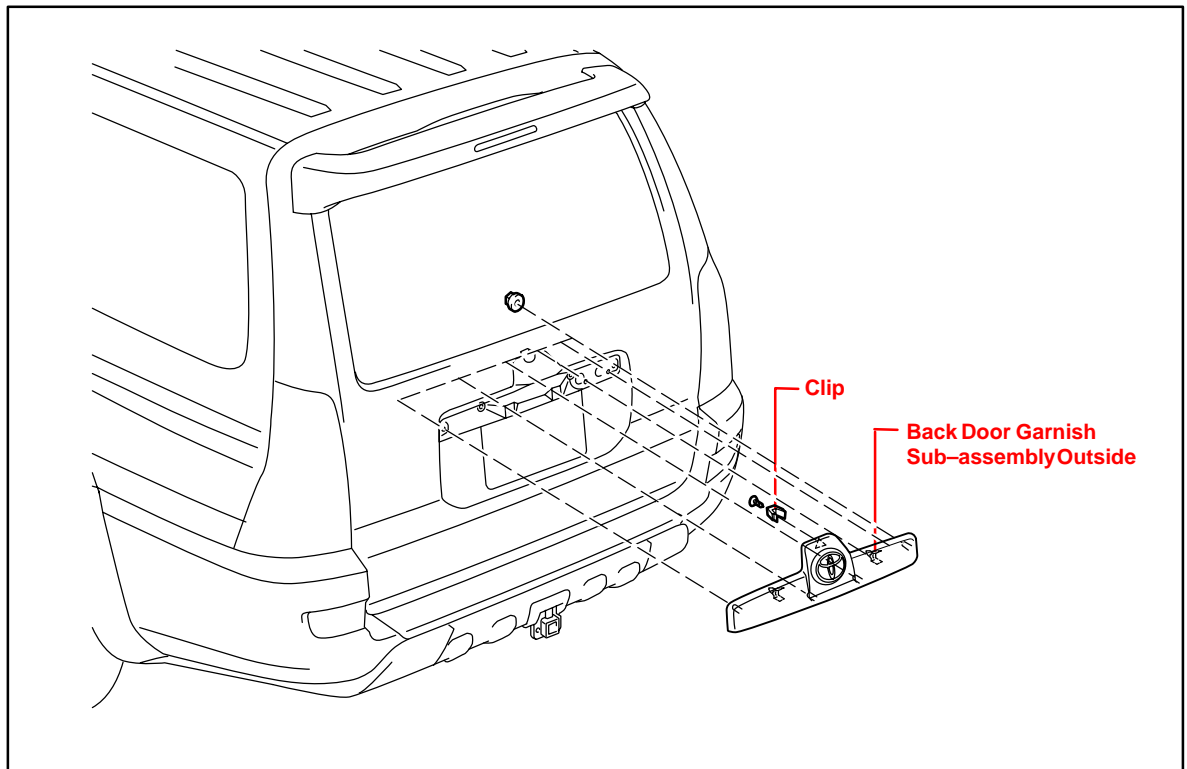
Due to the varying degree of stain that can develop, some vehicles may need to be repainted (or stain will need to be cleaned).

2. Remove back door service hole cover LH.
 - A. Remove the 6 nuts.
 - B. Disengage the 2 clips by pulling the garnish, and remove the garnish.
3. Replace the back door outside garnish sub-assembly with:
 - **Without the back monitor:** P/N 76801-35461
 - **With the back monitor:** P/N 76801-35471
