Rear Quarter Window Glass Scratched or Bubbled Condition

Service Category Vehicle Exterior

Section Window/Glass

YEAR(S)	MODEL(S)	ADDITIONAL INFORMATION
2009 – 2010	Matrix

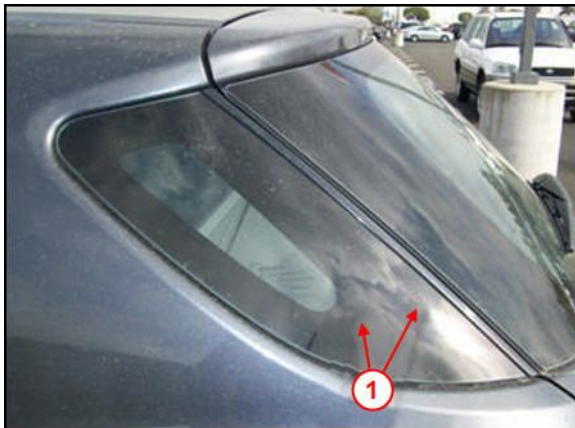
Figure 1.

Some 2009 – 2010 model year Matrix may exhibit a scratched or bubbled appearance on one or both rear quarter windows similar to the condition shown in Figures 1 and 2. Use the repair procedure below to address this condition.

1	General Location of Scratch or Bubble In Window Glass
----------	--

Replace the Quarter Window Glass with a new Service Part.

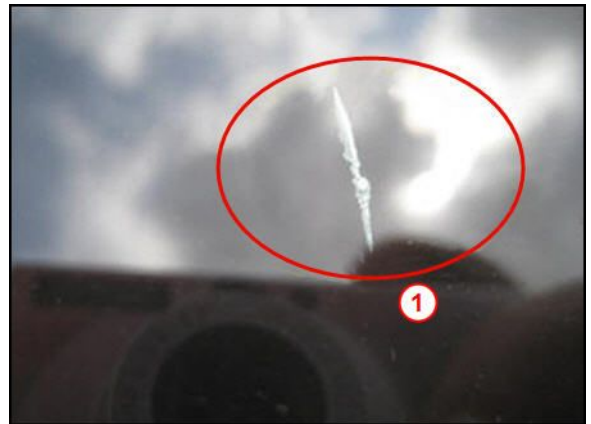
Figure 2.

1	Close Up of Surface Scratch
----------	------------------------------------
