**Technical Service
BULLETIN**

Title:
SECOND ROW SEAT BACK NOISE
Models:
'03 – '07 4Runner

NV003-04

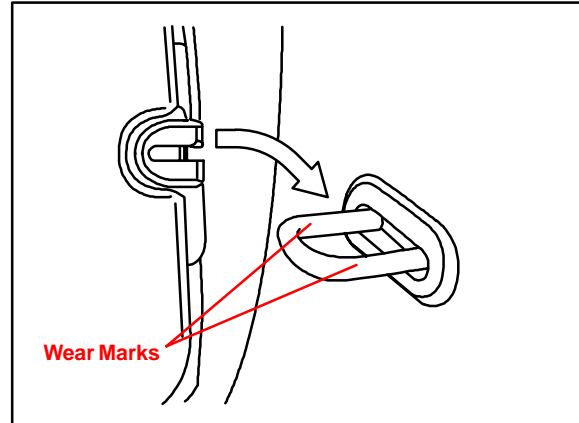
Wear marks on the top or bottom portion of the striker indicate a possible misalignment issue. If wear marks are found to be on top of the striker, the striker must be adjusted downward to remedy the condition and vice versa.

1. Check passenger side second row seat back latch to striker alignment.
2. Determine if the striker is centered in the seat back latch by slowly moving the passenger side second seat back toward the striker. Visually check to see if the striker is centered in the seat back latch.
