TECHNICAL SERVICE BULLETIN

REF.: BODY
NO.: BO95-003
DATE: JUNE 9, 1995
MODEL: GB (AVALON)

SLOW RETURN OF INSIDE DOOR HANDLES

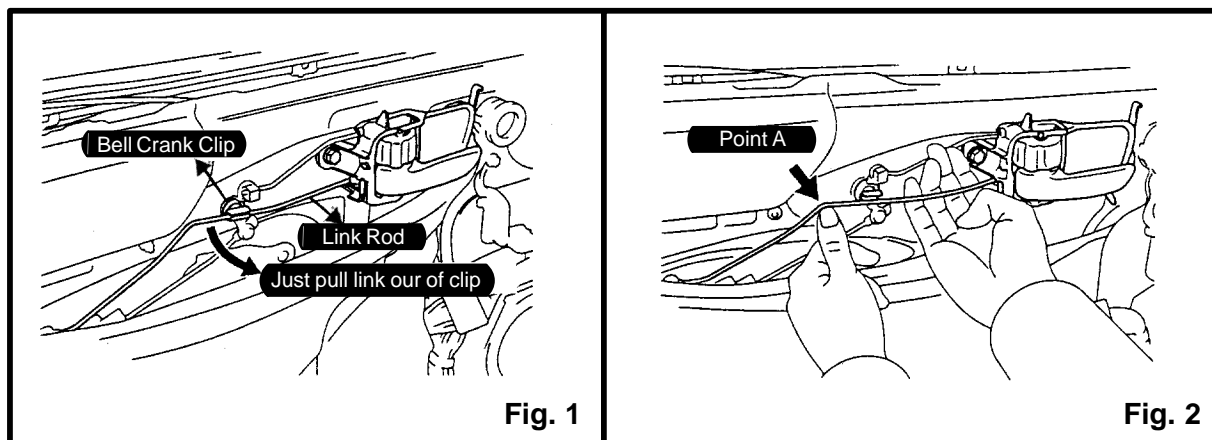
The inside door handle link rods have been modified to increase the return speed of the inside door handles.

1. Remove door trim panel.
2. Remove inside door handle link rod from bellcrank clip (Fig. 1).

3. Support the link rod by positioning the fingers of your right hand behind the link rod just forward of the bell crank clip to act like spacers. Then push outboard at the bend in the link rod (point A) to straighten the rod with your other hand (Fig. 2).
4. Reconnect the link rod to the bell crank clip and check the return speed of inside door handle. If return speed is still too slow, repeat steps 2-4 above.

NOTE: Excessive bending of the link rod may cause noisy inside door handle operation.
