**Technical Service
BULLETIN**

Title:
**SQUEAK & RATTLE SERVICE TIPS -
TRUNK & INSTRUMENT PANEL**

Models:
'00 ECHO

NVH
NV012-00

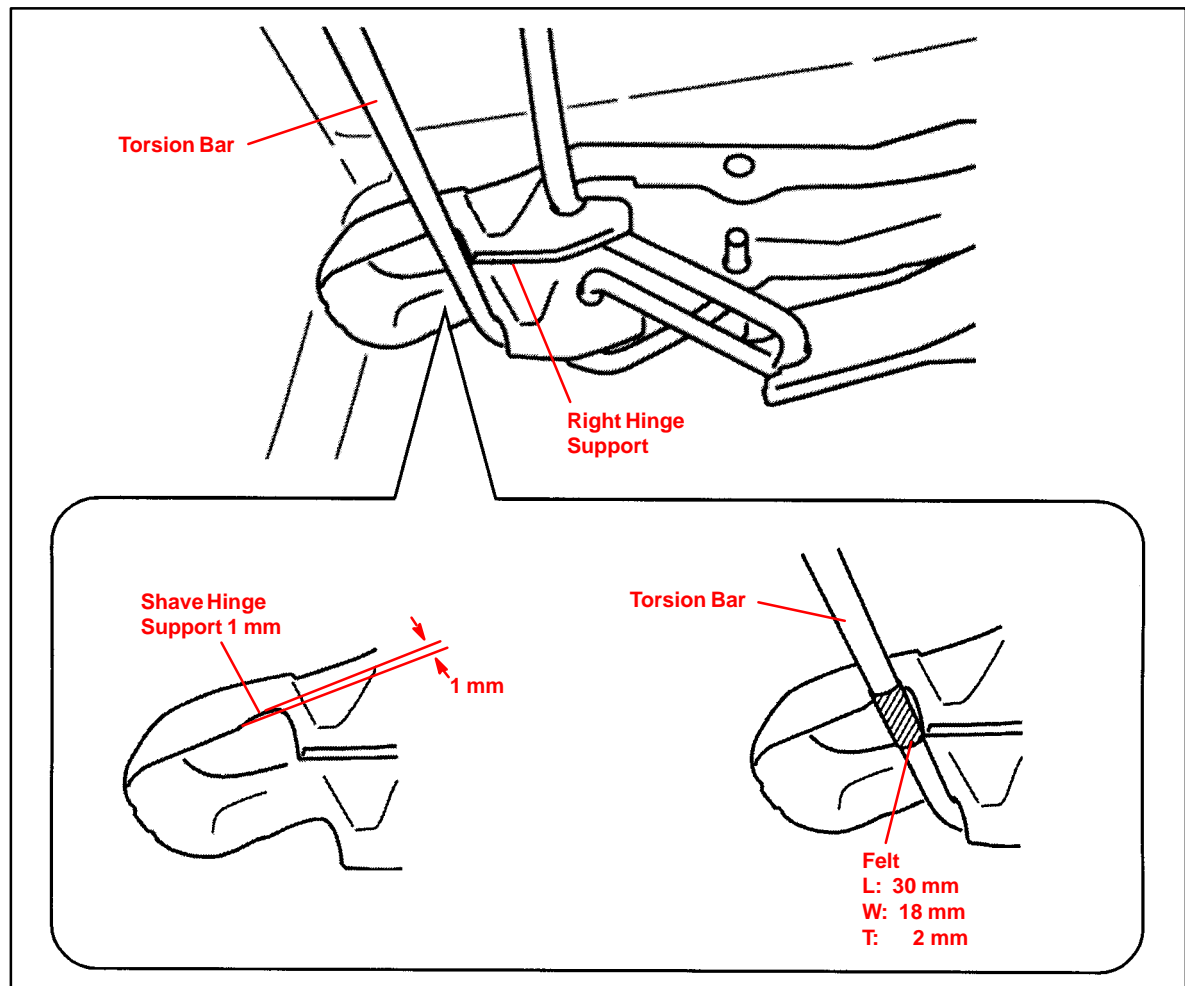
Repair Procedure **Buzz Noise From Trunk Area**

To eliminate a buzz noise caused by interference between the torsion bar and the luggage door right hinge support, perform the following steps:

1. Remove the torsion bars. Please refer to the 2000 ECHO Repair Manual, pages BO-27 to BO-28.
2. Shave the right hinge support 1 mm as shown in the following illustration.
3. Cut a felt piece from the Interior Noise Kit (P/N 08231-00801) in the following dimensions:

L	W	T
30 mm	18 mm	2 mm

4. Apply the felt piece to the torsion bar as shown in the illustration below.
5. Reassemble in the reverse order of disassembly.

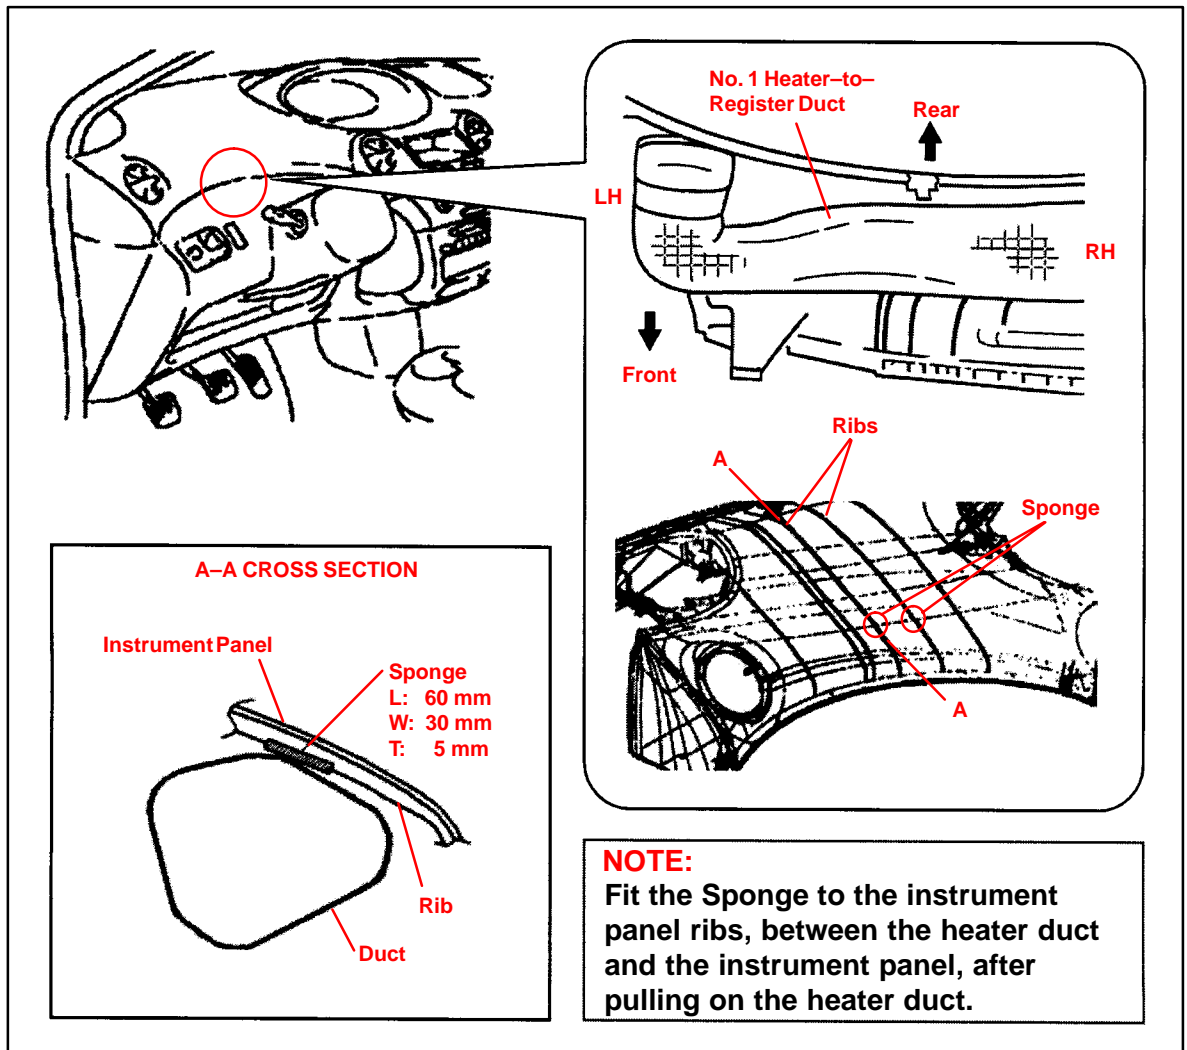
Rattle Noise From Instrument Panel Cover

To eliminate a rattle noise caused by interference between the instrument panel cover and the No. 1 heater-to-register duct, perform the following steps:

1. Remove the instrument panel cover. Please refer to the 2000 MY ECHO Repair Manual, pages BO-76 to BO-78.
2. Cut two pieces of sponge from the Interior Noise Kit (P/N 08231-00801) in the following dimensions:

L	W	T
60 mm	30 mm	5 mm

3. Apply sponge pieces between the back side of the instrument panel cover and the No. 1 heater-to-register duct, after pulling on the heater duct.
4. Reassemble in the reverse order of disassembly.
