**Technical Service
BULLETIN**

SQUEAK & RATTLE SERVICE TIPS

'00 ECHO

NV004-00

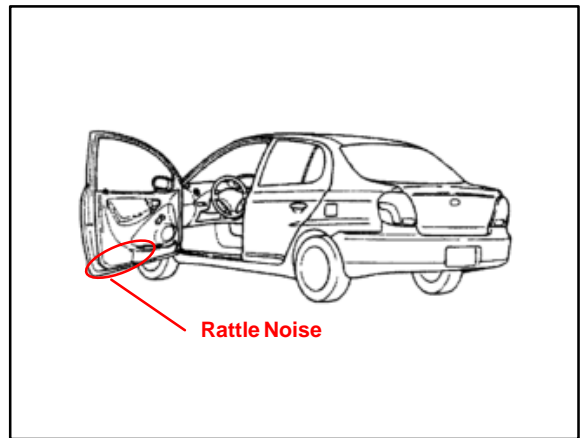
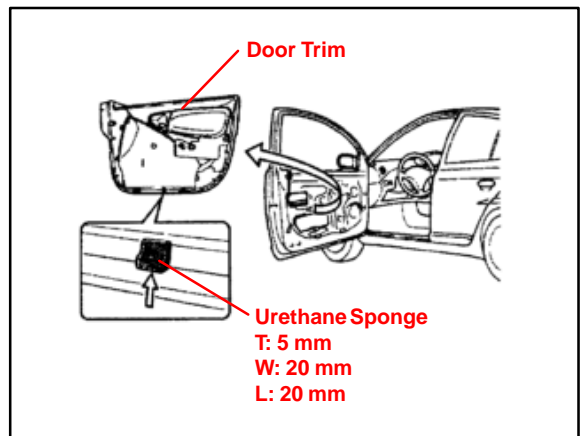
Repair Procedure Front Door Trim Rattle Noise

To eliminate a rattle noise from the lower door trim area:

1. Remove the door panel. (Refer to the 2000 model year ECHO Repair Manual page BO–8.)
2. Add a urethane sponge, 5 mm x 20 mm x 20 mm, as shown.

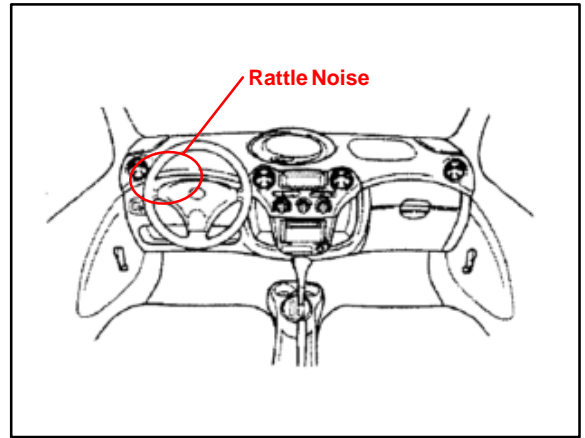
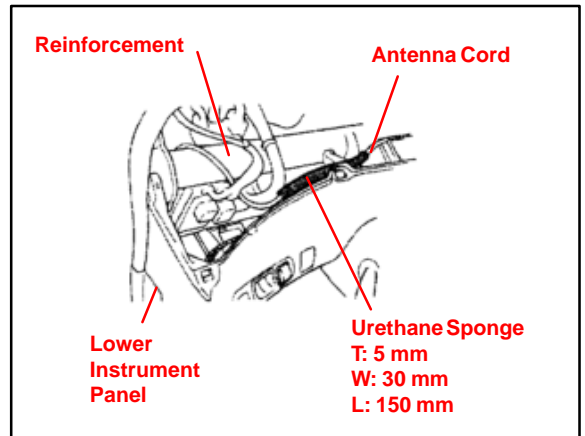
Antenna Cord Rattle Noise

To eliminate a rattle noise from the antenna cord:

1. Remove the upper instrument panel. (Refer to the 2000 model year ECHO Repair Manual pages BO–76 through BO–80.)
2. To eliminate the rattle noise from the antenna cord under the instrument panel, wrap a urethane sponge piece, 5 mm x 30 mm x 150 mm, as shown.

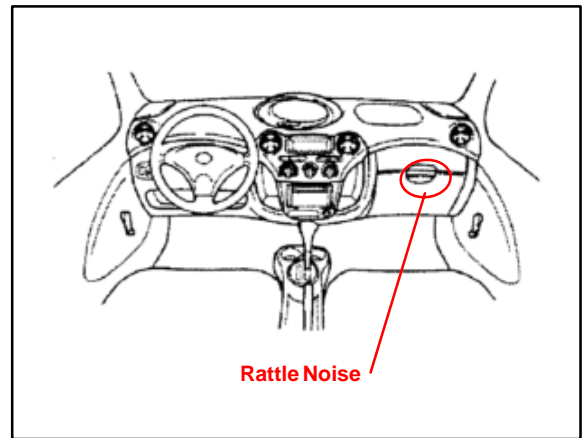
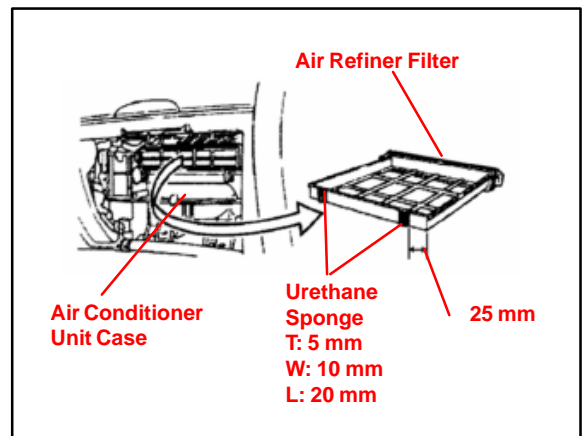
Air Refiner Filter Case Rattle Noise
(Only for vehicles with air refiner filter option.)

To eliminate a rattle noise from the glove compartment area:

1. Remove the air refiner filter. (Refer to the 2000 model year ECHO Repair Manual page AC–91.)
2. Add two urethane sponge pieces, 5 mm x 10 mm x 20 mm, as shown.

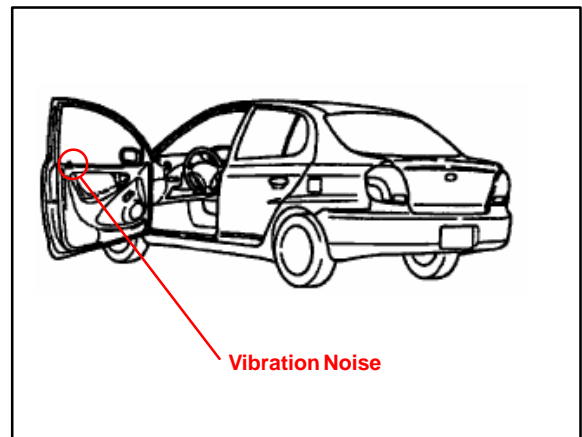
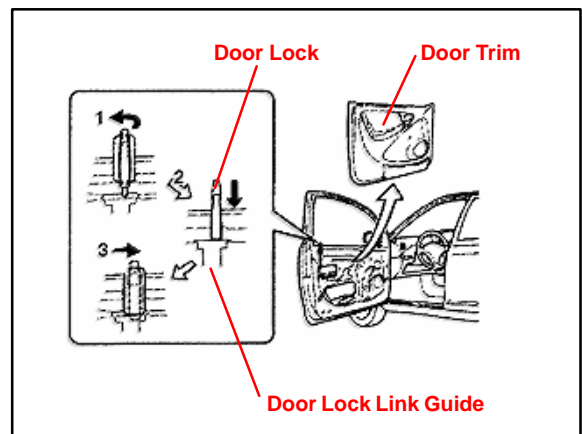
**Front Door Lock Control Knob
Vibration Noise**

To eliminate a vibration noise from the front door lock control knob:

1. Remove the door trim. (Refer to the 2000 model year ECHO Repair Manual page BO–8.)
2. Loosen the door lock control knob by 90 degrees, check if there is clearance between the door lock control knob and door lock link guide.
3. Tighten the knob to eliminate any clearance.

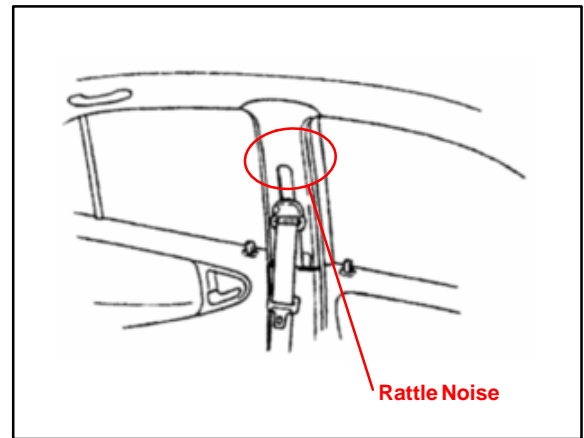
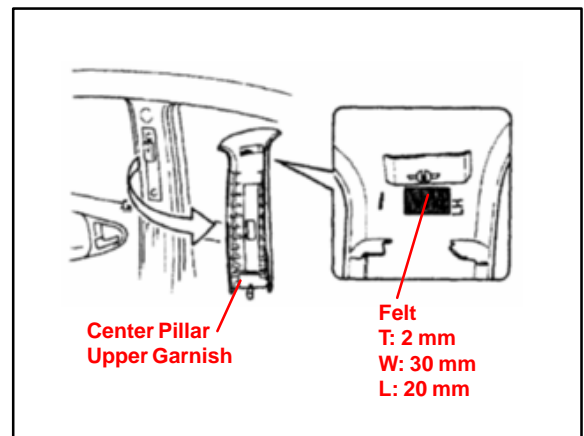
**Center Pillar Upper Garnish Rattle
Noise (RH and/or LH)**

To eliminate a rattle noise from the center pillar upper garnish:

1. Remove the center pillar upper garnish.
2. Add a felt piece, 2 mm x 30 mm x 20 mm, as shown.
