Technical Service BULLETIN

Title:
SQUEAK AND RATTLE SERVICE TIPS
Models:
'01 Highlander

NV
NV003-02

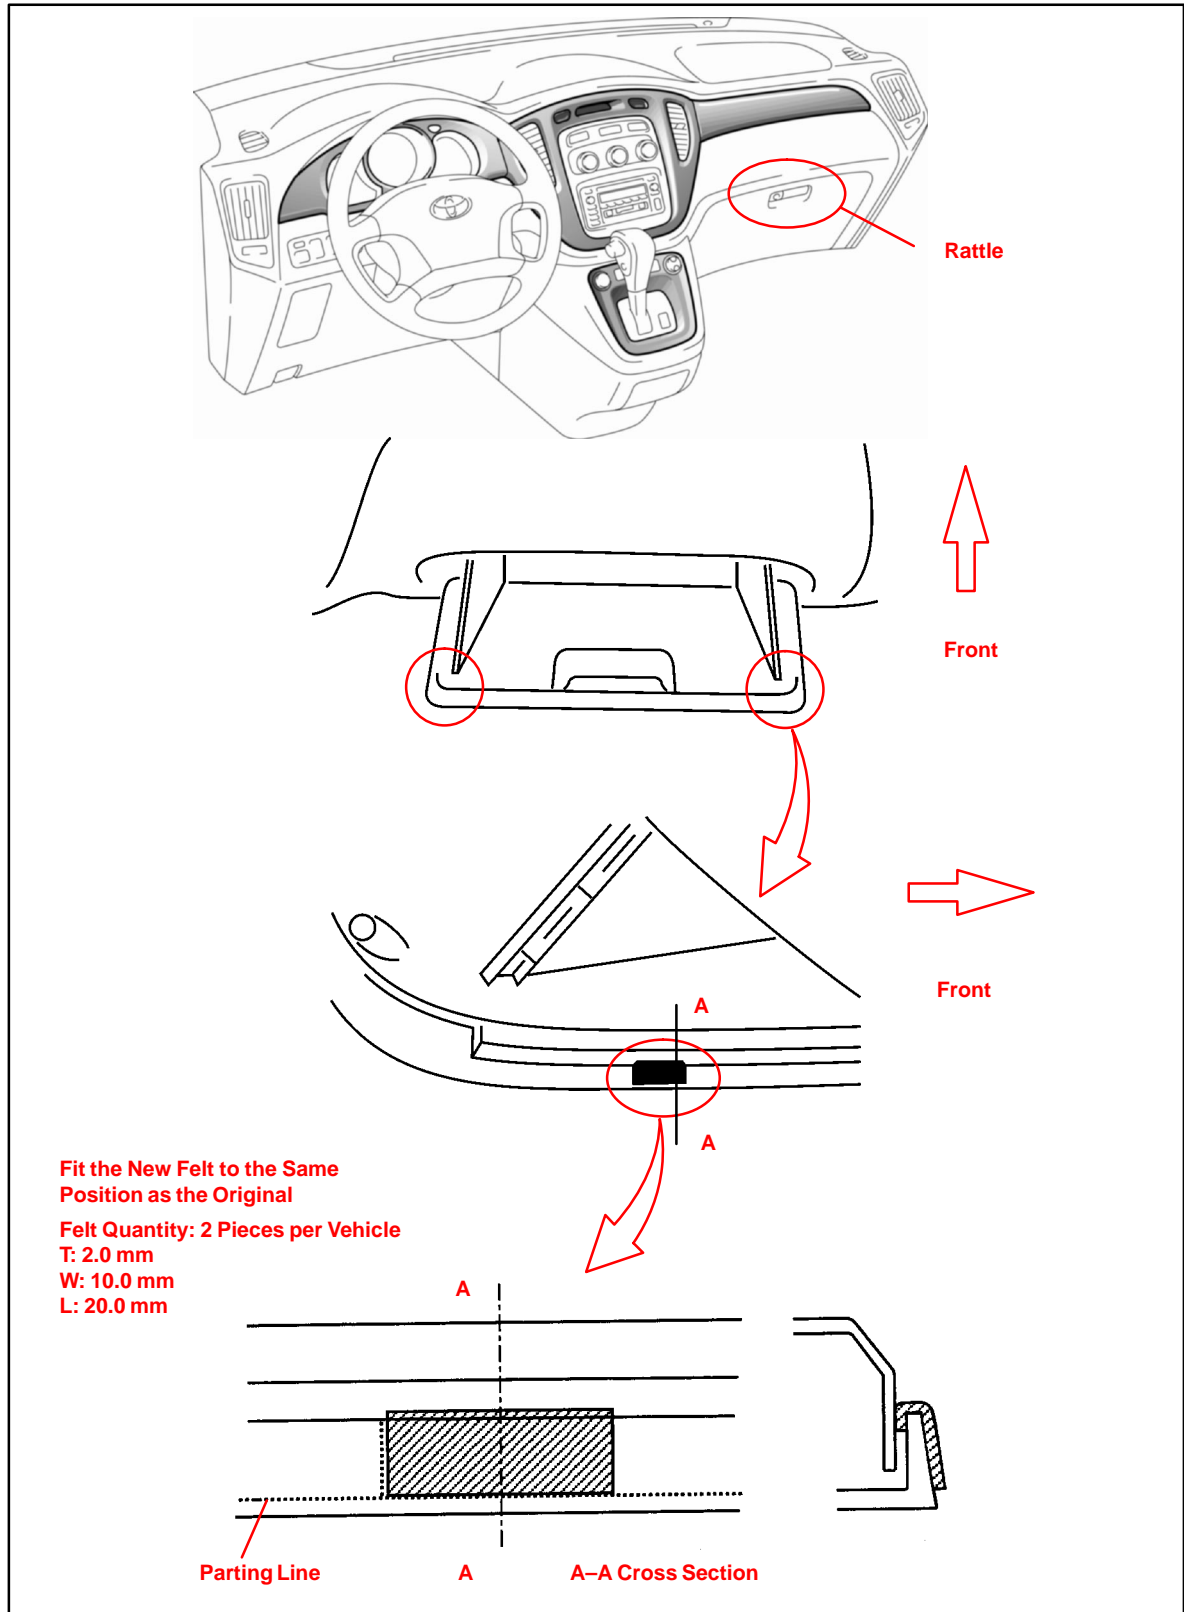
Glove Box Door

Repair Procedure 1 Replace two pieces of felt fitted to the right and left sides of glove box door with new ones with a thickness of 2.0 mm.

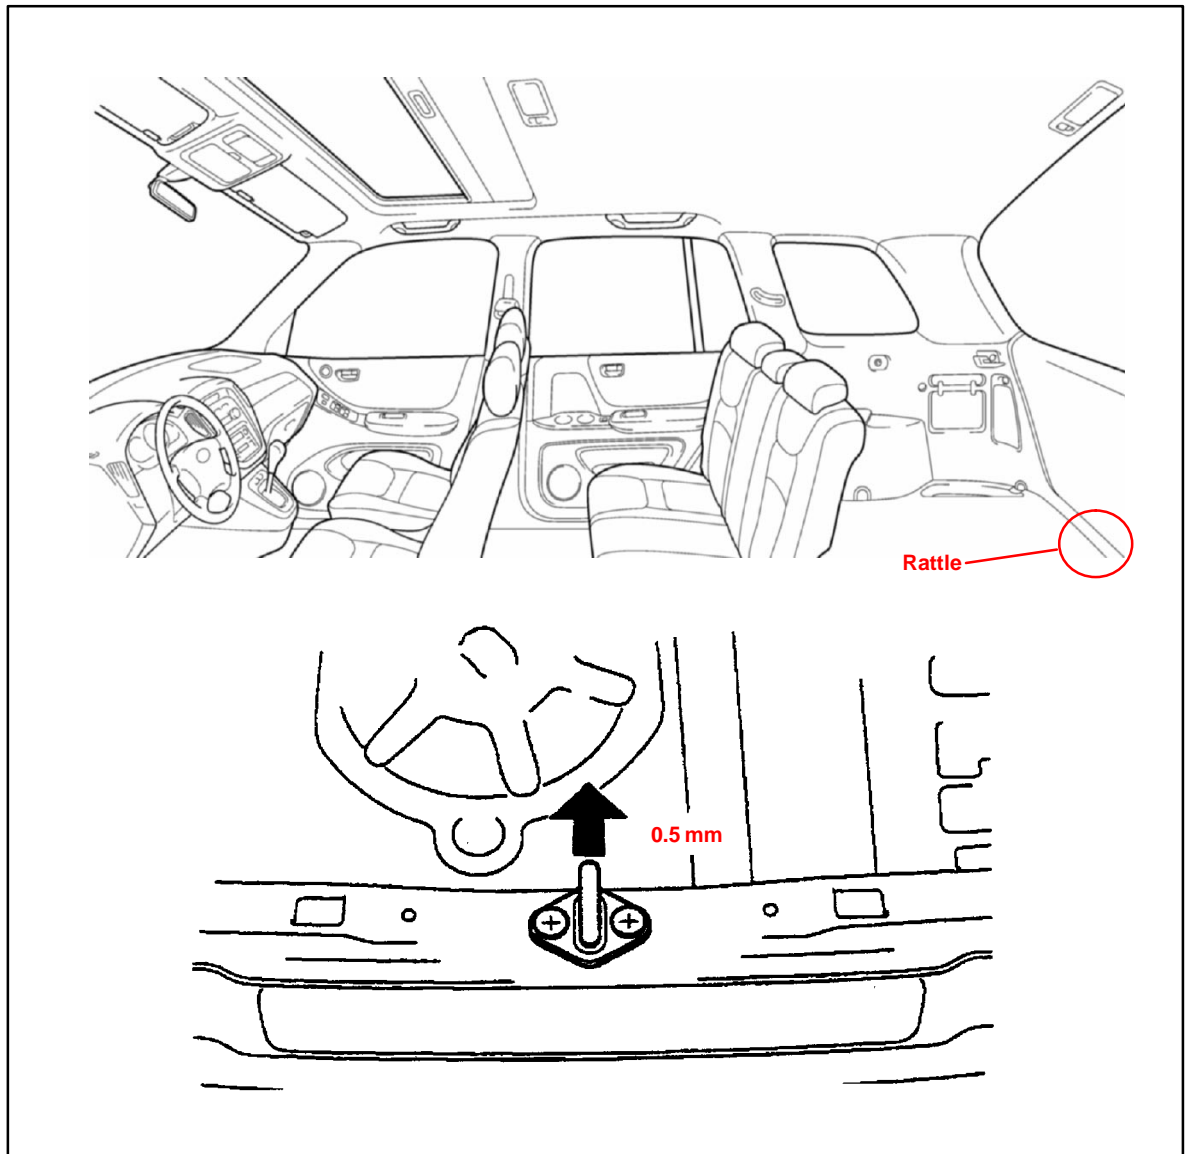
Rear Door Striker

Adjust the back door striker position forward 0.5 mm, as shown below.

Be sure to confirm that the back door can be closed after adjusting the back door striker. The back door will not close if the striker is moved more than 1 mm.
