# TOYOTA TECHNICAL SERVICE BULLETIN

REF.: BODY  
NO.: BO94-007  
DATE: MAY 20, 1994  
MODEL: RN/VN

## WINDSHIELD WIND NOISE REPAIR

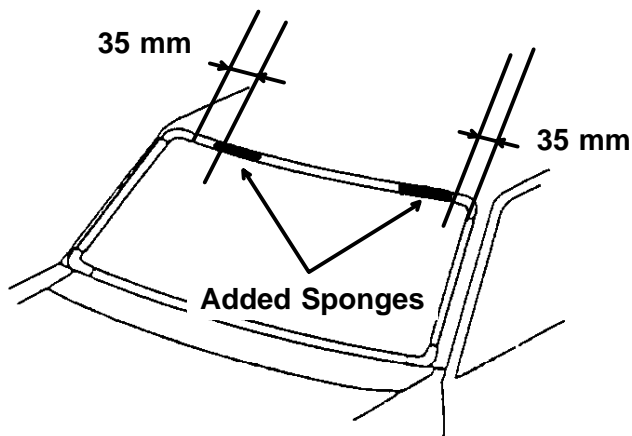
### ADDITION OF AIR DAM SPONGES

To reduce wind noise around the upper windshield area, air dam sponges have been added between the body and molding (at ends of upper windshield molding). Additionally, the rigidity of the windshield molding lip has been increased.
