# Wind Noise From Antenna

## Applicability

| YEAR(S) | MODEL(S) | ADDITIONAL INFORMATION |
|---|---|---|
| 2009 – 2010 | Matrix | |

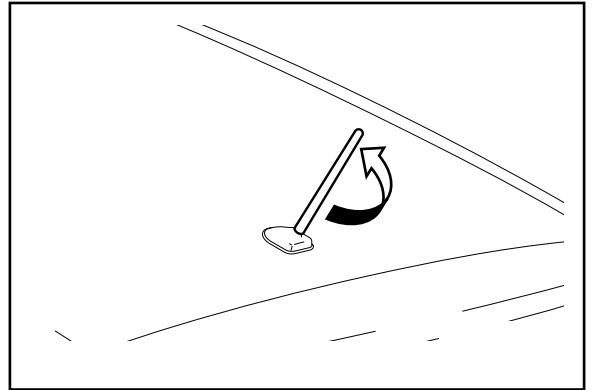
**Figure 1.**

Some customers may complain about wind noise at highway speeds from the rear of the vehicle where the antenna is mounted. A modified antenna has been made available to improve this condition.

1. Remove the roof antenna pole by turning it counterclockwise.
