Wind Noise From Front Door

YEAR(S)	MODEL(S)	ADDITIONAL INFORMATION
2009	Corolla	
2009	Matrix

Some 2009 model year TMMC built Corolla and Matrix vehicles may exhibit an excessive wind noise condition most noticeable from the driver's or passenger's side front door near the "B" pillar. Use the following repair procedure to address this condition.

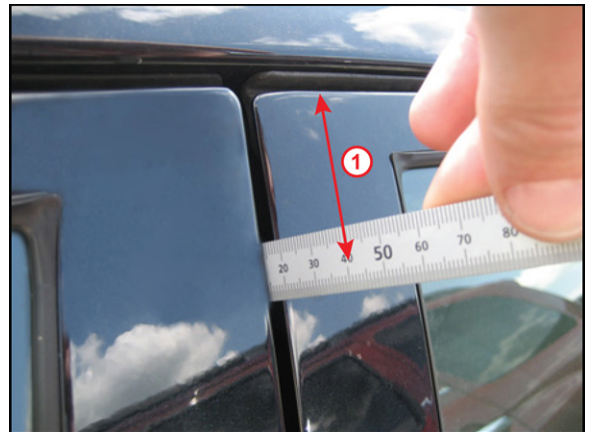
Figure 1.

1. Confirm wind noise is coming from the upper rear door frame area.
 - A. If wind noise is present, proceed to step 2.
 - B. If wind noise is NOT present, stop. If the source of the wind noise is coming from a different location, this TSB does NOT apply.
2. Repair the wind noise by adjusting the driver's or passenger's side door frame inward in 0.5 mm increments until the wind noise stops.
 - A. Close the front door and open the rear door.
 - B. With a straight edge, measure the distance between the "B" Pillar and the edge of the side door approximately 50 mm down from the top of the door.

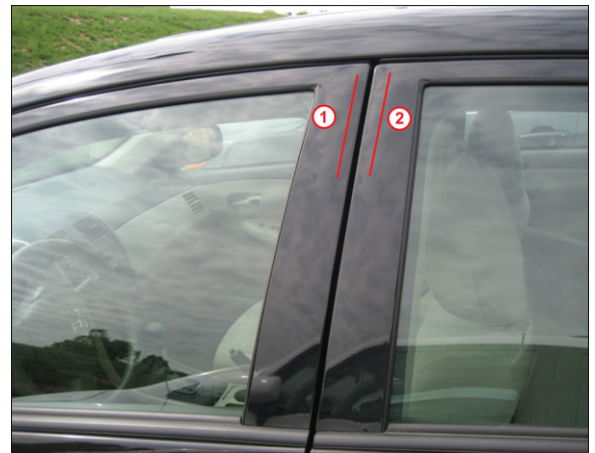
Figure 3.

Do not adjust the rear edge of the front door under flush to the front edge of the rear door. This can also create an excessive wind noise condition.

- 3. Close the door and check that the front side door frame moved inward 0.5 mm.
