Technical Service
BULLETIN

WIND NOISE REDUCTION

'96-'97 4Runner

BODY
B0019-97

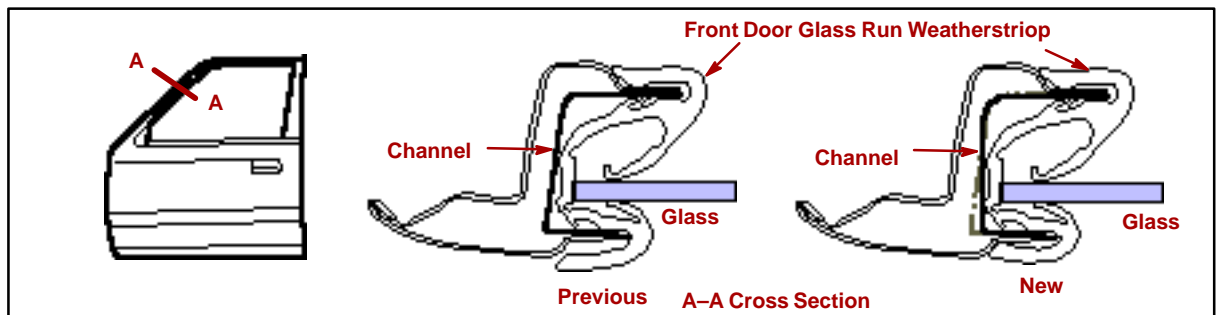
- Front Door Glass Run Weatherstrip
The shape of the left hand metal door channel has been modified to eliminate float of the outside lip portion of the Front Door Glass Run Weatherstrip.

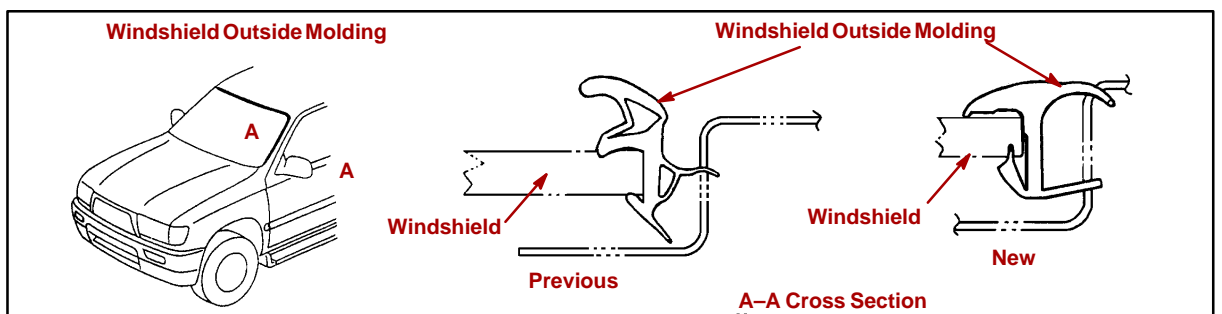
- Windshield Outside Molding (except cold spec vehicle)
The shape of the windshield outside molding has been changed.

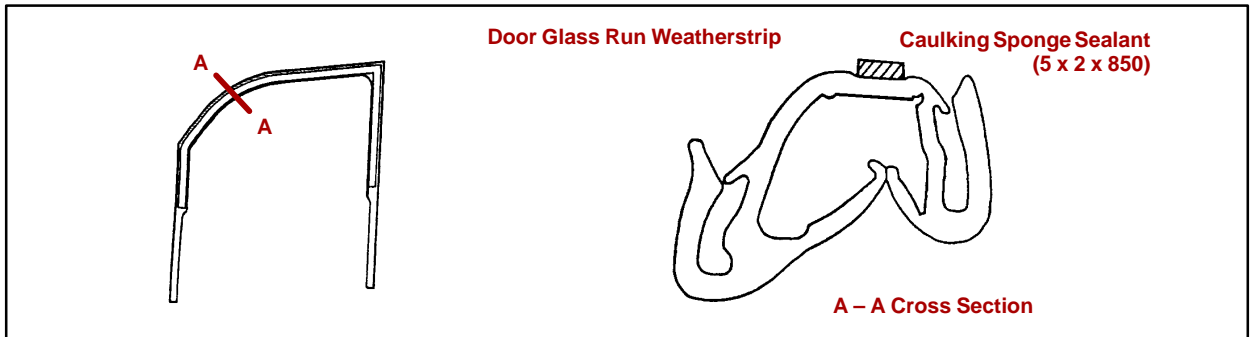
3. Front Door Glass Run Weatherstrip

Caulking sponge sealant has been applied to the back side of the front door glass run weatherstrip.

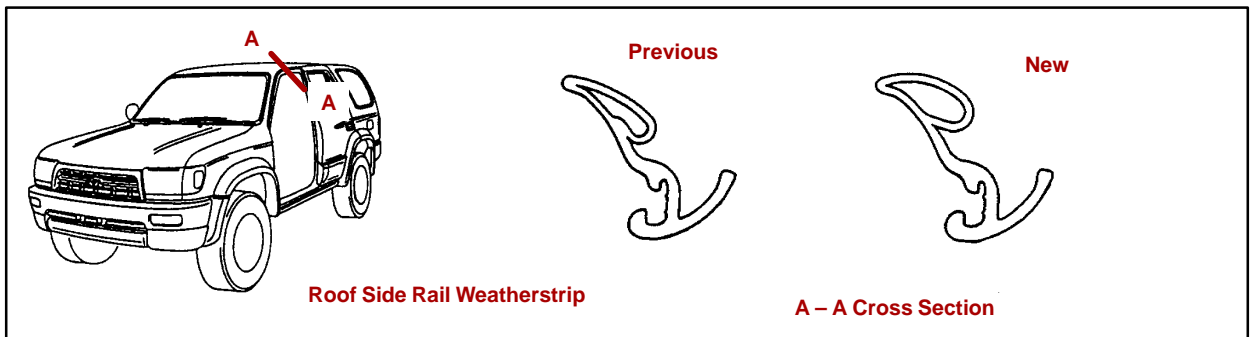
4. Roof Side Rail Weatherstrips

The shape of the Roof Side Rail Weatherstrip has been changed.

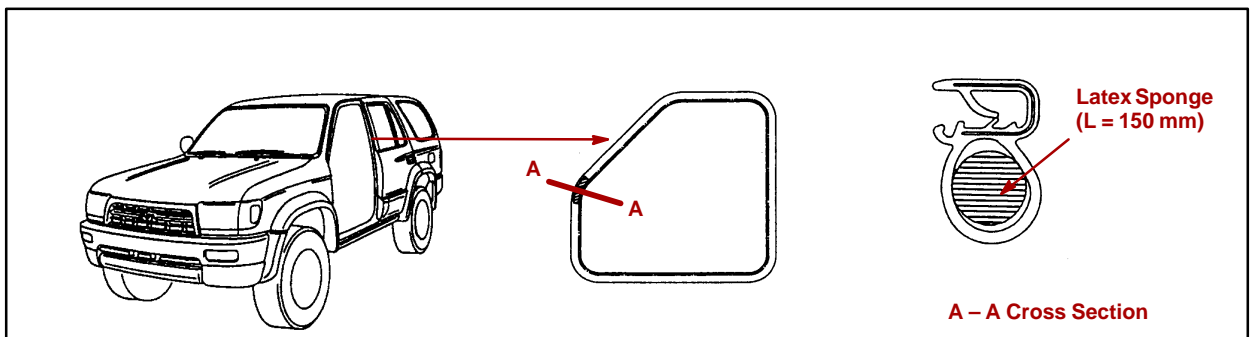
5. Front Door Opening Weatherstrips

Latex sponge has been added in the #1 corner of the front door opening weatherstrip.

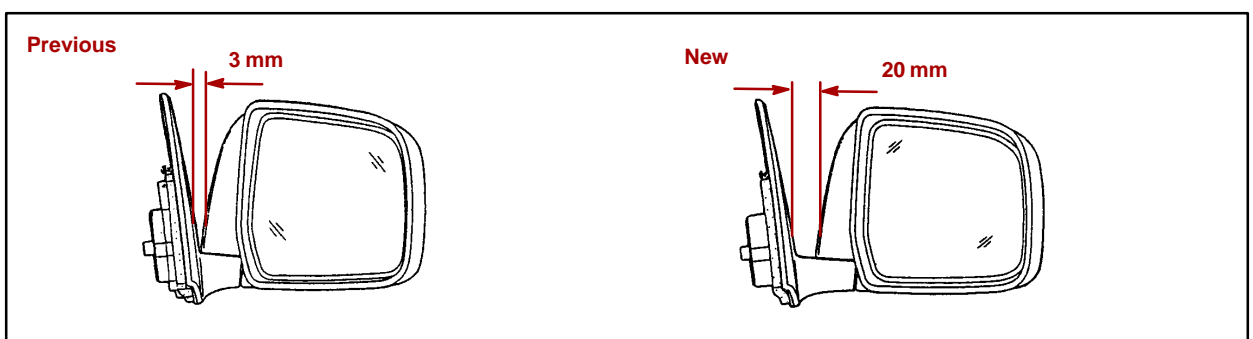
6. Outside Rear View Mirrors

The shape of the Outside Rear View Mirror Base has been changed.
