SERVICE BULLETIN

NUMBER 016

DATE 12-28-90

1990 FUJITSU TEN CD PLAYERS SCRATCHING CD'S

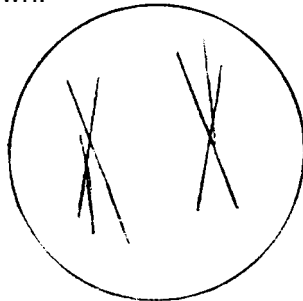
If the scratches occur, they will typically be straight and about 1-2 inches long on the label of playing surface of the CD as shown:

Fujitsu Ten has made the following production improvements to prevent this condition from occurring:

- Design change of transport mechanism.
- Prevention of foreign material contamination of the CD's transport mechanism.
- Cleaning of transport mechanism.

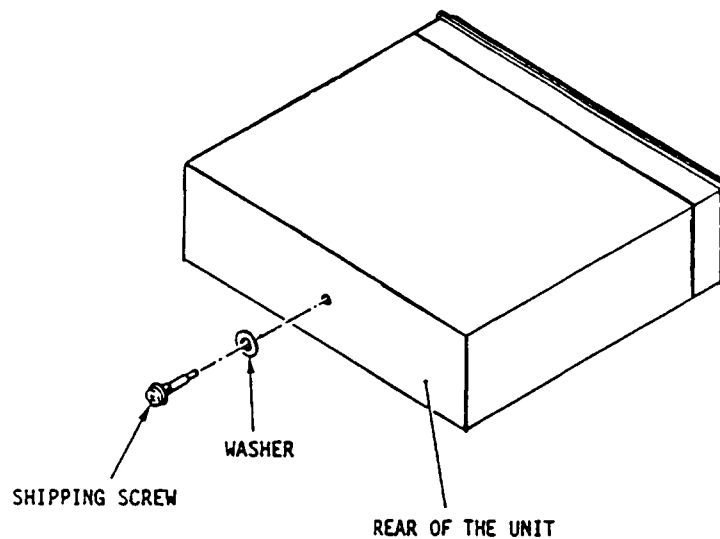
When shipping the CD Players, insert the shipping screw to prevent damage to the CD Player as illustrated below:
