# TECHNICAL SERVICE BULLETIN

**REF.:** AUDIO  
**NO.:** AU92-004  
**DATE:** AUGUST 21, 1992  
**MODEL:** ALL MODELS

## CD INOPERATIVE ON '92 PANASONIC 3-IN-1 RADIOS (56804 & 56801)

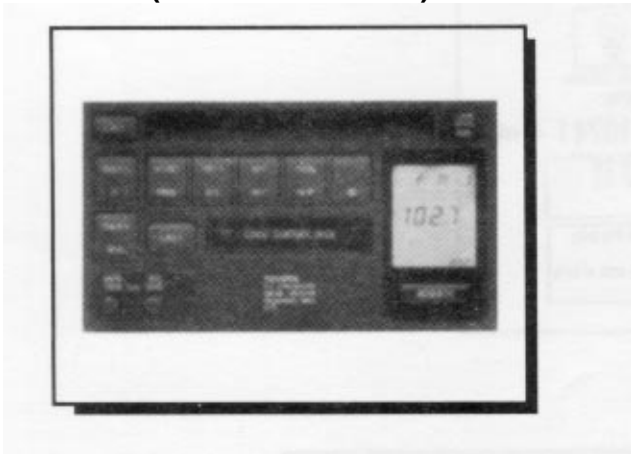
**56801  
(CRESSIDA ONLY)**

CD won't play or CD skipping conditions may occur on 3-in-1 radios 56804 (P/N 86120-33100) and 56801 (P/N 86120-2A022). This can be caused by the following:

- 1) Optical lens of the CD changer deforms with high temperature.
- 2) Guide pins contact the CD during play.

Production change has been made by Panasonic to the CD player's optical pick-up and guide pins starting 12/91 (vehicle production date).

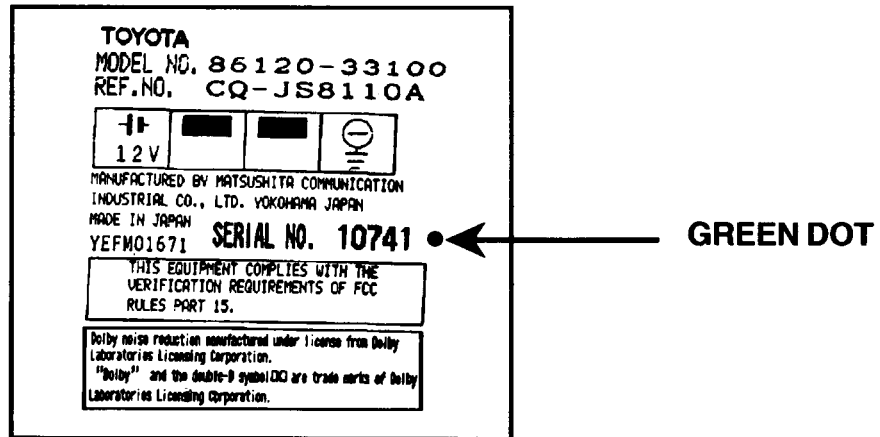
Exchange units have been countermeasured starting 2/92 and can be identified by a **GREEN DOT** next to the serial number on the ID label.
