**Technical Service
BULLETIN**

Title:
**CUPHOLDER PERFORMANCE
IMPROVEMENT**

Models:
'98 Avalon

BODY
BO006-98

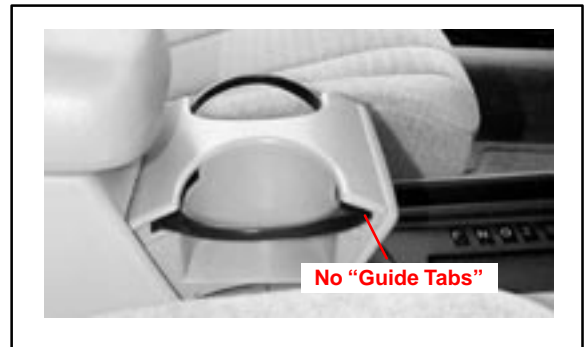
Introduction Production changes have been implemented to improve the performance and function of the console mounted cupholder on 1998 Avalon vehicles. In some cases, customers may be concerned by a sticking/slow operating cupholder.

NOTE:
Countermeasured parts can be identified by the absence of "Guide Tabs", which were located on the front edges of the cupholder.

Repair Procedure 1998 Avalons built prior to the starting VIN listed that exhibit a sticking/slow operating cupholder may be repaired by replacing the cupholder assembly.
