# TOYOTA

## SERVICE BULLETIN

MODEL MX 73

### AIR CONDITIONER CIRCUIT BREAKER OPEN CIRCUIT

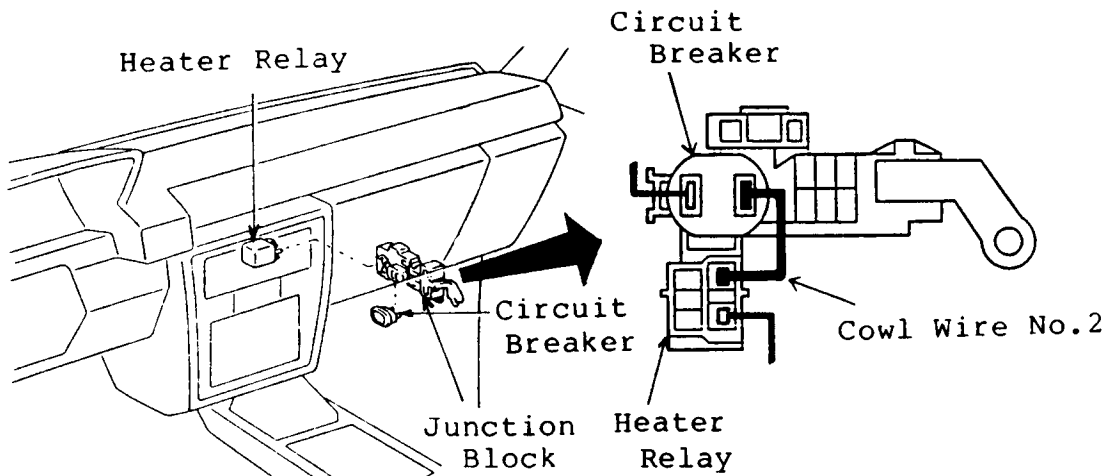
**[Location of Cowl Wire No. 2]**

Reverse Side of Junction Block

**CORRECTION:** To prevent the circuit breaker from triggering open, the current capacity of the **cowl wire No. 2** has been increased in length and gauge size.
