TECHNICAL SERVICE BULLETIN

NO.: AC001-96

MODEL: AVL

AMBIENT TEMPERATURE DISPLAYS -22°F

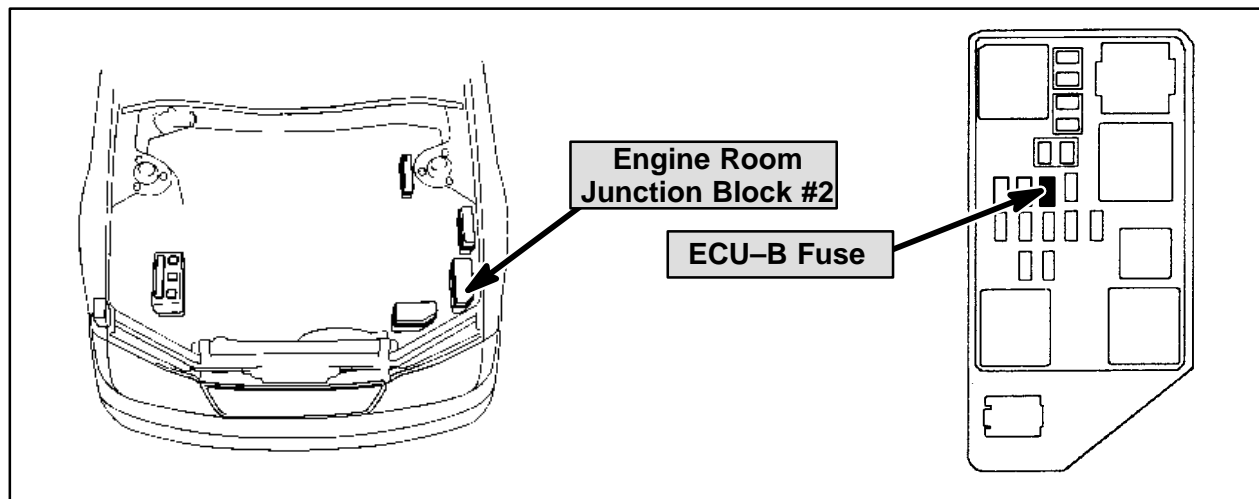
Remove the following fuse for 30 seconds and reinstall (see illustration):

Fuse	Junction Block	Location
ECU-B	Engine Room (#2)	Left Engine Compartment

This condition can be corrected by briefly removing the fuse supplying the B+ power source to the A/C amplifier.

Do not attempt repairs before performing the following reset procedure:

If ambient temperature display is not corrected, refer to repair manual for diagnosis.
