TECHNICAL SERVICE BULLETIN

REF.: BODY
 NO.: BO005-96
 DATE: APRIL 26, 1996
 MODEL: AVL

AVALON SUNVISOR RATTLE NOISE

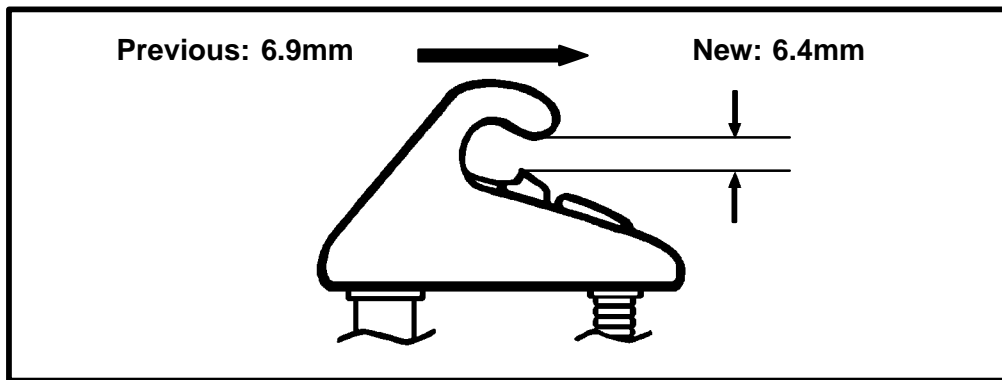
A rattle noise may be heard from the driver and passenger sunvisors on some 1995 Avalons. To eliminate this condition the sunvisor clip opening size has been decreased in production as follows:

To correct this condition, remove the original sunvisor clips and replace them with new ones. If the condition still exists, add felt material behind the mirror to prevent rattle noise.

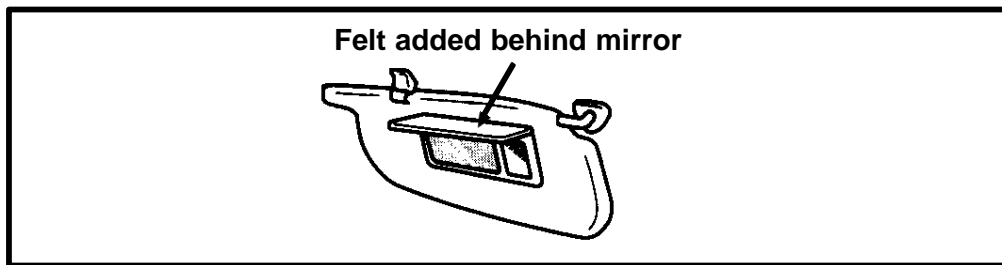
Additionally, felt material was added behind the mirror to provide a tighter fit between the mirror and frame.
