# Back Door Handle Garnish Loose or Broken

YEAR(S)	MODEL(S)	ADDITIONAL INFORMATION
2005 – 2010	tC	Plant Code(s): 0 WMI(s): JTK

Some 2005 – 2010 model year tC vehicles may exhibit a condition where the back door handle garnish becomes loose, or in some cases may break if used when the garnish is loose. An improved back door handle garnish has been developed to correct this condition. Please follow the procedure contained in this bulletin to replace the back door handle garnish.

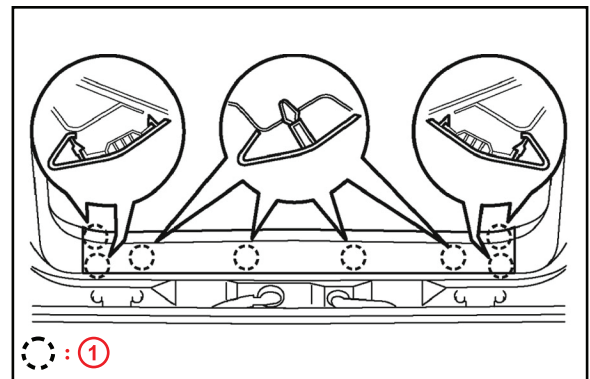
Figure 1.

- Using a plastic pry tool, detach the 8 claws and remove the back door garnish center.

1	Claws
---	-------

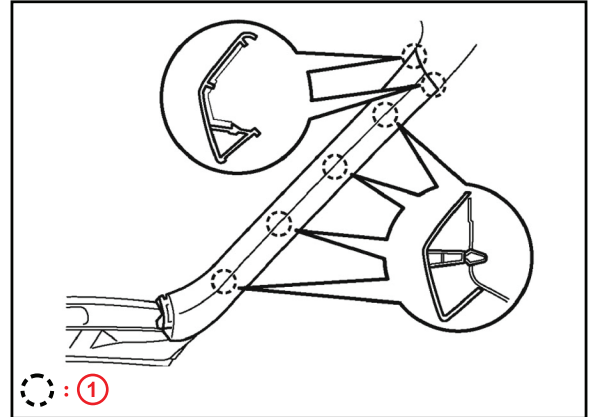
Figure 2.

2. Using a plastic pry tool, detach the 7 claws and remove the left and right hand side back door garnish.

<b>1</b>	<b>Claws</b>
----------	--------------

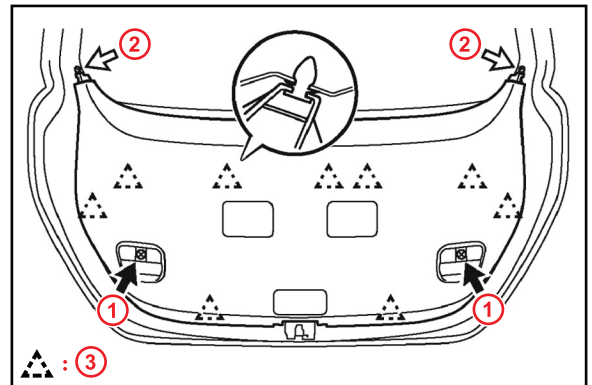
Figure 3.

3. Remove the back door trim board assembly.
  - A. Remove the 2 screws.
  - B. Using a plastic pry tool, detach the two upper clips.
  - C. Using a plastic pry tool, remove the 9 lower clips and remove the back door trim board assembly.

<b>1</b>	<b>Screws</b>
<b>2</b>	<b>Upper Clips</b>
<b>3</b>	<b>Lower Clips</b>

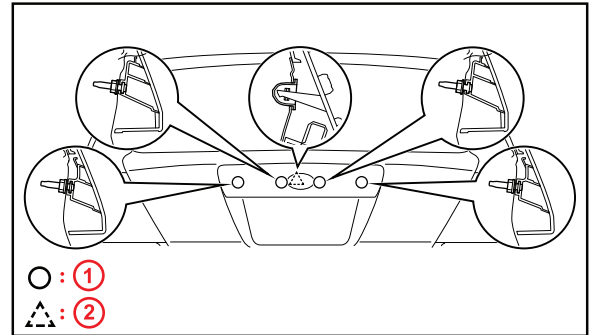
Figure 4.

4. Remove the back door outside garnish sub-assembly.
  - A. Remove the 4 nuts.
  - B. Detach the clip and disconnect the connector. Then remove the garnish.

<b>1</b>	<b>Nuts</b>
<b>2</b>	<b>Clip</b>

6. Install the 2 screws and the opener switch in the NEW back door garnish sub-assembly (P/N 76801-21070).
7. Install the back door outside garnish sub-assembly.
  - A. Install the back door outside garnish sub-assembly.
  - B. Install the 4 new nuts (P/N 90080-17189).
8. Reassemble vehicle in reverse order of disassembly steps 1 – 5.

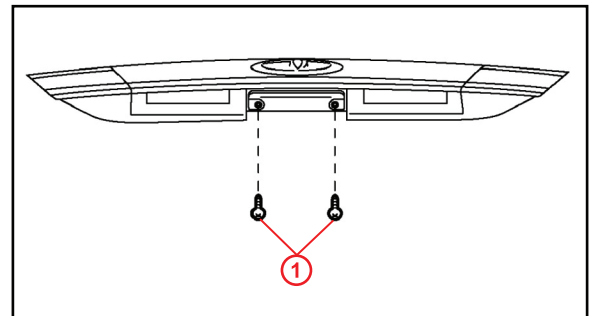
Figure 5.

5. Remove the 2 screws and the opener switch.

<b>1</b>	<b>Screws</b>
----------	---------------
