# TECHNICAL SERVICE BULLETIN

REF.: ELECTRICAL  
 NO.: EL95-006  
 DATE: DECEMBER 22, 1995  
 MODEL: 4RN

## DOM FUSE INSTALLATION DURING PDS ON 1996 4RUNNER

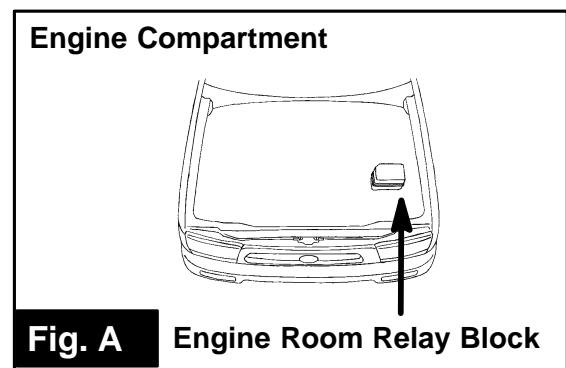
The removed Dome Fuse (15A) is stored in the back of the Engine Room Relay Block Cover in the engine compartment as shown in Figure A.

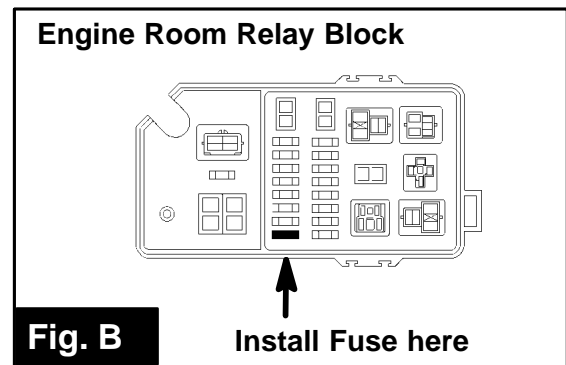
Please install the Dome Fuse in the correct position during (Pre-Delivery Service) as shown in Figure B.
