SERVICE BULLETIN

REFERENCE AUDIO
NUMBER 007
DATE 08-04-89
MODEL AE,EL,MA,ST,SV,YR

INOPERATIVE CASSETTE PLAYER

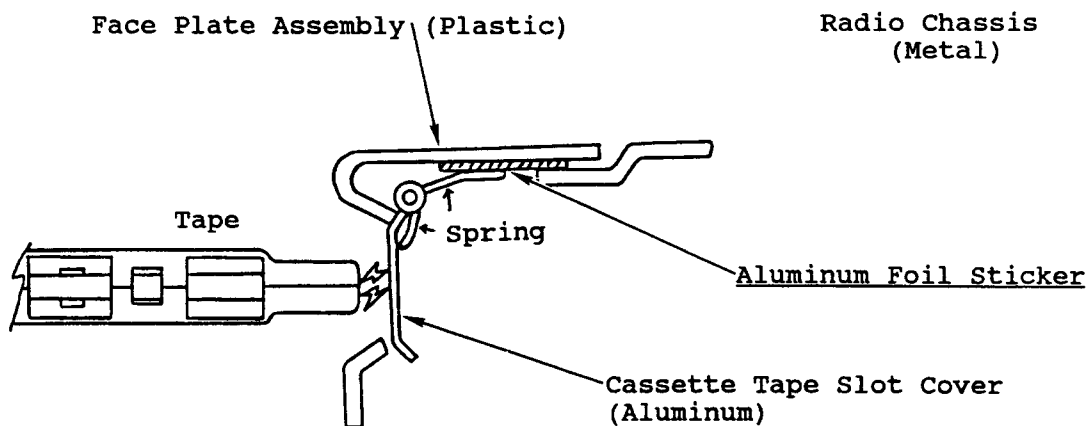
CUTAWAY SIDE VIEW

To prevent electrostatic discharge from disabling the cassette player, an aluminum foil sticker has been added to the inside of the face plate assembly. The sticker provides a pathway for the electrostatic discharge originating from a cassette to go directly to the audio chassis and avoid any damage to the printed circuit board and components.

The following are examples of electrostatic damage:

- Tape will not eject.
- Player will not accept tape.
- Tape player is inoperative.

NOTE: If a customer comes in with a tape "stuck" condition, do not attempt to remove the tape. Forcible removal of the tape will damage the tape player mechanism. Instead, contact Fujitsu Ten for a replacement unit and request to have the tape returned.
