**Technical Service  
BULLETIN**

**NAVIGATION SYSTEM SHOWS VEHICLE  
IN WRONG LOCATION**

'06 Sienna, '06 – '07 4Runner, & '07 Camry,  
Camry HV, & Solara

REVISÉD  
ELECTRICAL  
EL012-06

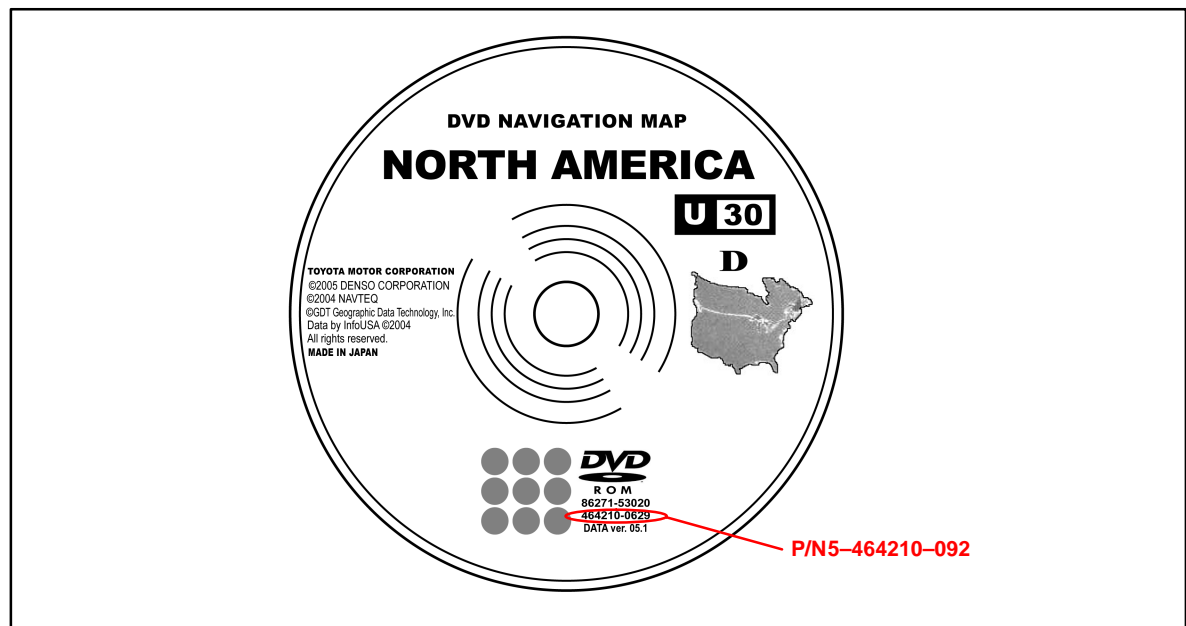
The map disc supplier part number changed to 5-464210-092. Refer to the following illustration to locate the supplier's part number (directly below the OEM part number):

1. Order a navigation map disc through DENSO by calling 1–888–285–4236.  
When ordering this special map disc, provide DENSO the TSB number, dealer code, and vehicle information.
2. Replace the navigation map disc.  
Refer to the Technical Information System (TIS), 2006 or 2007 model year applicable vehicle Navigation Owner's Manual: *Appendix*.
3. Cut the original navigation map disc in half and dispose of it.
