SERVICE BULLETIN

REFERENCE ENGINE _____
NUMBER 019 _____
DATE 02-09-90 _____
MODEL VV, VN, ST87, ST85 _____

PLASTIC REGION CONNECTING ROD BOLT TIGHTENING PROCEDURE

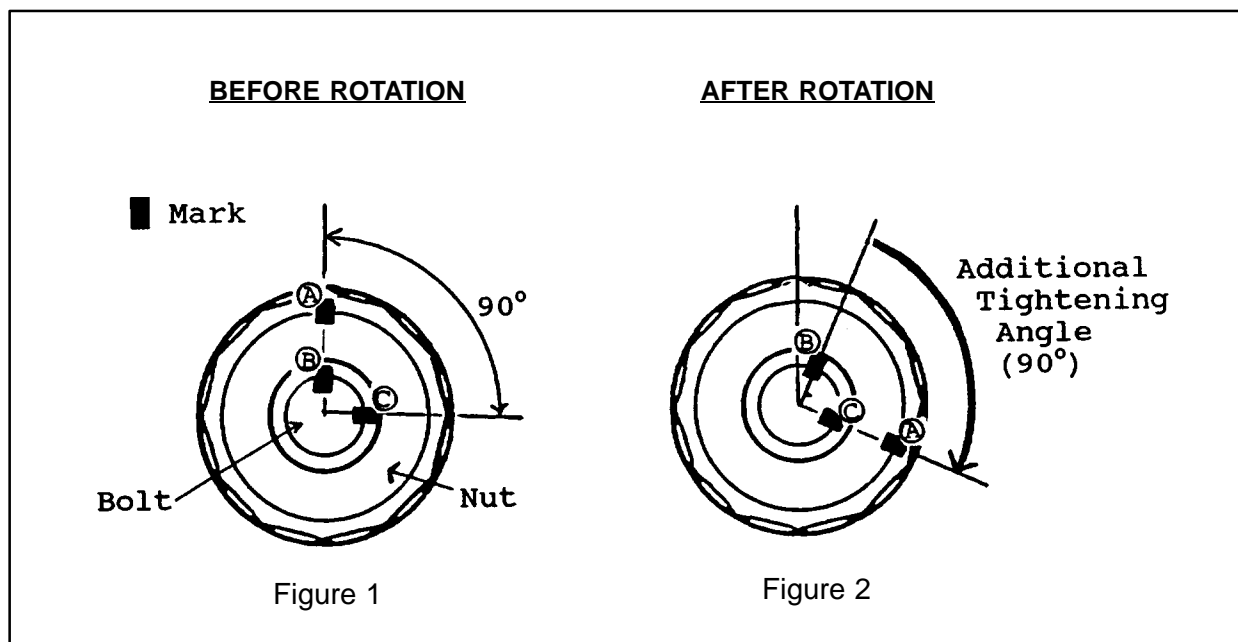
- 1) Perform the initial torque as specified in the appropriate repair manual.
- 2) Place two marks ('B' and 'C' in figure 1 below) on the end of the connecting rod bolt 90° apart. Place a third mark ('A' in figure 1 below) on the nut in line with mark "B" on the rod bolt.
- 3) Tighten the nut until mark "A" (on the nut) lines up with mark "C" (on the bolt).

The bolt has a tendency to rotate slightly inside the rod when performing the final tightening. If not compensated for, this results in a lower final torque than specified. To achieve the correct torque use the following procedure. This procedure will ensure that a full 90° of nut rotation relative to the bolt is achieved during the final tightening:
