SERVICE BULLETIN

MODEL MX73

RADIO FUSE INSTALLATION AT PDS 1988 - CRESSIDA WITH CD PLAYER

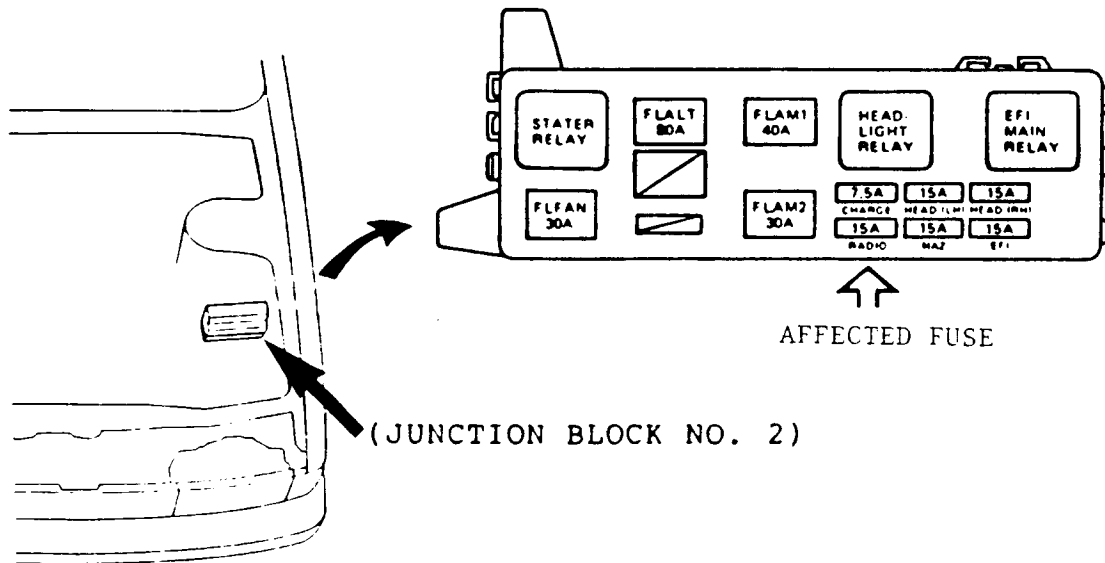
The radio fuse which is located on the back side of the Junction Block No. 2 in the engine compartment, must be reinstalled during PDS.

The 1988 MX73 Cressida with the optional CD player will be produced in the late December, 1987. The radio fuse in Junction Block No. 2 has been removed at the factory to reduce static discharge during transportation of the vehicle.
