**RATTLE FROM FRONT HEADRESTS**

**STANDARD SEAT**

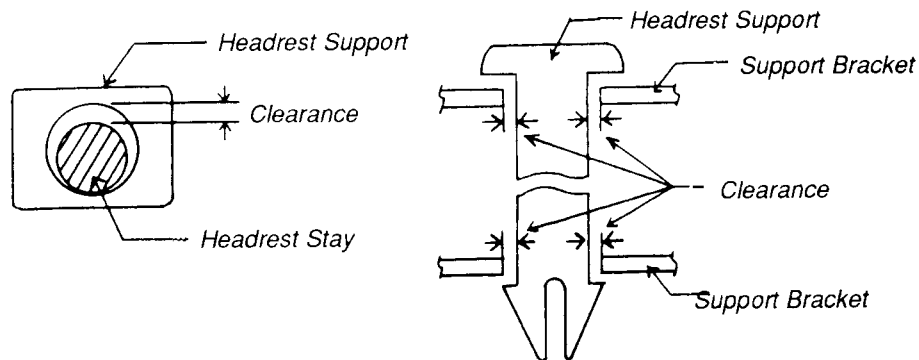
**CONDITION:** The headrests emit a rattle noise over bumps.

**CAUSE:** Rattle noise is caused by clearance between the headrest stay and the headrest support, or between the headrest support and the support bracket. See illustration below.

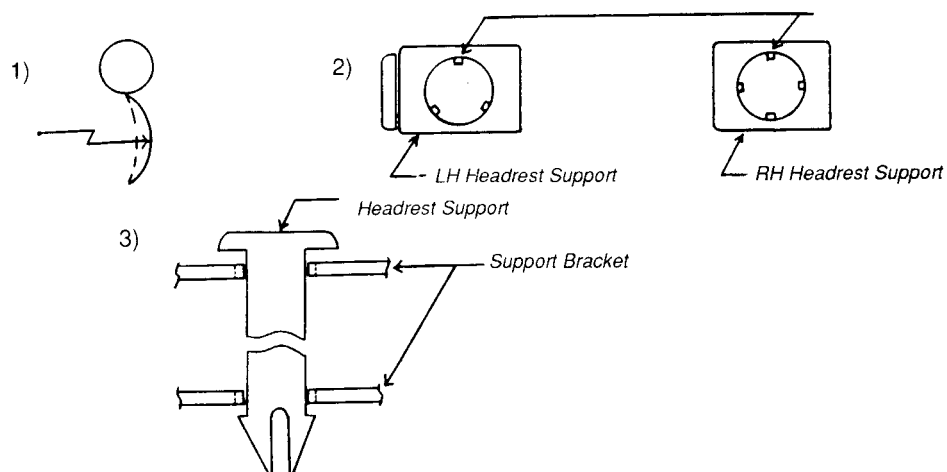
To reduce operating clearance between affected components, the following production changes have been made:

- 1) The curvature of the headrest stays have been increased starting with April, '90 production.
- 2) Ribs have been added to the headrest support from October, '90 production.
- 3) The diameter of the headrest support bracket has been reduced starting with November, '90 production.

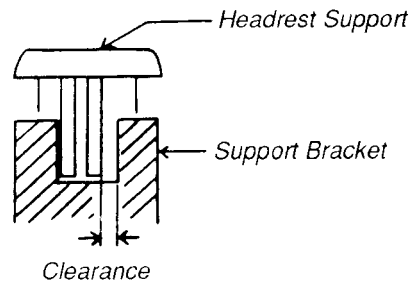
CONDITION: The headrests emit a rattle noise over bumps.

CAUSE: Rattle noise caused by clearance between headrest support and headrest support bracket. See illustration below.

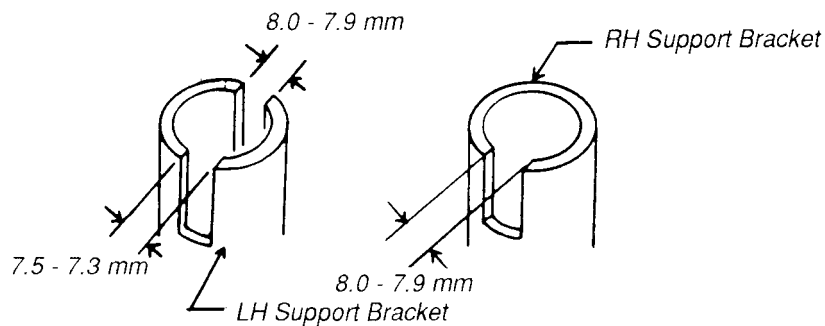
1) The groove of the headrest support bracket has been reduced starting with June, '90 production (see illustration).
