**Technical Service  
BULLETIN**

**ROOF DRIP MOLDING LOOSE**

'01 – '02 ECHO

**BODY**  
**B0014-02**

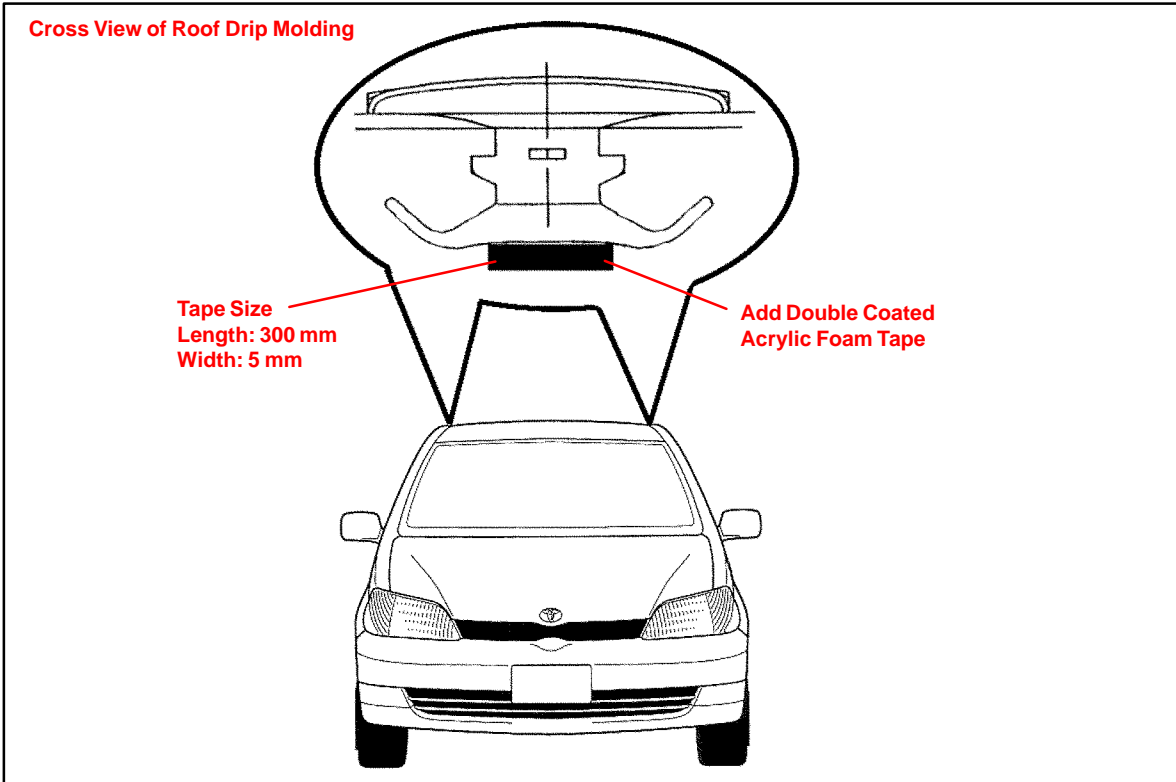
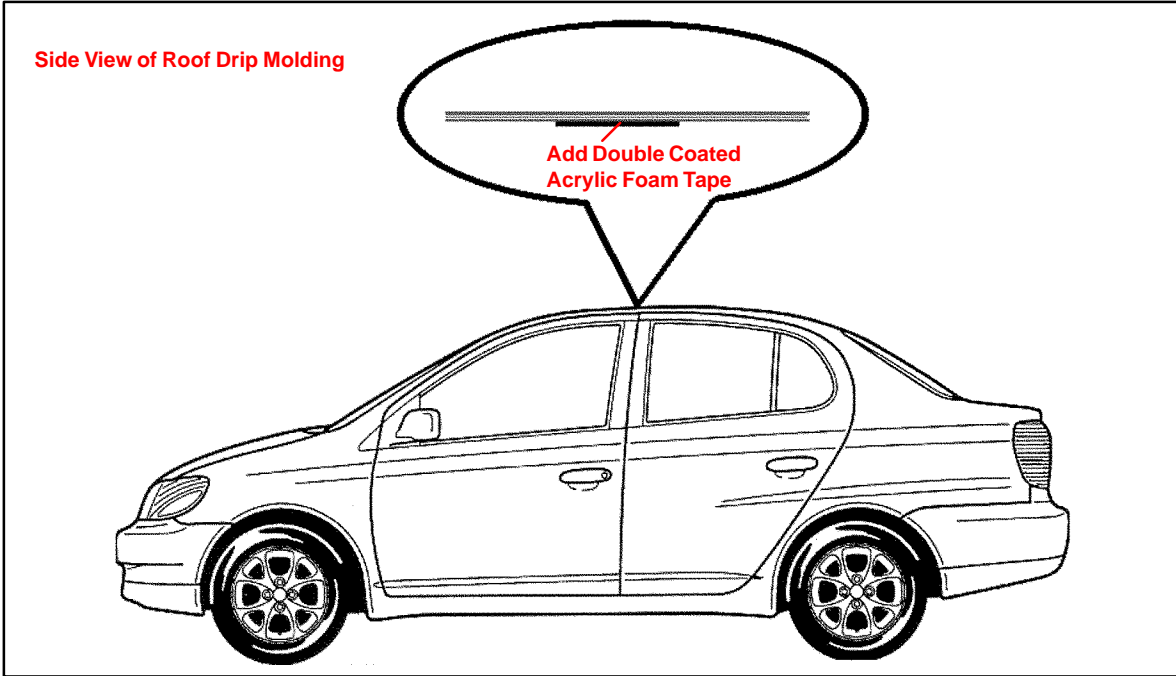
**Introduction** The roof molding may come loose or become deformed on certain 2001 model year ECHO vehicles.

Add double coated acrylic foam tape to the center portion of the roof molding as shown in the illustrations below.

**Tape Size:**  
**Length: 300 mm**  
**Width: 5 mm**

**NOTE:**  
Replace molding as necessary.
