**Technical Service
BULLETIN**

ROOF RACK RATTLE NOISE

'07 FJ Cruiser

ACCESSORIES
AX006-06

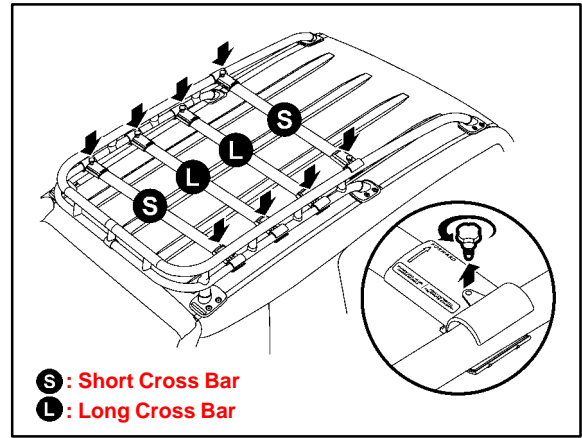
1. Remove the cross bar from the rack by unscrewing both the right and left thumbwheels. Be sure to grab the lower clamp before it falls on the roof. Set aside cross bars according to length specs.

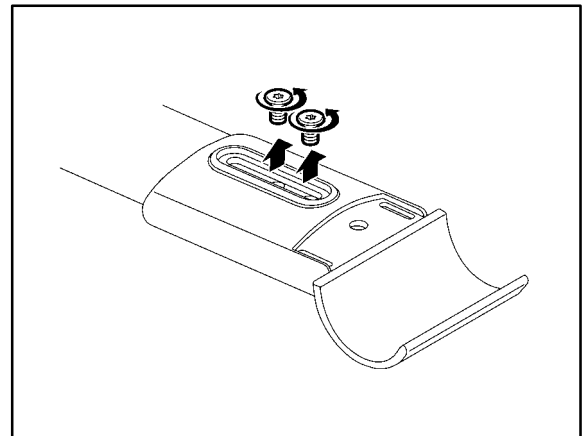
2. Set the cross bar on a table upside down and using a T-25 Torx screwdriver, remove and discard the two (2) screws from the driver's "slotted side" as shown.

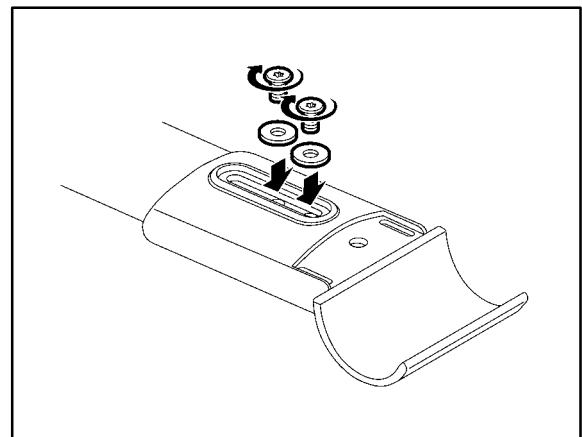
3. Using parts from the washer repair kit (P/N PT278-35070-WK), add one (1) plastic washer under the head of each NEW screw and replace the screw in the cross bar.

- Keep the washer centered on the screw so that it does NOT bind on the screw's shoulder during installation.
- Do NOT overtighten the screws — tighten them just snug enough so that the plastic clamp can still slide onto the driver's end of the cross bar.

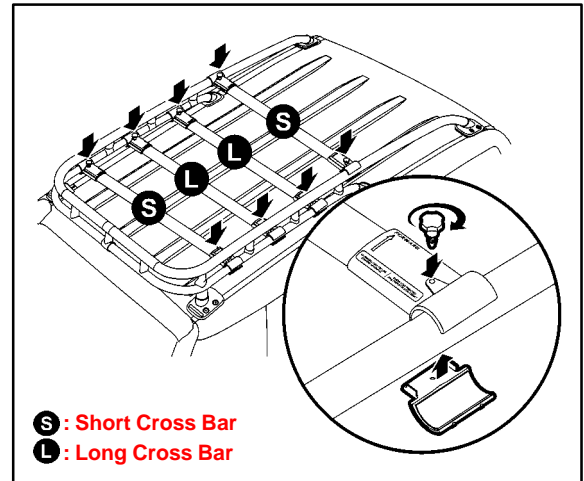
5. Reinstall the thumbwheel and lower clamps to each cross bar and tighten the thumbwheels securely.
