## SERVICE BULLETIN

NUMBER 001

MODEL MX83

### SUN VISOR VANITY MIRROR WIRE ROUTING

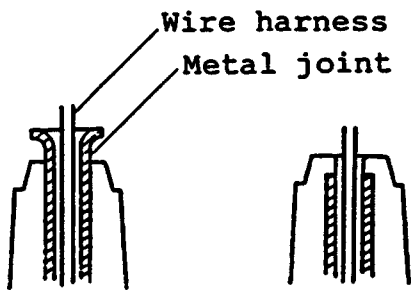
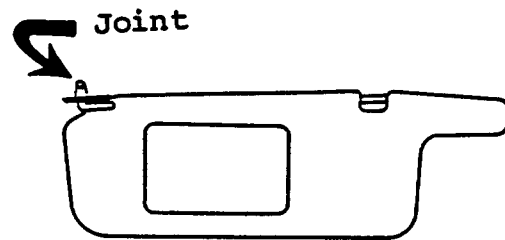
To improve the wire harness routing to the vanity mirror light, the design of the metal joint on the sun visor arm has been changed. The flare at the top of the metal joint of sun visor has been removed as shown below:

Previous

New

#### PRODUCTION CHANGE INFORMATION:

JT2MX83-0032225

May, 1989

The part numbers remain unchanged.
