# Transmission Fluid or Gear Oil Seepage from Transfer Case Vent (AWD)

**Section** Transfer/4wd/Awd

The information contained in this TSB supersedes TSB No. TC008-07.

Some 2004 – 2009 model year Highlander, 2001 – 2005 model year RAV4, and 2004 – 2010 model year Sienna AWD (4WD) vehicles may display a transmission fluid or gear oil seepage from a vent on the right side of the transfer case. The seepage is from the transfer RH (right-hand) bearing retainer No. 2 oil seal. Production improvements have been implemented to prevent this condition from occurring. Follow the repair procedure in this bulletin to replace the RH bearing retainer No. 2 oil seal assembly.

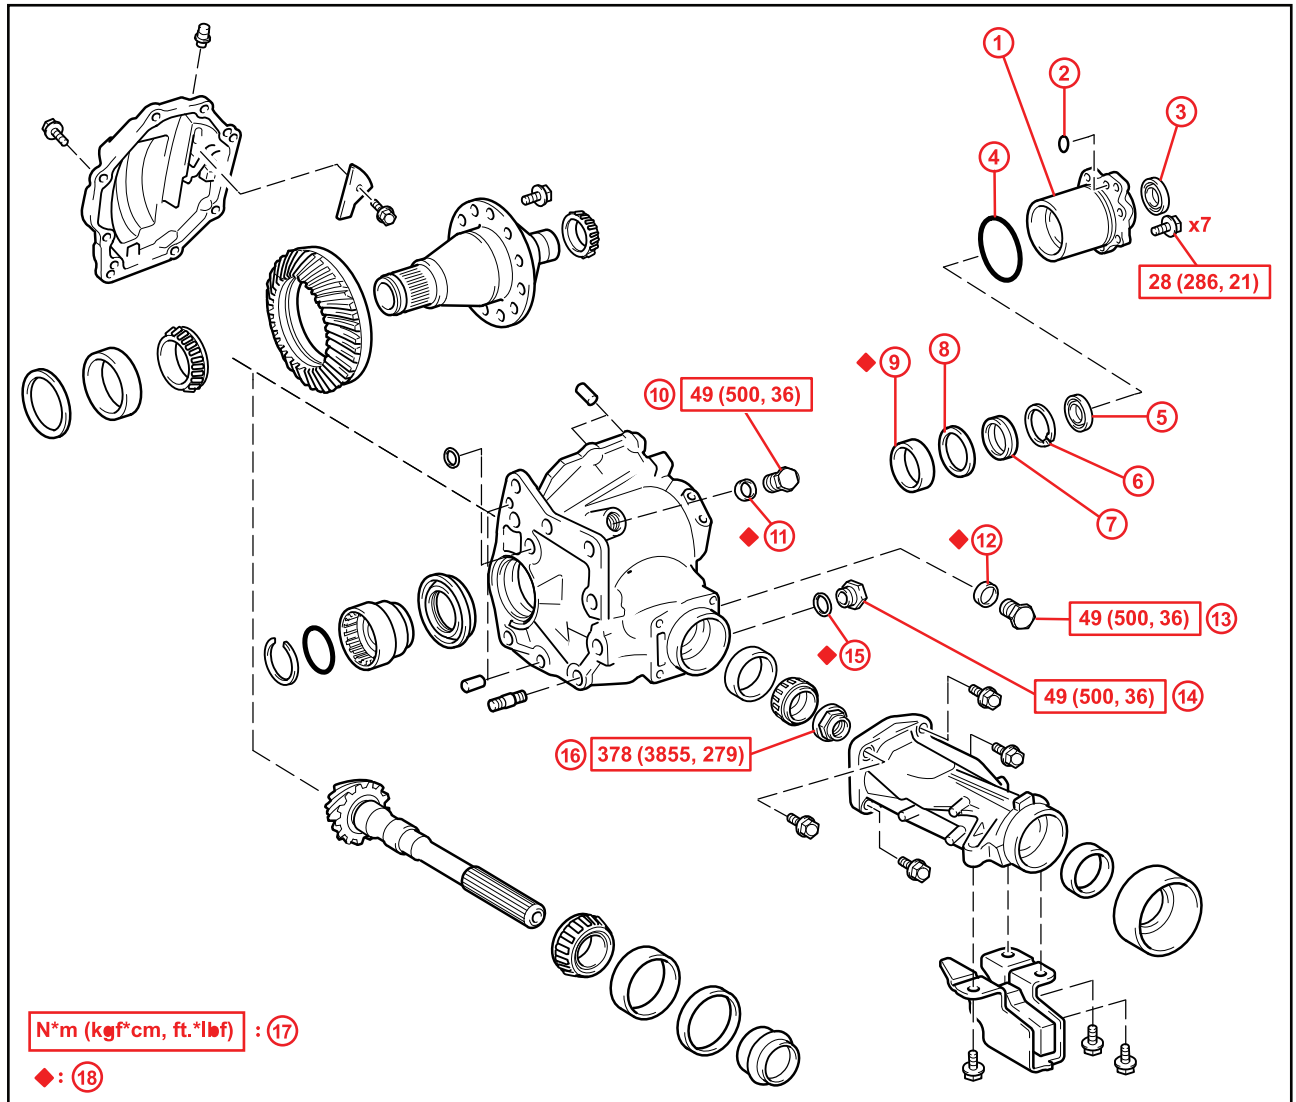
Figure 1.

1	RH Bearing Retainer Sub-assembly
2	RH Bearing Retainer O-ring
3	RH Bearing Retainer Oil Seal No. 1
4	O-ring
5	Side Gear Shaft Holder Bearing
6	Snap Ring
7	RH Bearing Retainer Oil Seal No. 2
8	Ring Gear Mounting Case Washer No. 2
9	Center Differential Case Tapered Roller Bearing RH (Outer Race)

10	No. 2 Plug
11	Gasket No. 2
12	Gasket No. 1
13	No. 1 Plug
14	Drain Plug
15	Drain Gasket
16	Lock Nut
17	Specified Torque
18	Non-reusable Part

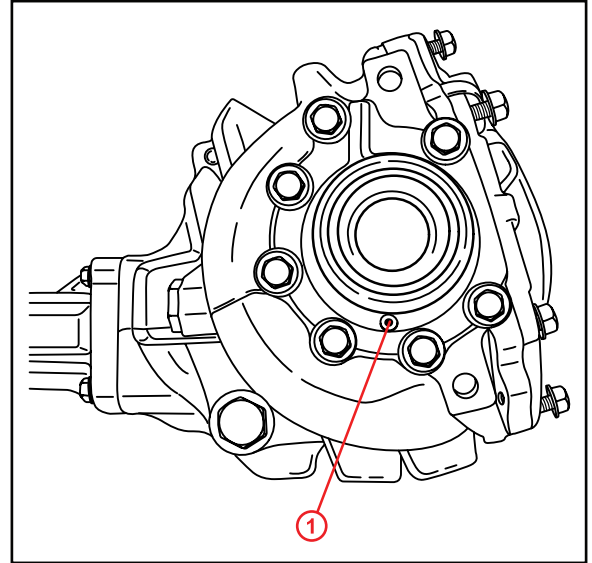
Figure 2.

1. Confirm source of gear oil/transmission fluid seepage is from vent on RH bearing retainer.

<b>1</b>	Location of Seepage in RH Bearing Retainer (Vent)
----------	---

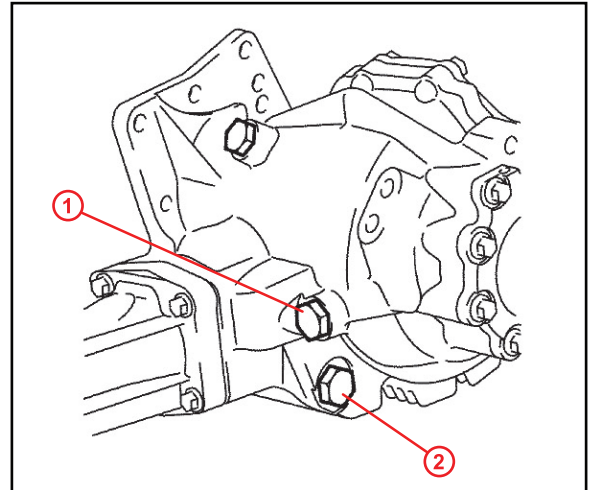
**Figure 3.**

4. Remove the transfer case No. 1 plug and remove the gasket from the plug.

<b>1</b>	<b>No. 1 Plug</b>
<b>2</b>	<b>Drain Plug</b>

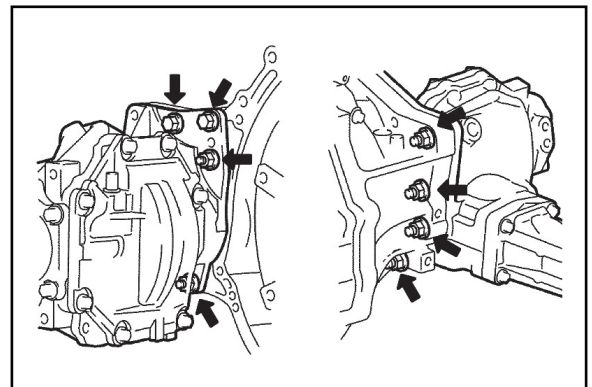
**Figure 4.**

5. Remove the transfer drain plug and remove the gasket from the drain plug.
6. Remove the transfer assembly.
  - A. Remove the 2 bolts and 6 nuts.
  - B. Using a plastic hammer, drive out the transfer assembly from the transaxle assembly.

- **Disconnect the transfer assembly from the transaxle assembly without tilting.**
- **When moving the transfer assembly, do NOT hold the assembly by the oil seals.**

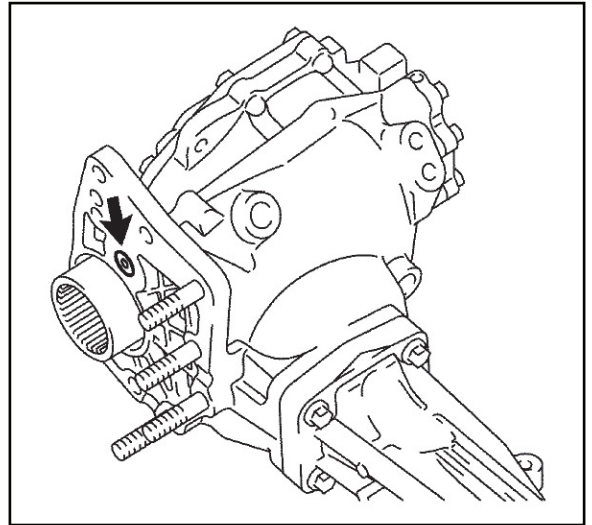
**Figure 5.**

- Remove the transfer cover gasket from the transfer assembly.

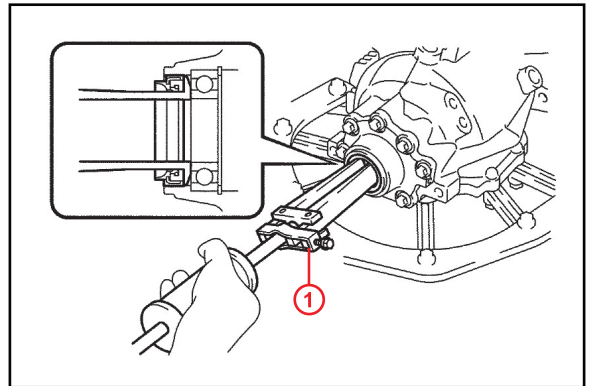
**Figure 6.**

- Using the SST, remove the transfer RH bearing retainer oil seal.

**SST P/N 09308-00010**

**Be careful NOT to damage the oil-seal-fitted surface of the retainer.**

<b>1</b>	<b>SST</b>
----------	------------

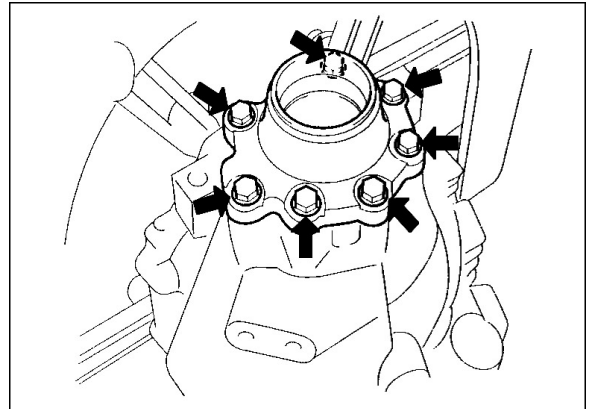
**Figure 7.**

A. Remove the 7 bolts from the RH bearing retainer sub-assembly.

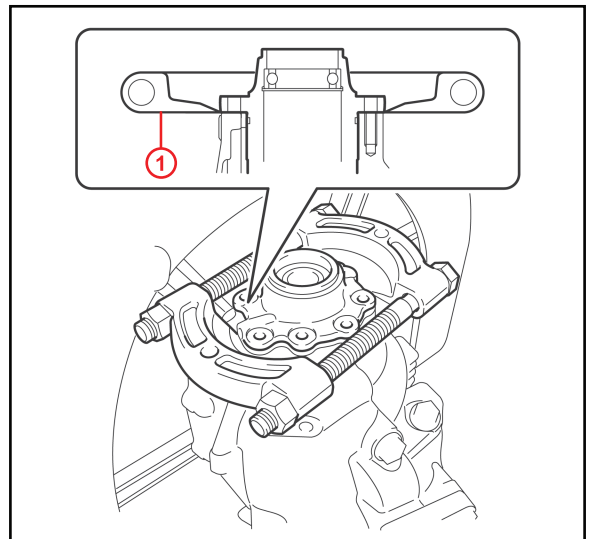
**Figure 8.**

B. Using the SST, make a clearance between the RH bearing retainer sub-assembly and the transfer case.

**SST P/N 09950-00020**

<b>1</b>	<b>SST</b>
----------	------------

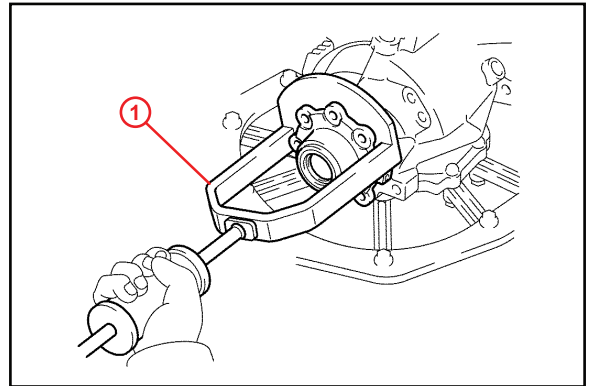
**Figure 9.**

- D. Using the SST, remove the RH bearing retainer sub-assembly from the transfer case.

**SST P/N 09520-10021**

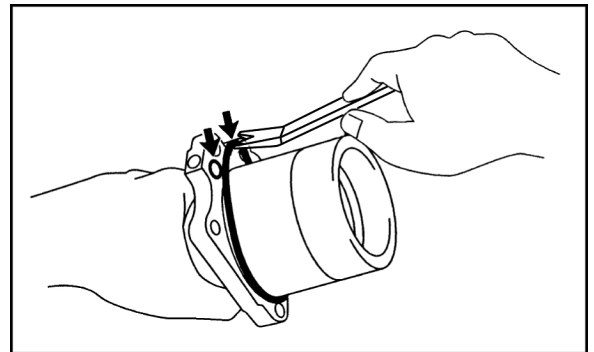
**Figure 10.**

Using a plastic pry tool or equivalent, remove the two (2) O-rings from the RH bearing retainer.

**Be careful NOT to damage the retainer's groove for the O-ring.**

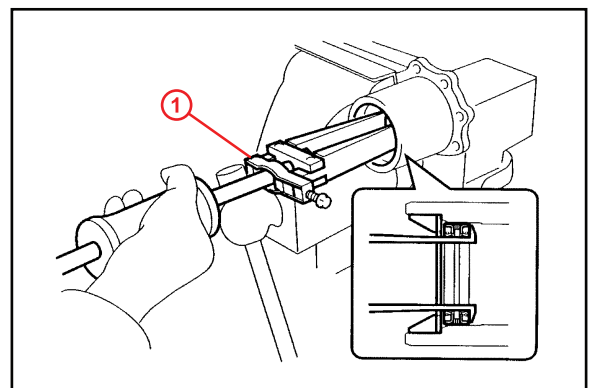
**Figure 11.**

- A. Hold the RH bearing retainer in a vise.  
 B. Using the SST, remove the outer race, washer, and No. 2 oil seal from the RH bearing retainer.

**SST P/N 09308-00010**

**Be careful NOT to damage the oil-seal-fitted surface of the retainer.**

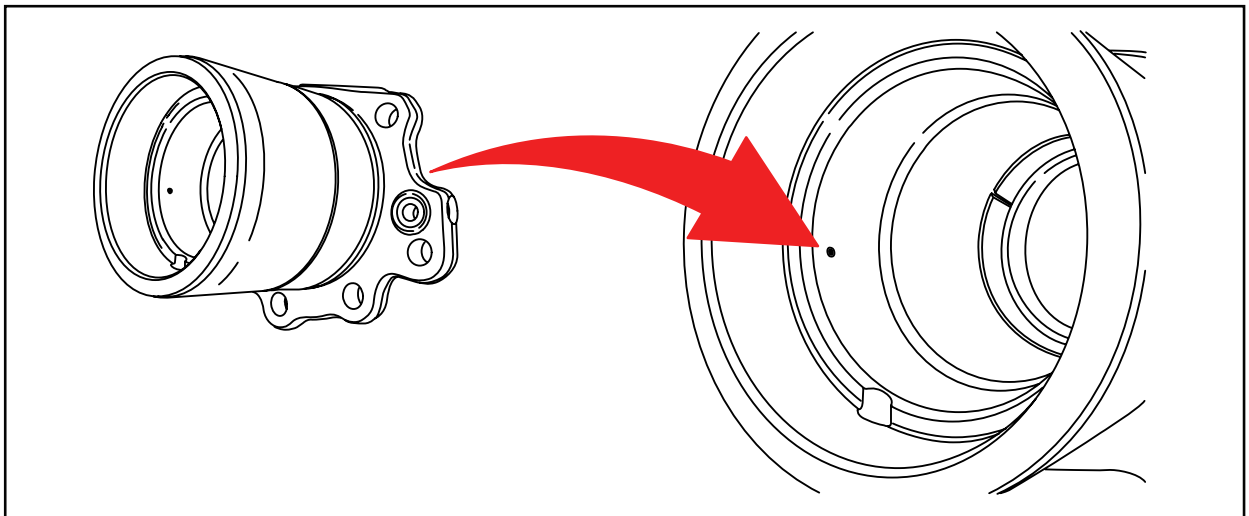
Figure 12.

1. Install a NEW No. 2 oil seal in the RH bearing retainer.

The No. 2 oil seal **MUST** be positioned so that the seal is aligned over the hole located inside the RH bearing retainer. Failure to properly align the seal so that it seals on **BOTH** sides of the hole (vent) will cause the transfer case to leak fluid out of the vent assembly on the RH bearing retainer.

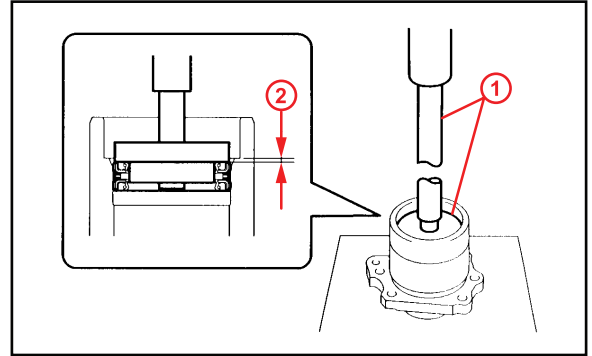
**Figure 13.**

2. Install the transfer RH bearing retainer oil seal No. 2.
  - A. Using the SST and a press, install the oil seal No. 2 to the RH bearing retainer.  
**SST P/N 09950-60010 (09951-00360, 09951-00540, 09952-06010), 09950-70010 (09951-07150)**

Carefully press-fit so that the oil seal is **NOT** tilted.

- B. Apply a small amount of MP grease No. 2 to the oil seal lip.

<b>1</b>	<b>SST</b>
<b>2</b>	<b>1.5 – 2.5 mm (0.059 – 0.098 in.)</b>

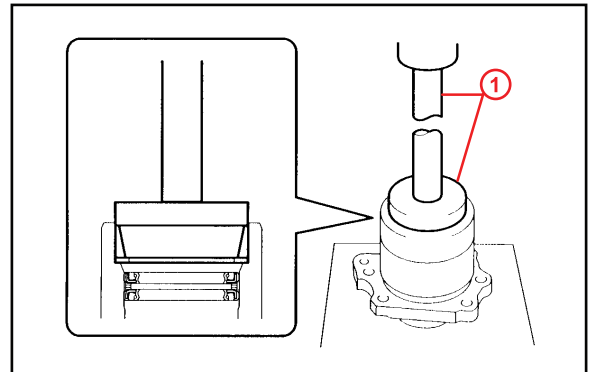
**Figure 14.**

Using the SST and a press, install the outer race to the RH bearing retainer.

**SST P/N 09950-60010 (09951-00620), 09950-70010 (09951-07150)**

<b>1</b>	<b>SST</b>
----------	------------

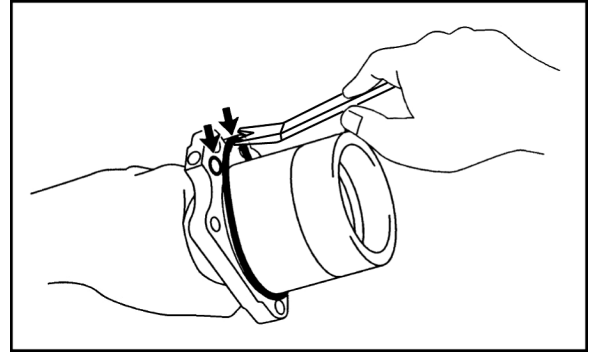
Figure 15.

5. Install the O-rings.
  - A. Apply Hypoid gear oil to the two NEW O-rings.
  - B. Install the two (2) O-rings to the RH bearing retainer.

Be careful NOT to twist the O-ring and fit it into the retainer's groove properly.

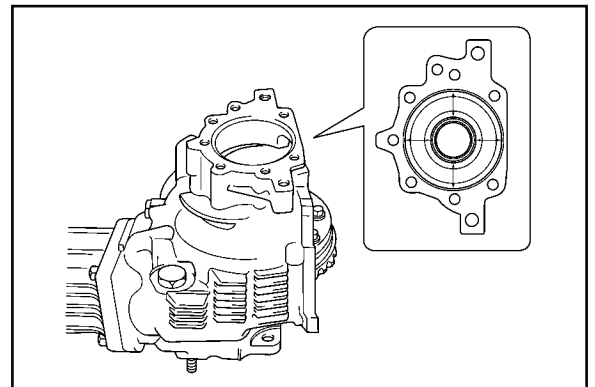
Figure 16.

6. Install the transfer RH bearing retainer sub-assembly.
  - A. Place the transfer case with the face where the RH bearing retainer is to be installed facing up, as shown in the illustration.

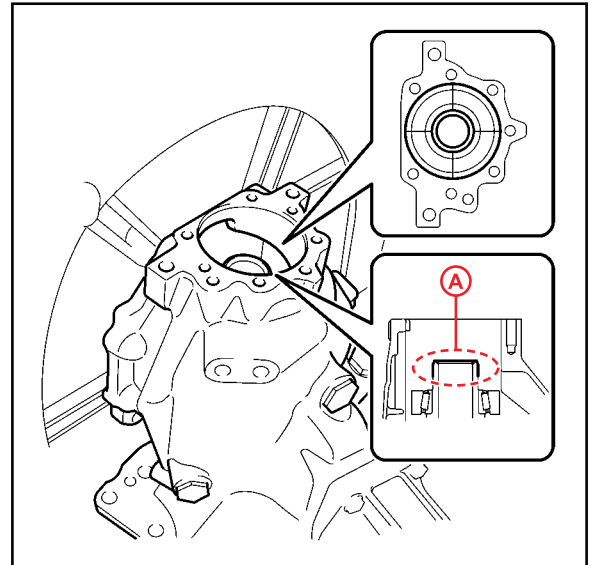
Figure 17.

- C. Apply MP grease No. 2 thinly to area A as shown in the illustration.

Apply MP grease No. 2 to prevent the oil seal lip from rolling back.

1 Area A

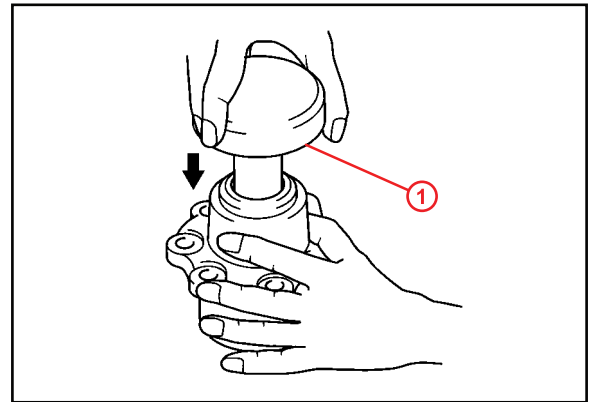
Figure 18.

- D. Insert the SST into the transfer RH bearing retainer sub-assembly.

SST P/N 09387-00090

Insert the SST straight in order NOT to damage the oil seal.

1 SST

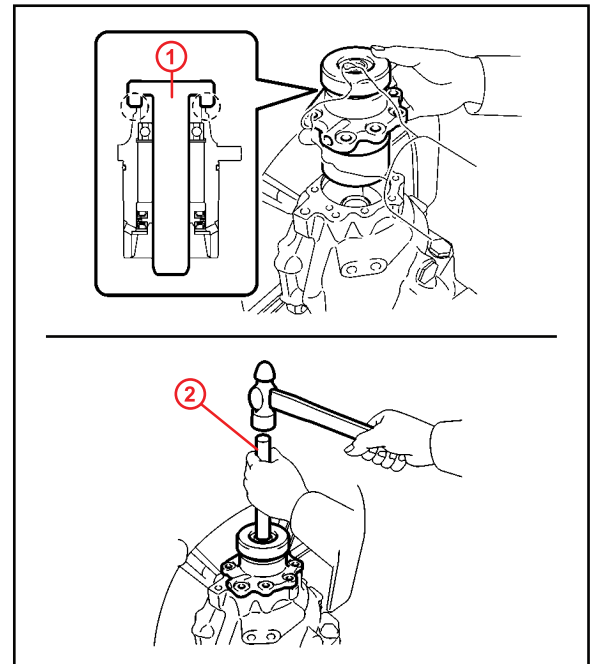
Figure 19.

- E. With the SST and the transfer RH bearing sub-assembly in close contact, install the transfer RH bearing retainer sub-assembly together with the SST into the transfer case.

- Avoid interference between the case and the retainer and between the SST and the transfer ring gear mounting case.
- Carefully check the retainer's O-ring for damage and incorrect fitting.

- If the engagement is tight, tap the SST with a hammer placing a brass bar on the center of the SST.
- If the SST and retainer are NOT in close contact, the seal for the inner end of the retainer may NOT be properly aligned when the retainer goes into position. This may result in the lip of the oil seal being rolled back during installation.
- If the SST and retainer are NOT in close contact, the center of the retainer or transfer ring gear mounting case may come out of position when the retainer is being installed. This can cause the lip of the oil seal to be rolled back.

1	SST
2	Brass Bar

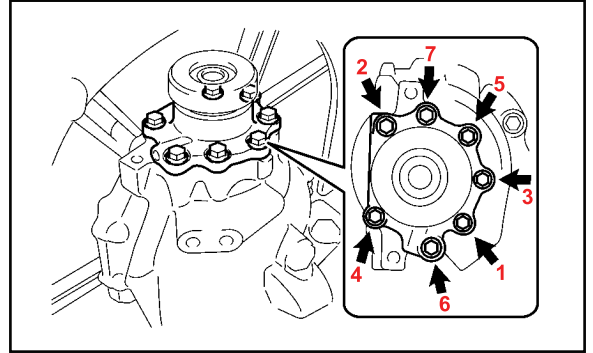
**Figure 20.**

- G. Tighten the 7 bolts evenly in the order shown in the illustration.

**Torque: 28 N\*m (286 kgf\*cm, 21 ft\*lbf)**

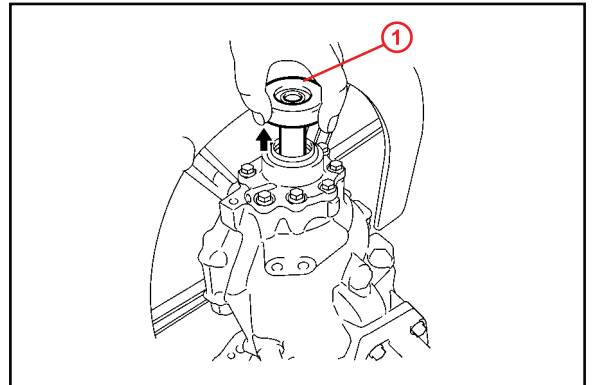
**Figure 21.**

- H. Remove the SST.

<b>1</b>	<b>SST</b>
----------	------------

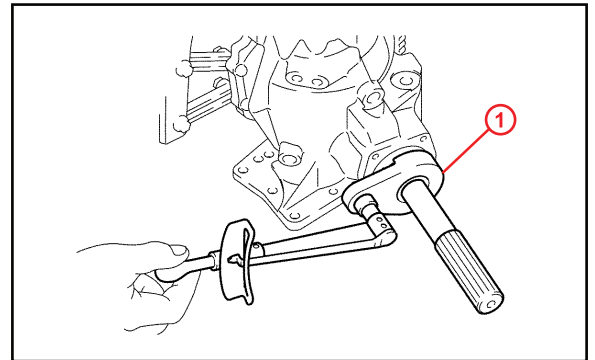
**Figure 22.**

- A. Using the SST and a torque wrench, measure the initial torque between the driven pinion bearing and the ring gear face.

**SST P/N 09326-20011**

**Driven Pinion Preload +0.15 – 0.30 N\*m  
(+1.6 – 3.1 kgf\*cm, +1.3 – 2.7 in\*lbf)**

Use a torque wrench with a fulcrum length of 160 mm (6.30 in.).

Measure the torque after rotating the bearing in both clockwise and counterclockwise directions to make it fit.

<b>1</b>	<b>SST</b>
----------	------------

- B. If the preload is too large, replace the bearing spacer with a NEW one.
- C. If the preload is too small, repeatedly adjust the preload by tightening the lock nut 5 – 10 degrees at a time until the standard value is obtained.
- D. If the preload is insufficient even though the tightening torque of the lock nut exceeds the maximum of the standard value, loosen the lock nut and apply gear oil SAE 90 (GL-5) to the lock nut and the screw thread and base of the driven pinion. Then repeat the preceding operation. If the tightening torque is smaller than the standard, replace the bearing spacer with a NEW one and adjust it.

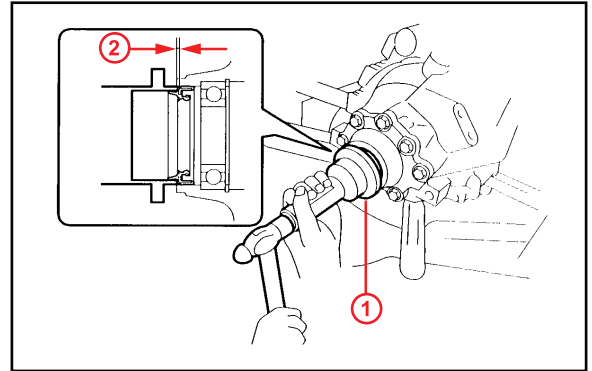
**Figure 23.**

8. Install the transfer RH bearing retainer oil seal.
  - A. Using the SST, drive the oil seal into the RH bearing retainer to the position shown in the illustration.

**SST P/N 09223-46011**

Drive in the oil seal carefully so that it will NOT be tilted.

<b>1</b>	<b>SST</b>
<b>2</b>	<b>0.7 – 1.3 mm (0.028 – 0.051 in.)</b>

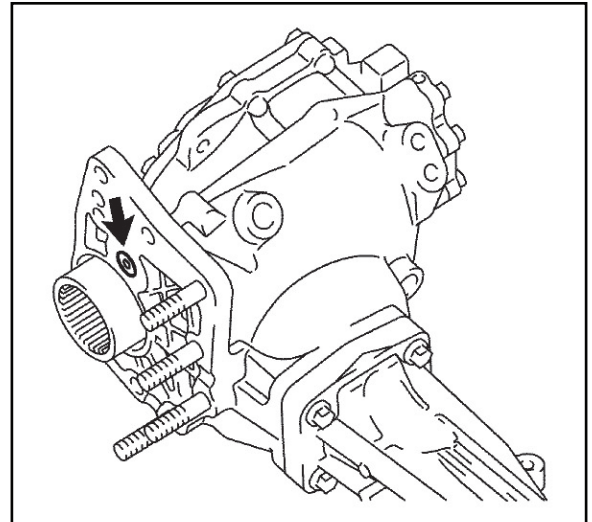
**Figure 24.**

9. Install a NEW transfer cover gasket to the case.

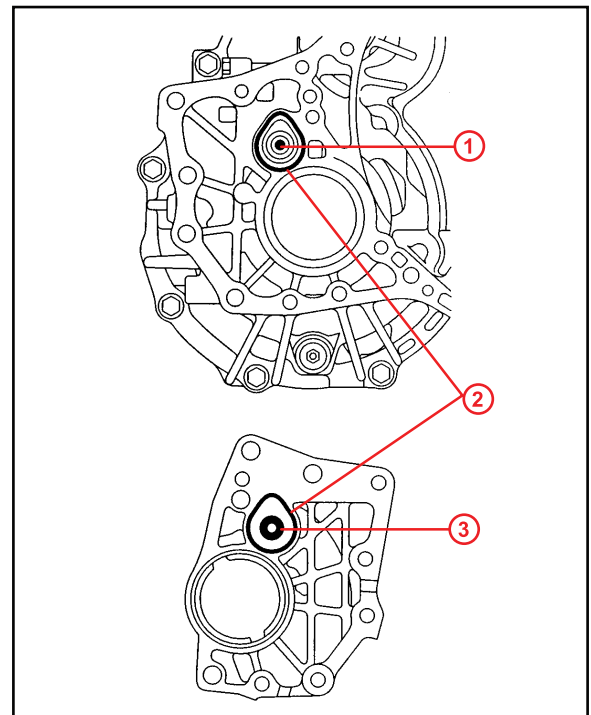
Figure 25.

- A. Apply FIPG sealant 1281 to the transaxle assembly and the transfer assembly in continuous beaded form of 1.2 mm (0.05 in.) diameter as shown in the illustration.

**FIPG sealant: Three Bond 1281, or equivalent**

- Remove any grease from the attaching surfaces.
- Install the transfer assembly **within 10 minutes** after application of the sealant.
- Sealant stuck on the gasket, case oil seal, and driving plug may cause oil leakage and seizure due to oil shortage.

1	Driving Plug
2	Sealant
3	Gasket

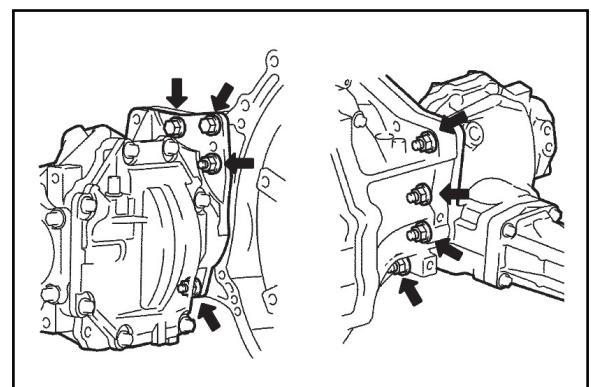
Figure 26.

- B. Install the transfer assembly to the transaxle assembly with the 2 bolts and 6 nuts.

**Torque: 69 N\*m (700 kgf\*cm, 51 ft\*lbf)**

- Check that the gasket is installed to the transfer assembly before installing it to the transaxle assembly.
- Install the transfer assembly to the transaxle assembly without tilting.
- When moving the transfer assembly, do NOT hold by the oil seals.

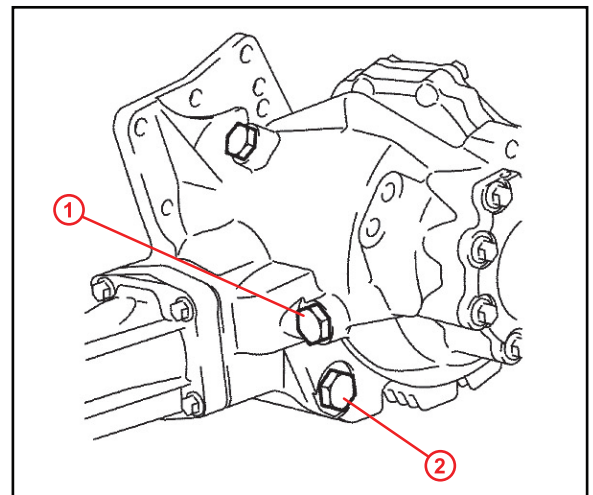
**Figure 27.**

13. Install the transfer drain plug with a NEW gasket.  
**Torque: 49 N\*m (500 kgf\*cm, 36 ft\*lbf)**

<b>1</b>	<b>No. 1 Plug</b>
<b>2</b>	<b>Drain Plug</b>
