Washer Hose Loose

Service Category Vehicle Exterior

Section Wiper/Washer

YEAR(S)	MODEL(S)	ADDITIONAL INFORMATION
2009 – 2010	Corolla

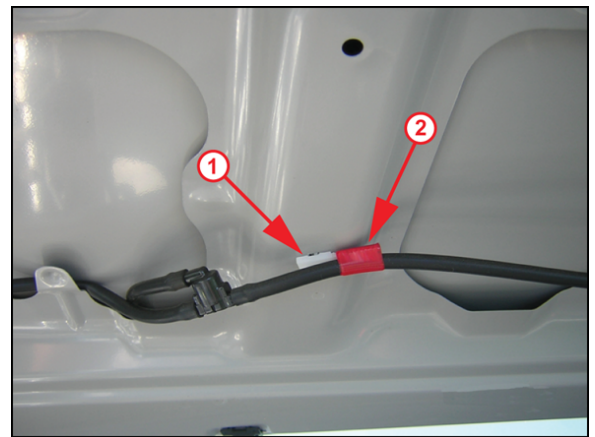
1. Remove the red tape holding the windshield washer hose to the hood clip, as shown in Figure 1.
 - A. Remove the clip from the hood.
 - B. Remove the tape by cutting.

1	Hood Clip
2	Red Tape

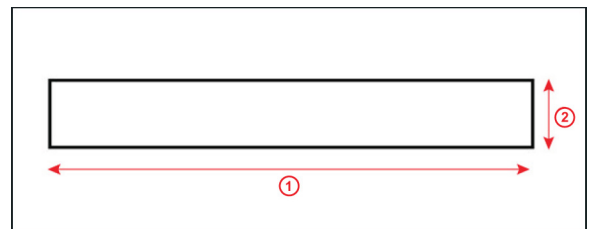
Figure 2.

2. Cut the tape into 3 separate pieces to the following dimensions:
 - Length: 90 mm (3 5/8 in.)**
 - Width: 19 mm (3/4 in.)**

1	90 mm (3 5/8 in.)
2	19 mm (3/4 in.)

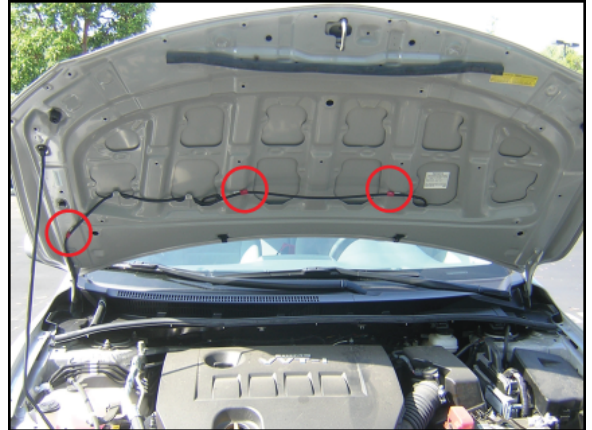
3. Reattach the washer hose to the clip by wrapping it a minimum of 3 turns using NEW tape.

Perform this repair in the 3 locations shown in Figure 3.

4. Reinstall the clips to the hood.
