# TOYOTA Technical Service BULLETIN

## Title: **BODY MOUNT NOISE**

Models:  
**'03 4Runner**

NVH  
NV002-04

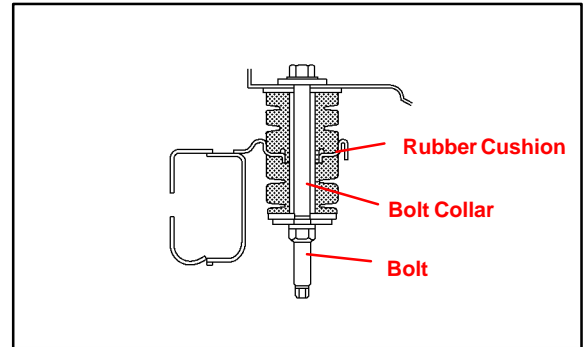
**Introduction** The following field fix procedure was developed to help reduce the possibility of noise from the left front body mount.
